Executive Summary: Replaced the tonneau riser clevis ends with a pair of McMaster-Carr #2447K17, \$8.51 ea. Minor modification (filing) required to accommodate the [intentionally] bent washer, which activates the latching fork, and to keep it oriented correctly. Used the original bolt and washer, plus an additional shim washer rather than the included clip. Necessitated readjusting the latching pawl per Spyder Service Manual Supplement p.42-172. Ran top auto-configure.

Tonneau Riser Clevis End

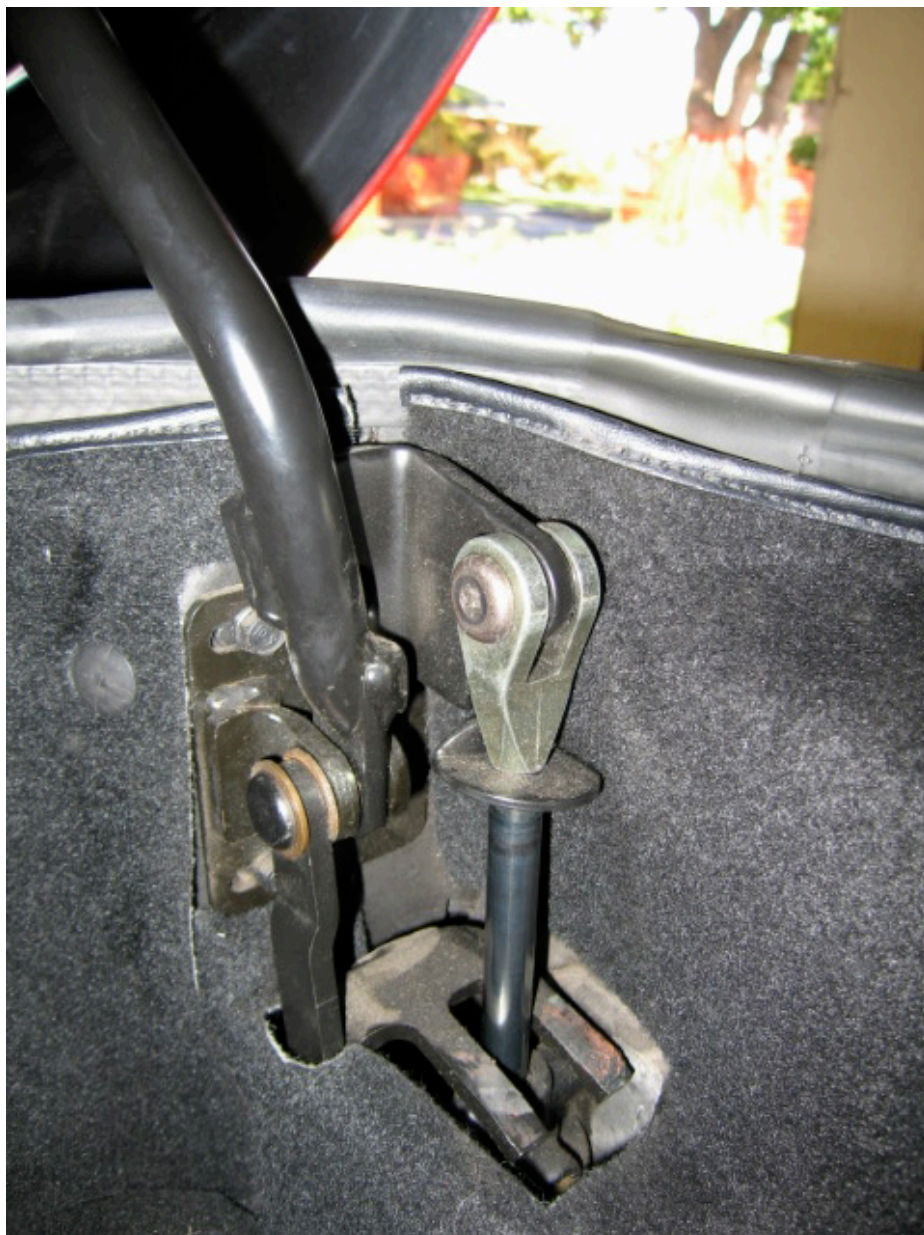
Photo 1 is a look at the original part, installed.

The threads on one of the tonneau riser clevis ends stripped when I ran the top auto-configure. I heard the hydraulic pump whine, then a scary clunk. I believe this problem had already started months ago when that side of the tonneau began failing to latch. Latching on that side has always been a problem, with the Mitsu mechanic making adjustments which worked only for awhile.

The clevis had about 4 or 5 threads stripped out, leading me to wonder if it had been screwed on fully. The piston rod appeared in good shape. I cleaned it up with a 3/8" x 24tpi die (yes, inches--see discussion in the "bracket for tonneau cover" thread).

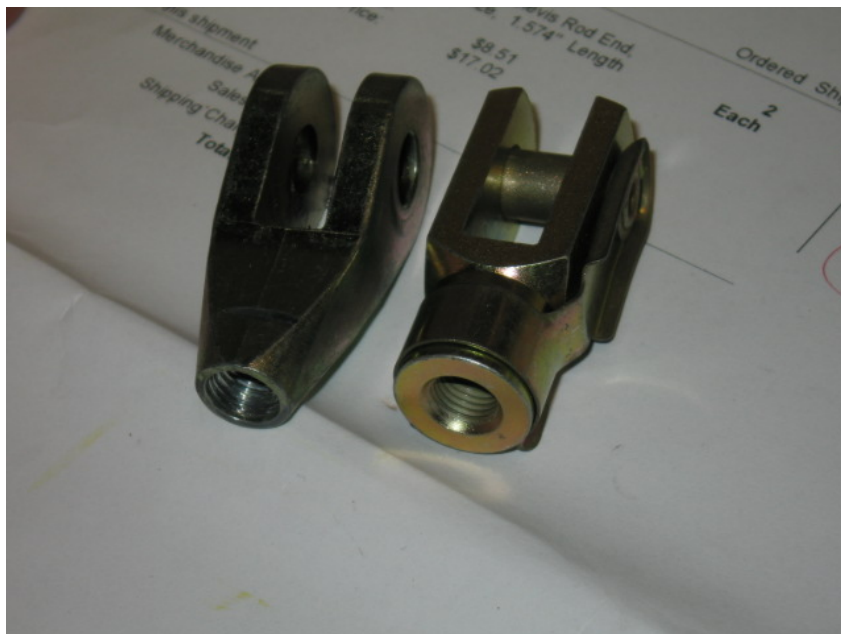
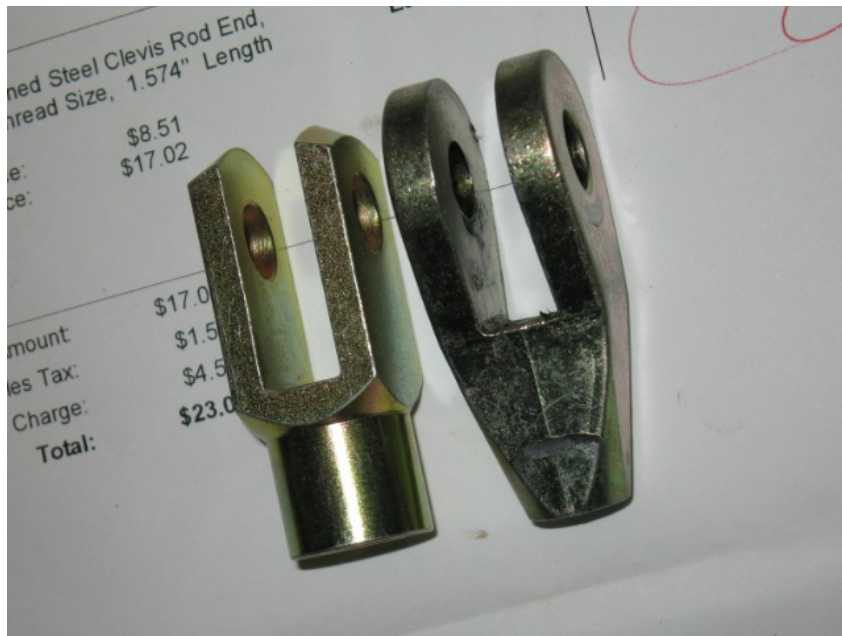
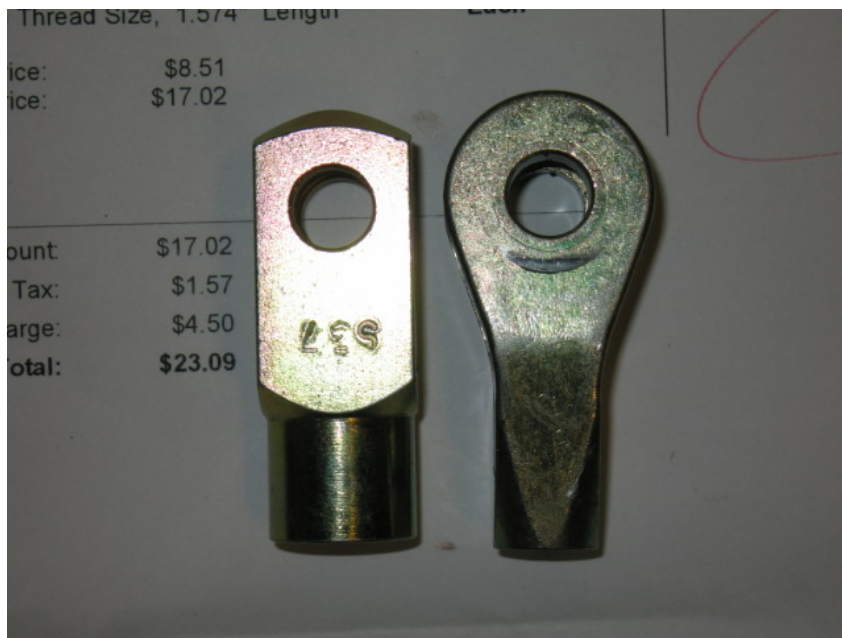
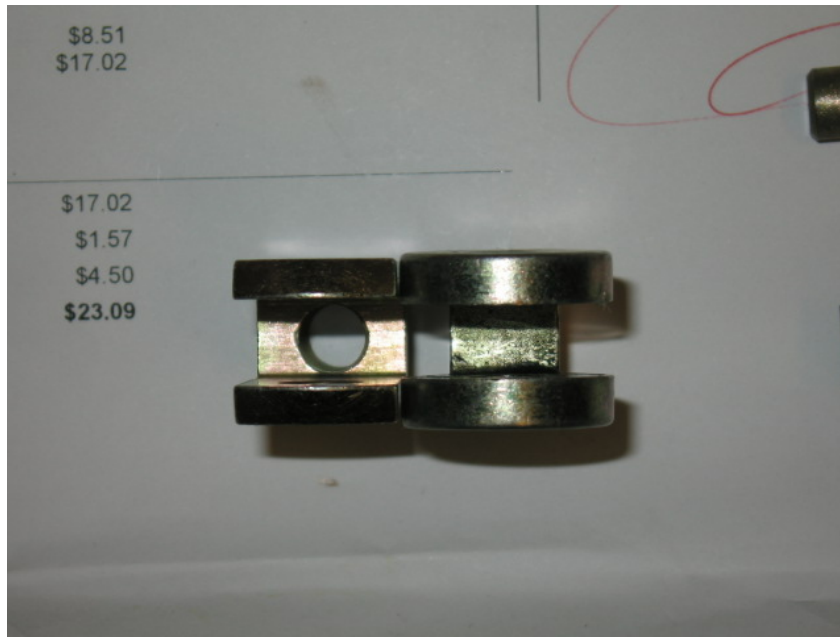
The measurements aren't exactly the same, as can be seen in the following photos. However, they are sufficiently close, especially given the computer can compensate for the length difference during auto configuration. The McMaster ones are machined zinc-plated steel, which should be stronger than the original cast steel (see Marc Mayer's 9/29/09 10:54 message).

Photos 2-5 show comparison of the McMaster part to the original.

I replaced both clevis ends, for balance, with [McMaster-Carr #2447K17](#), which are \$8.51 ea. They come with a quick-attach clip pin, which I ended up not using (see below).

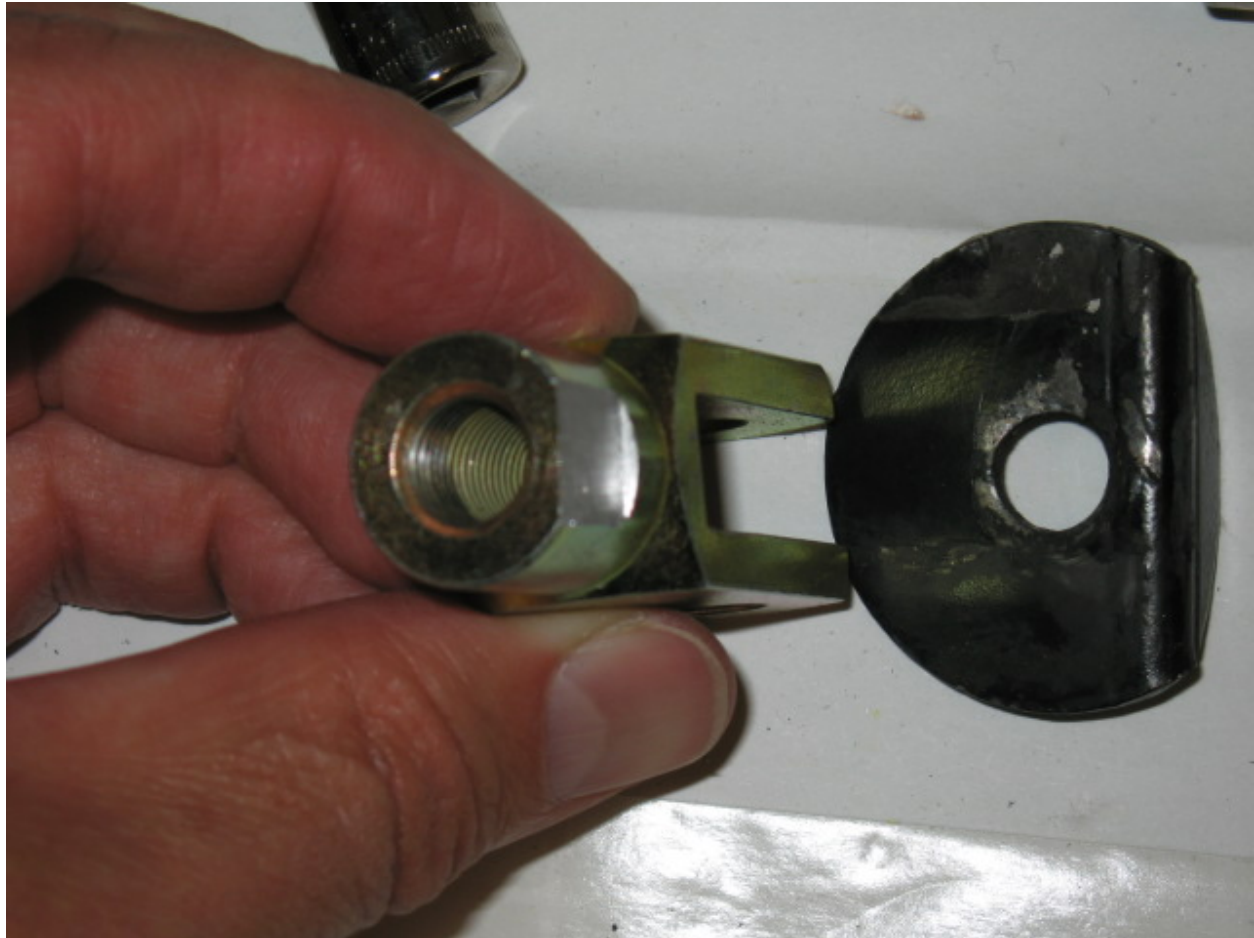
The McMaster part required a slight modification to accommodate the [intentionally] bent washer which sits below the clevis end and activates the fork attached to the tonneau latching pawl. The base of the original part is both narrower (so the bent edge of the washer fits past it) and flattened on the part toward the back of the car (keeping the bent washer oriented). I filed the McMaster part to achieve these goals, as seen in photo 6. (Read below before filing.)

Suggestion: To determine which side of the clevis to file, put the washer on upside down (so the unfiled clevis won't have to clear the washer bent edge) and screw the clevis on to see which side ends up at the back of the car.

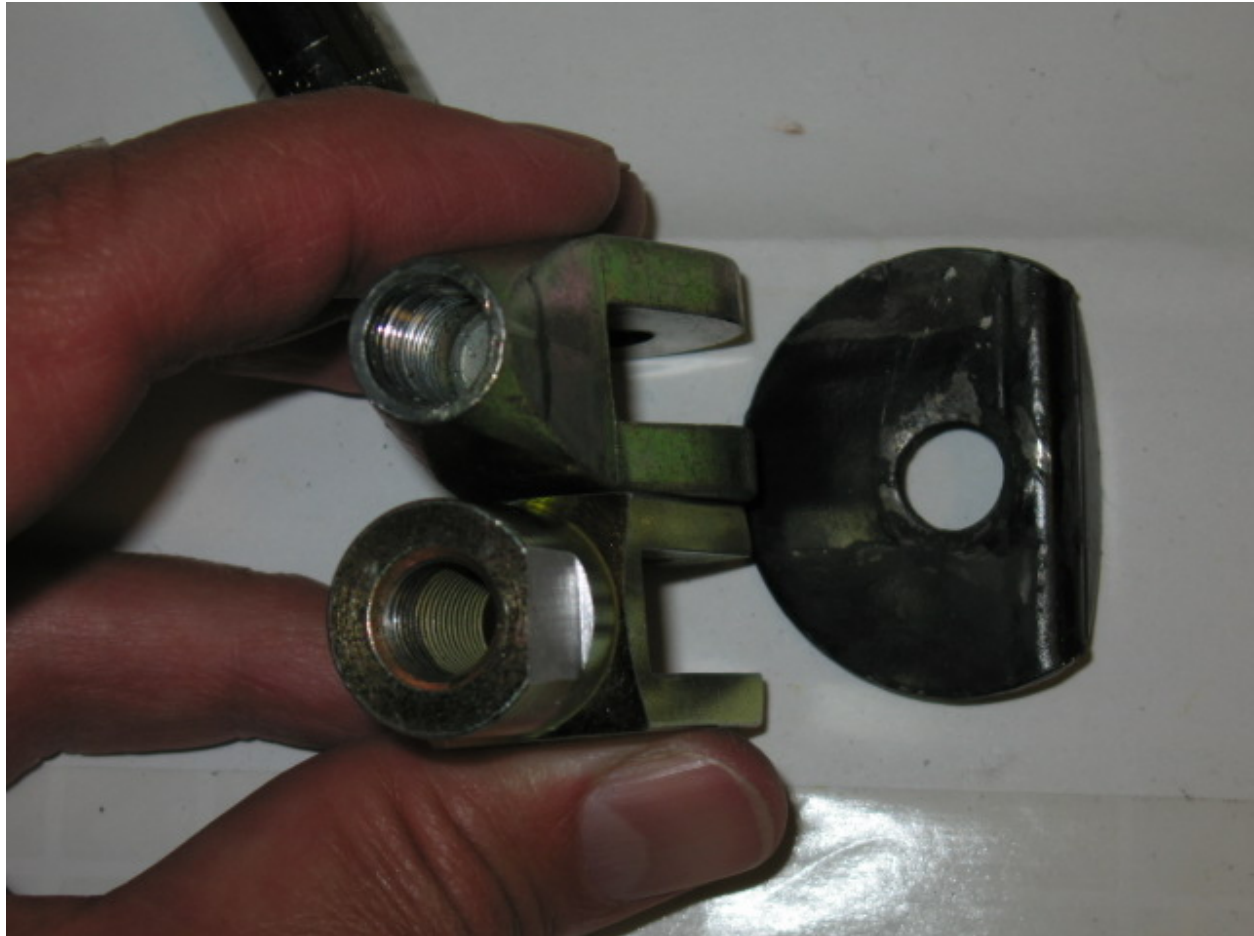
I was somewhat concerned about the wall thickness after filing. However, it is at least as thick as the original part (photo 7).

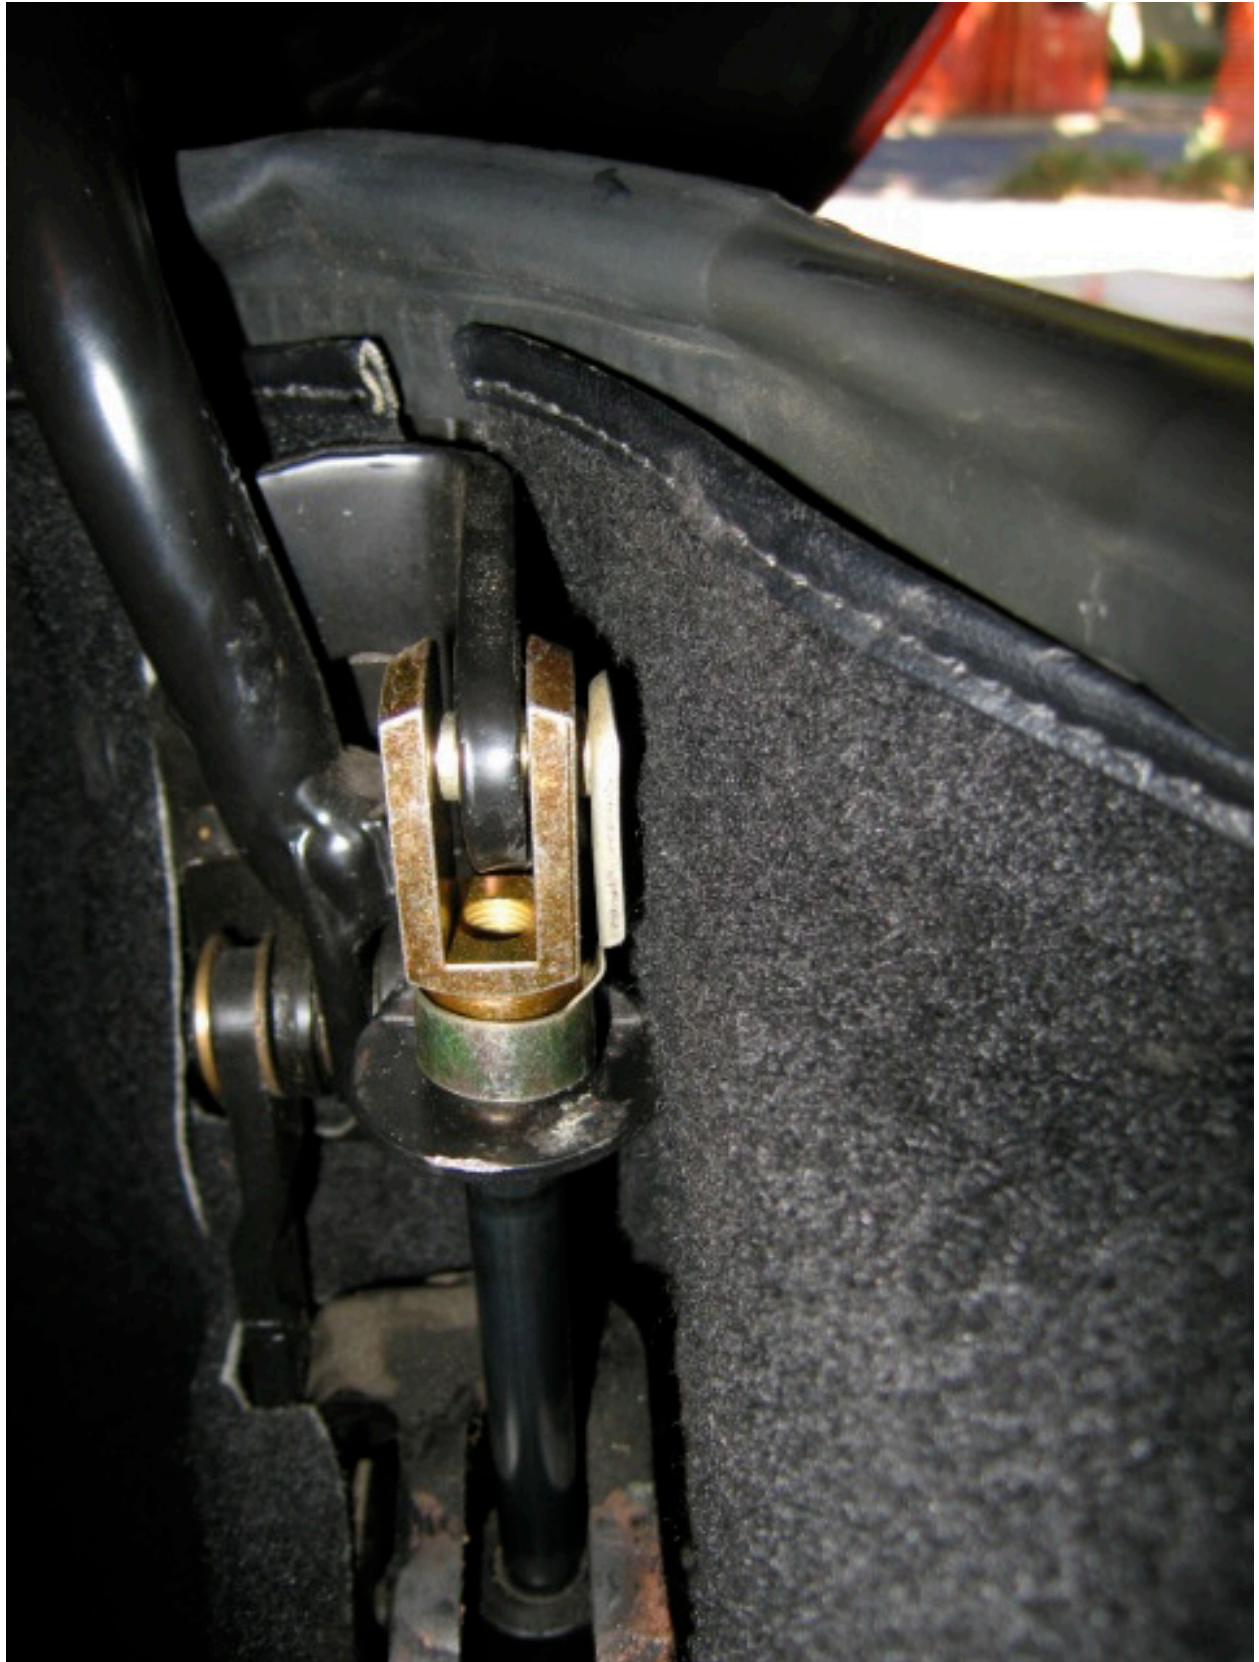
The clip has very sharp edges and they will rub against the trunk carpet on the driver side (see photo 8). (It cannot be reversed as it has to pivot onto the clevis and the washer bent edge is in the way of this on the back side.) Concerned that the clip might cut into the carpet over time, I decided not to use it. An additional consideration in this decision is that the clip doesn't quite fasten completely due to the washer bent edge being in the way. It's probably the safer choice anyway to bolt it.

I used the original bolt and nut. Because of the same consideration for rubbing against the carpet, I oriented the smoother torx end toward the carpet. (Originally, on both drive and passenger sides, they were oriented with the torx ends to the passenger side.) It probably doesn't matter in practice, and would look slightly neater from inside the trunk, as well as be easier to install, with the torx ends facing the center of the car.

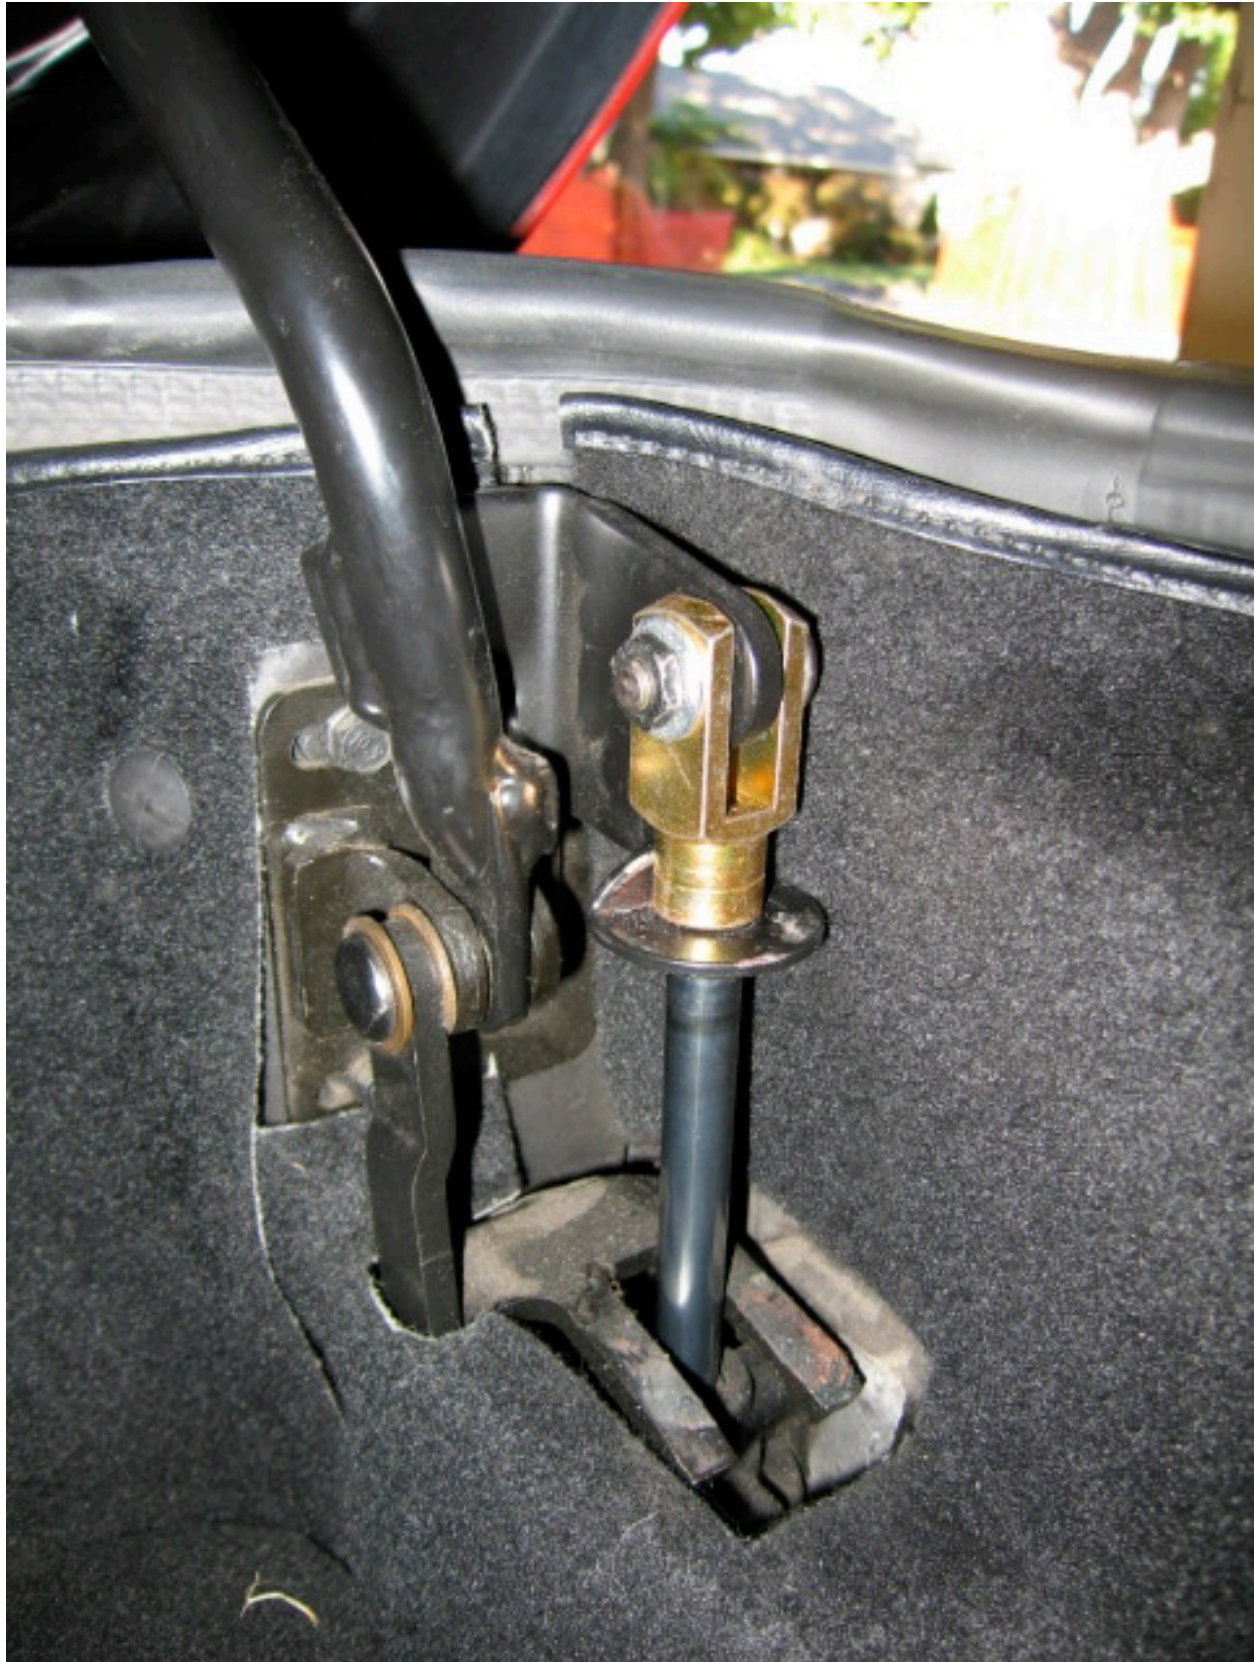
Photo 9 is the installed view.

The bent washer depresses the fork (see bottom of final photo) which activates the tonneau latching pawl. The mechanics ensure the pawl begins to rotate forward just as the striker on the tonneau enters it. Because the washer position may have changed (the new clevis did not put the washer at exactly the same height on my installation), the latch mechanism must be adjusted.

Briefly, raise and lower the tonneau manually (set the passenger-side hydraulic valve to point down) and watch where the striker enters the latch. I had to use a flashlight as the tonneau is almost closed at that point. On mine, the striker was actually hitting on the tip-top of the front ridge, then forcing the pawl forward with a clunk, rather than entering basically in the gap between the two pawl ridges.

Because the forks of the original clevis are slightly wider, I used a washer as a shim, which you can just make out inside the nut in the final photo.

The rough adjustment is done by adjusting the mounting height of the fork, and the fine adjustment by adjusting the cable end from the bottom of the fork where it is mounted on the chassis. That latter required two 10mm open-end wrenches due to space constraints (another trip to the hardware store).
