TECHNICAL SERVICE BULLETIN

SPYDER RETRACTABLE HARDTOP REPAIR

NO. TSB-95-42A-001

MODEL 1995-96 Spyder

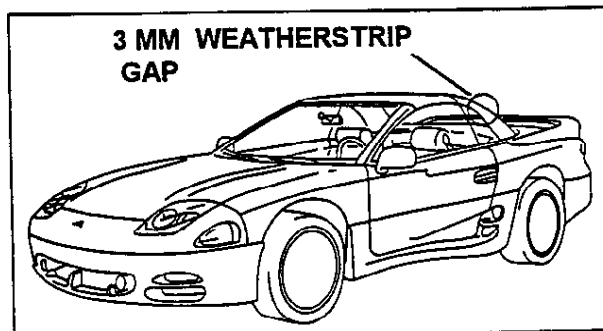
- The quarter glass weatherstrip is designed with a 3 mm gap between the glass seal and the upper edge of the glass. This gap is normal and should not cause wind leak or turbulence noise. If the gap is more than 3 mm, quarter window servicing is required.

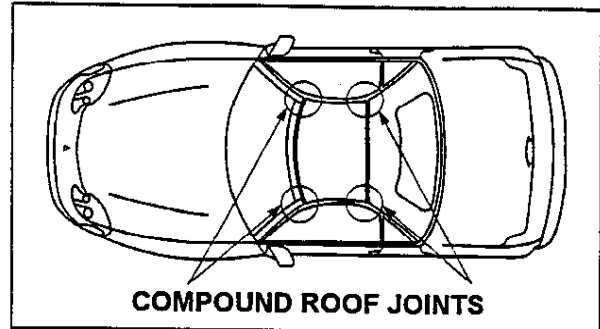
- **Normal** - Signs of seepage at any or all of the compound roof joints are normal. As with any convertible top, it is normal for some leakage to occur when flooding the seal joints with large amounts of water, such as in an automatic car wash or when spraying at a seal joint with a garden hose.

- **Service Required** - Under normal conditions, the vehicle should not experience any water leakage. Vehicle servicing is required if water leakage occurs under normal conditions.

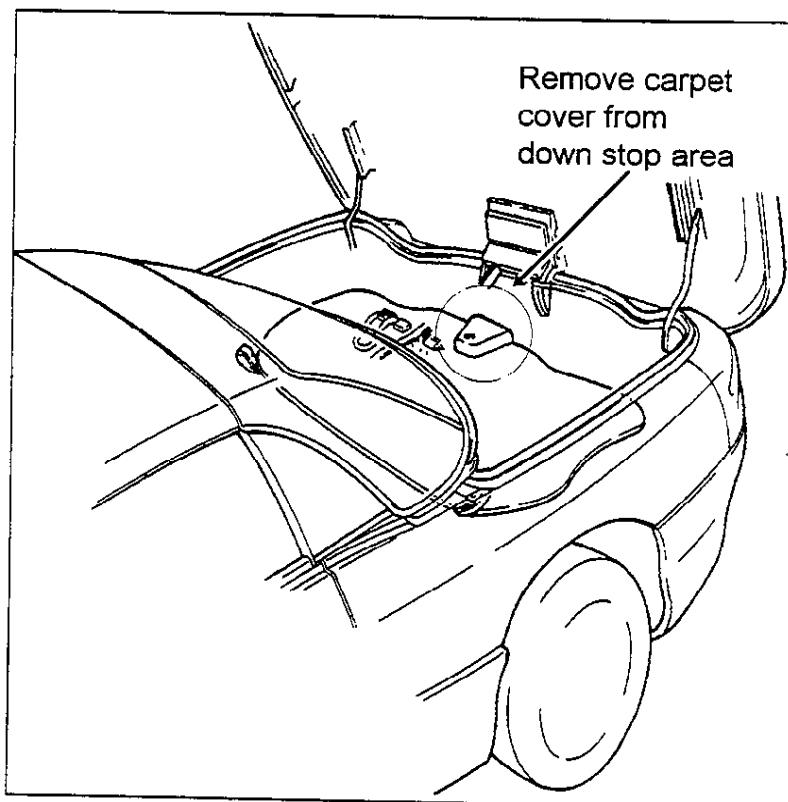
Some 1995 Spyders may have a piece of specially molded carpeting covering the retractable hardtop downstop. This carpeting interferes with the retractable hardtop when it is retracted into the trunk. The carpeting may crease the retractable hardtop weather-strip moulding causing a potential water leak inside the vehicle.

1. Using the Hardtop and Hard Tonneau control switches, fully open the tonneau.
2. Gently lift the object-in-trunk sensor enough to gain access to the hardtop down stop.
3. Remove and discard the hardtop down stop carpet cover.
4. Reposition the object-in-trunk sensor to its correct location.
5. Close the hard tonneau.
6. Cycle the hardtop twice on a flat level surface.
7. If the hardtop will not cycle, ensure the object-in-trunk sensor is properly connected.

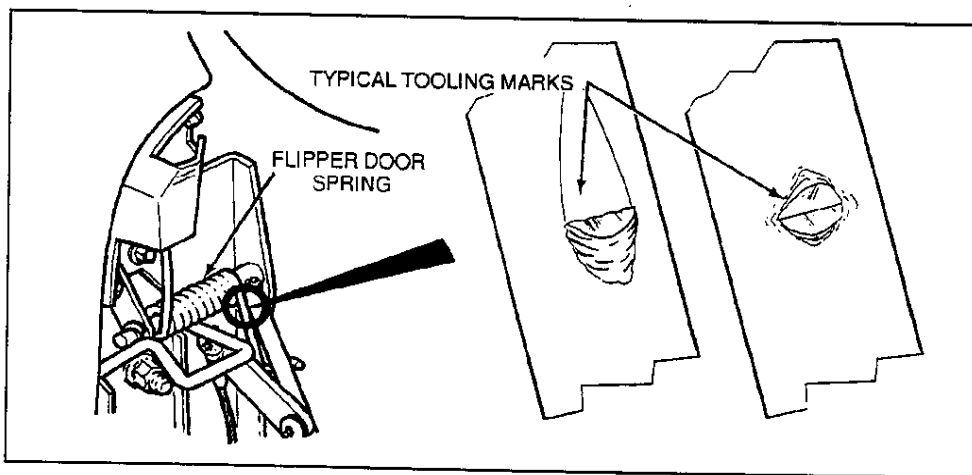
There is a slight possibility that over time and after many cycles of the retractable hardtop, the flipper door springs may break. Whenever an affected unit is in your dealership for service, inspect the flipper door springs for a tooling mark. Replace the spring(s) if the tooling mark is present.

- Hold down one flipper door at a time and inspect the flipper door spring closely. Look for small tooling marks on the hooked side of the spring near the coil.
 - If the spring(s) have no tooling marks, no further action is necessary. Carefully let the flipper doors go back into position and close the tonneau.
 - If the spring(s) have the tooling mark, carefully let the flipper doors go back into position then proceed with step 3.
