Identified and Resolved an ESD Defect Spike via Dielectric Thickness Control

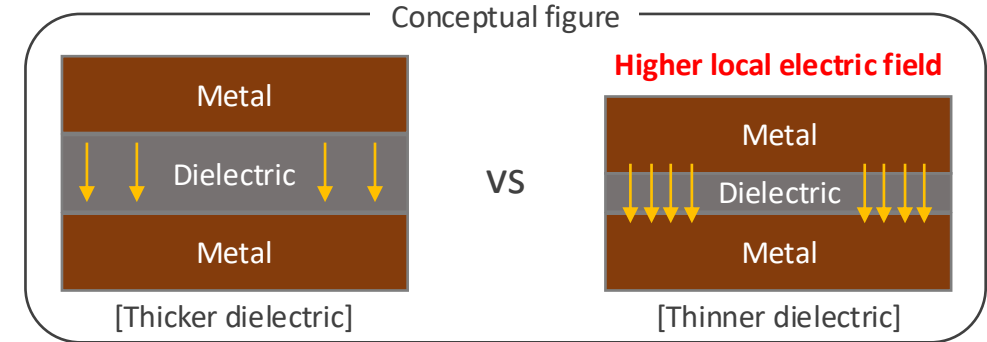
Capacitive coupling effect

- Thinner dielectrics in the capacitive stack led to higher local electric fields, increasing ESD susceptibility
