Identified and Resolved an ESD Defect Spike via Dielectric Thickness Control

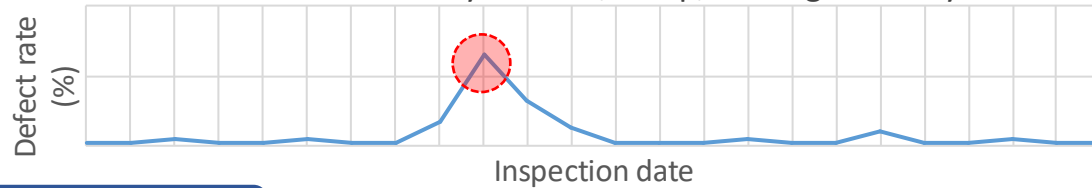
ESD defect rate spike

- A sudden spike in the electrostatic discharge (ESD) defect rate occurred
- This defect caused reliability failures, scrap, and significant yield loss

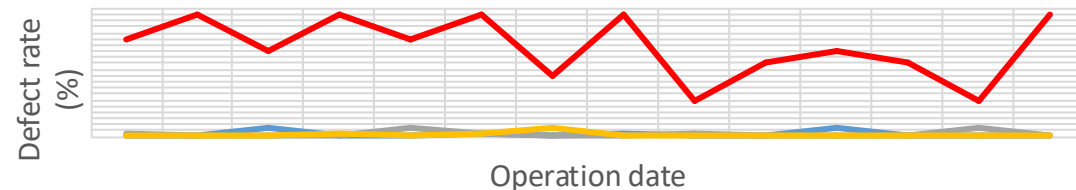
Tool-to-tool defect rate variation

- **One photolithography coater** showed a higher defect rate than others
- Confirmed through tool-level analysis at a specific process step

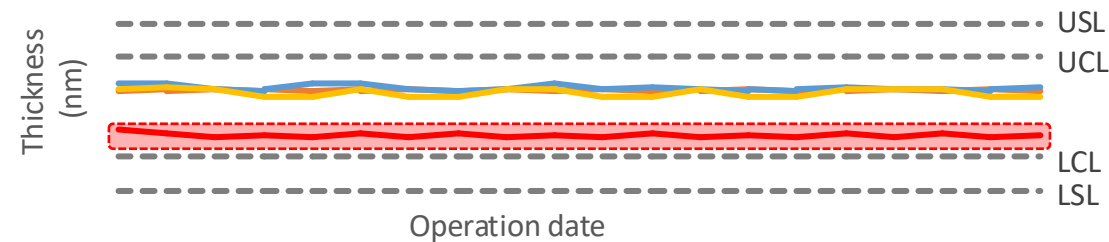
Lower thickness

- The same photolithography coater produced a **thinner layer**
- Confirmed by inline thickness monitoring data and SEM analysis

- **Adjusted the thickness target** and **redefined spec** with related teams

- Implemented automated thickness monitoring with email alerts
- Increased thickness measurement frequency

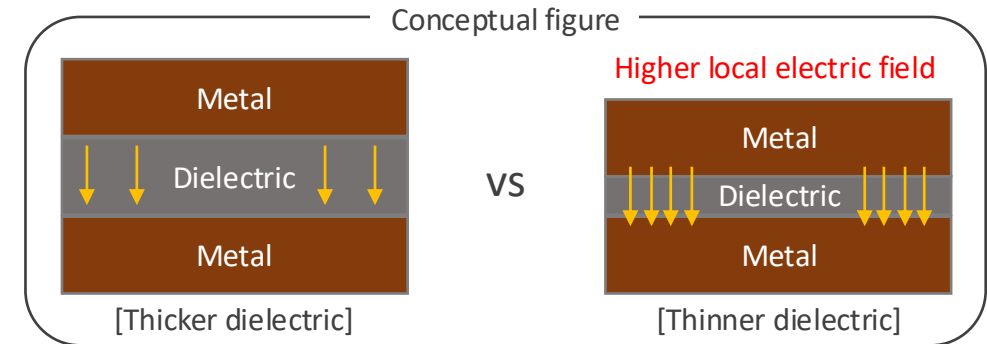
Capacitive coupling effect

- **Thinner dielectrics** in the capacitive stack led to **higher local electric fields**, increasing ESD susceptibility
