# Identified and Resolved an ESD Defect Spike via Dielectric Thickness Control

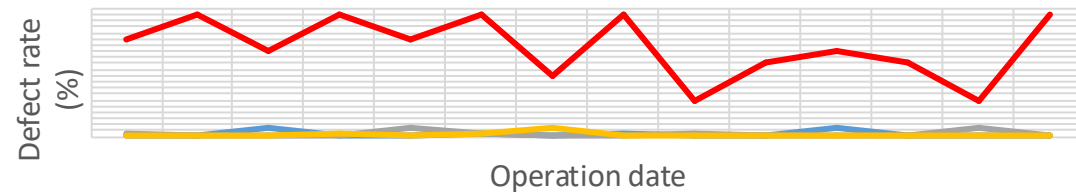
### Tool-to-tool defect rate variation

- **One photolithography coater** showed a **higher defect rate** than others
- Confirmed through tool-level analysis at a specific process step

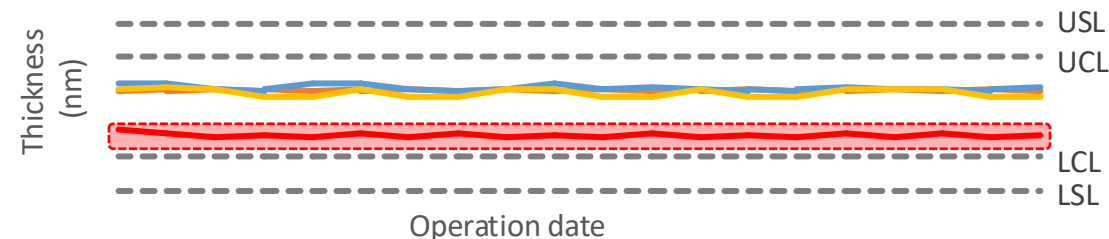
### Lower thickness

- The same photolithography coater produced a **thinner layer**
- Confirmed by inline thickness monitoring data and SEM analysis

- Showed that most ESD-defective samples had thinner dielectric layers

- **Adjusted the thickness target** and **redefined spec** with related teams

- Implemented automated thickness monitoring with email alerts
- Increased thickness measurement frequency

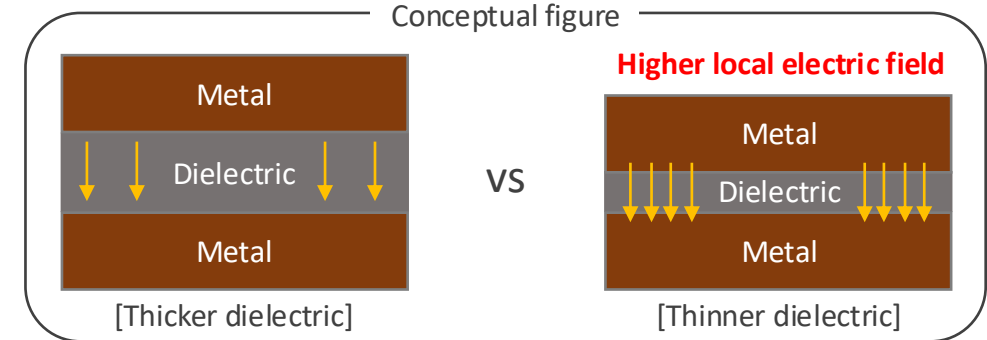
### Capacitive coupling effect

- Thinner dielectrics in the capacitive stack led to higher local electric fields, increasing ESD susceptibility
