PIC24FJ128GA204 Family Silicon Errata and Data Sheet Clarification

The PIC24FJ128GA204 family devices that you have received conform functionally to the current Device Data Sheet (DS30010038B), except for the anomalies described in this document.

PIC24FJ128GA204 FAMILY

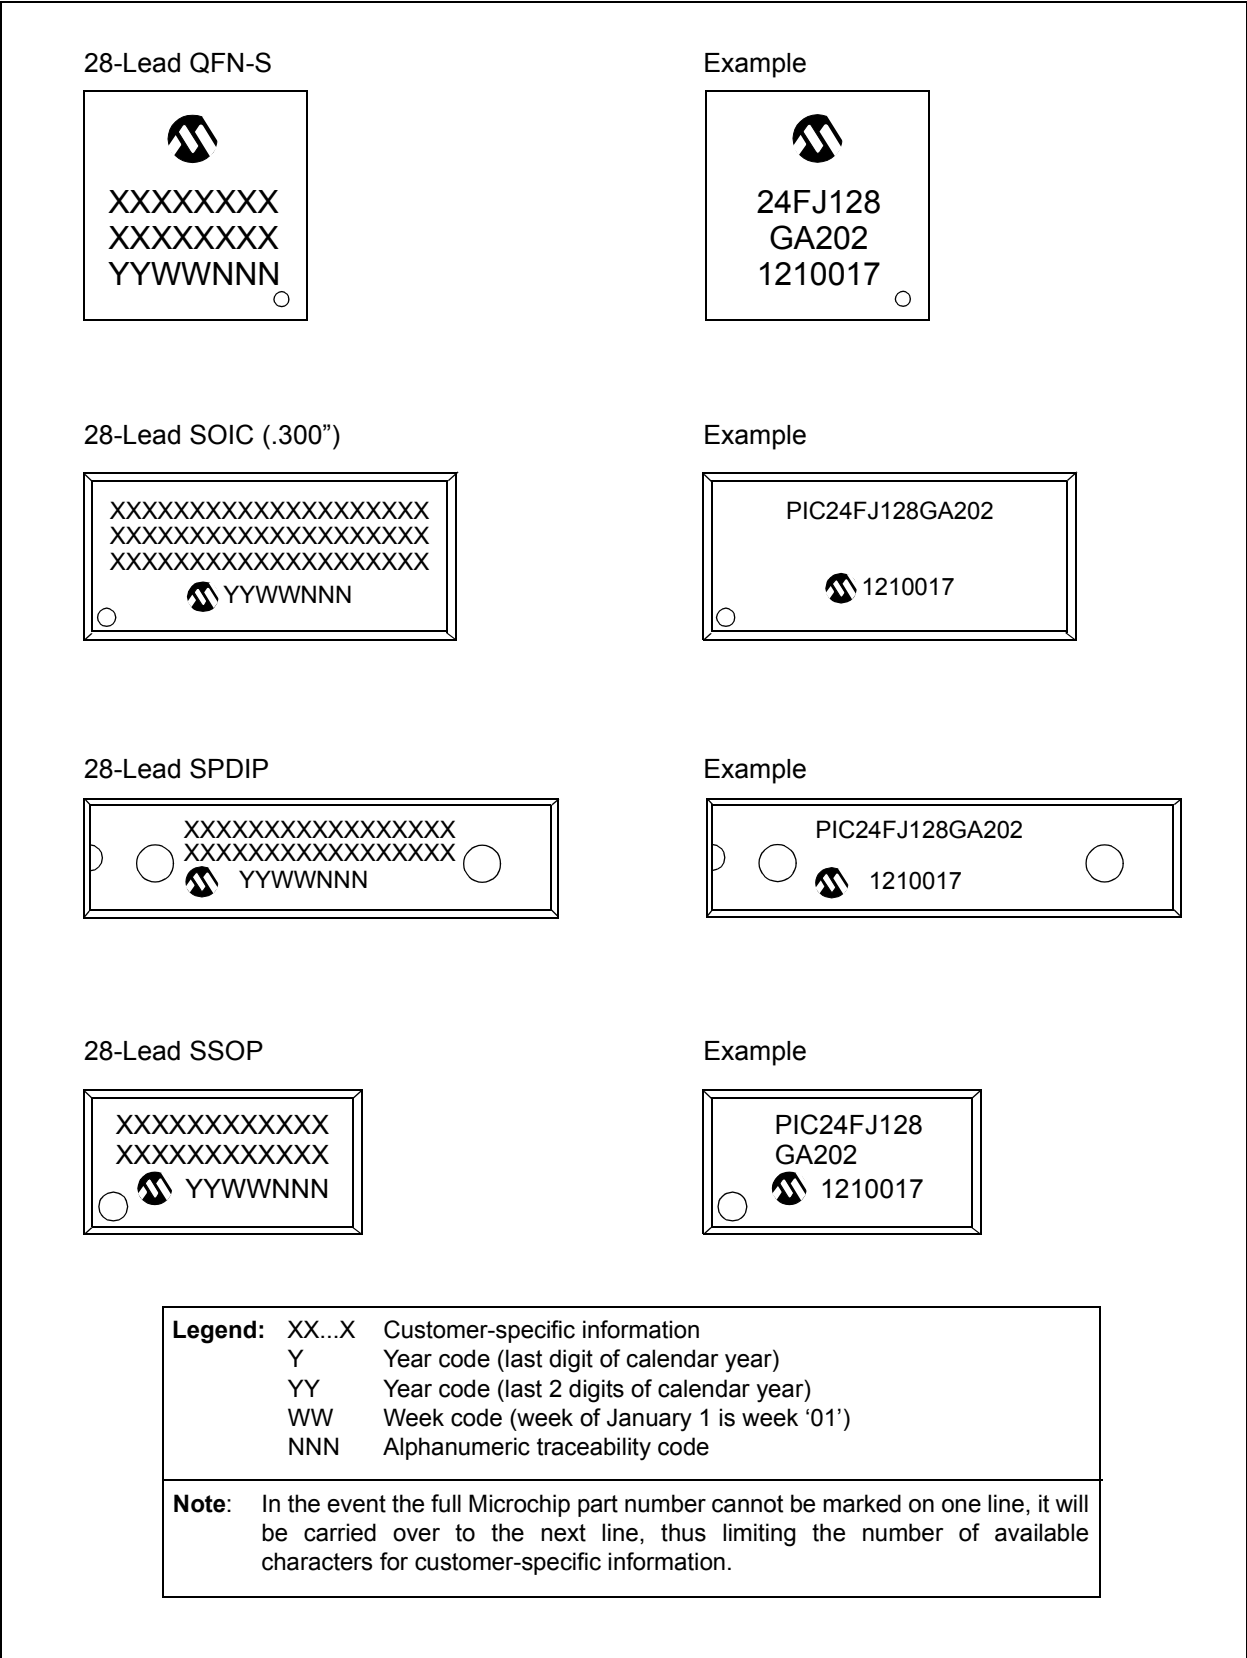
FIGURE 1: UPDATED PACKAGE MARKINGS

The package markings for all PIC24FJ128GA204 family devices have changed. Package markings are now limited to the short part number, manufacturing date code, trace code and Microchip trademark (where space is available). The operating temperature code and packaging code have been removed from the marking as redundant.

The diagrams in **Section 33.1 “Package Marking Information”** are changed, as shown in [Figure 1](#) and [Figure 2](#) (following pages), to reflect these modifications.
