Company: **Rezayat Company Limited**

Project/ Site Name: Site Name: Catering Auditorium & Recreation Facilities : **097-C76R**

**Type of Incident:**

Near Miss

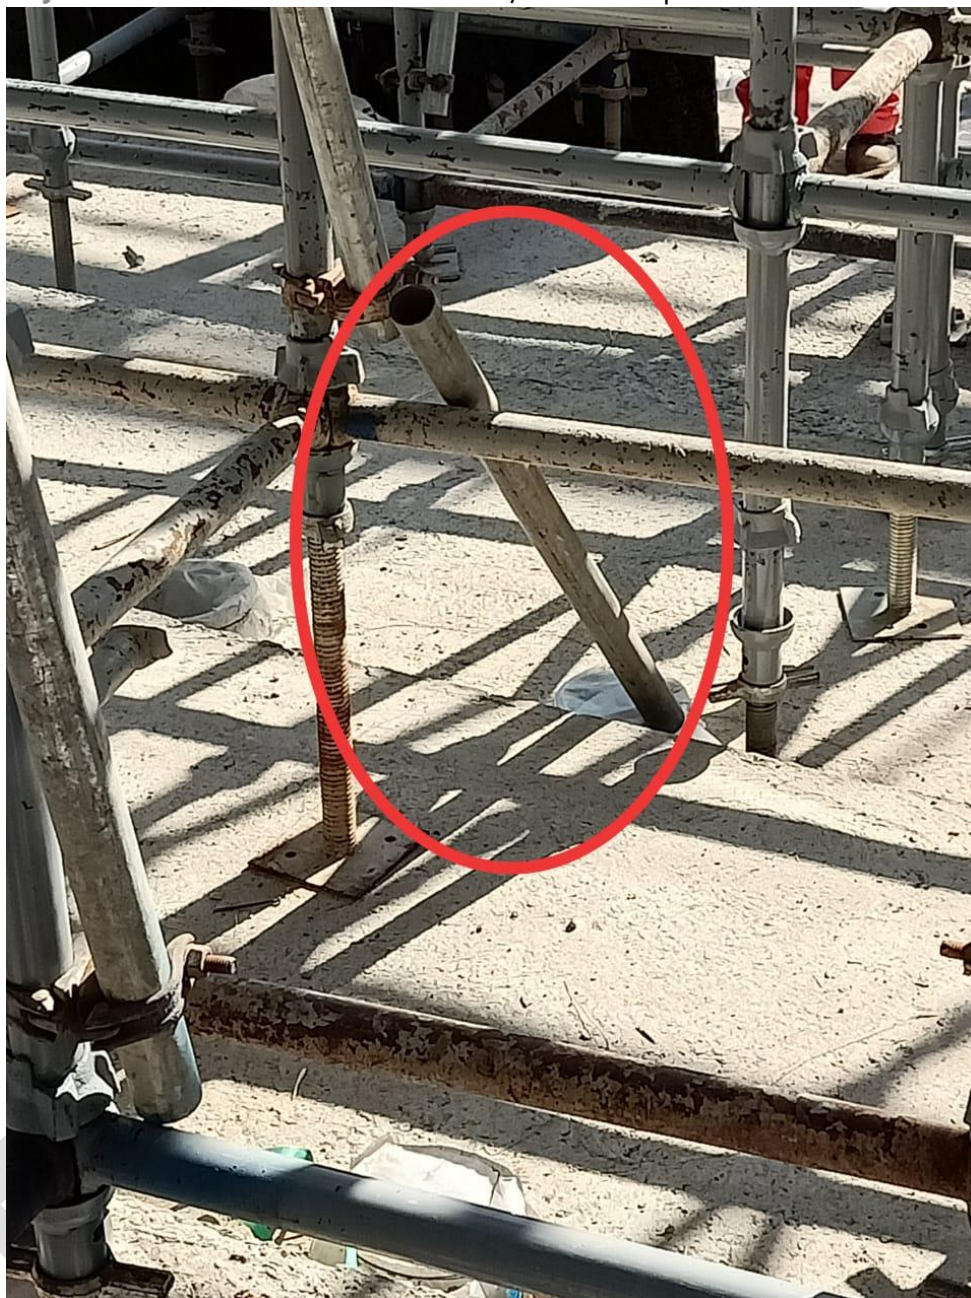
Today at 10:30 hours, while the steel fixing team was working on one of the scaffolding platform,

one scaffolding pipe (length 1 meter) fell from the platform (between the DOKA gaps)

Where steel team was working and hit the ground near to the scaffolder who was working downside the scaffolding platform.

Work was stopped immediately and Near miss was discussed with the crew.

Always ensure no loose material on platform before putting yellow tag.

Avoid simultaneous operation as far as possible.

Barricade the area and ensure no one stand beneath the working platform.

Supervisor should be present there for close monitoring.
