| Division / Department | Civil | | | Project Name | Catering Auditorium & Recreation Facilities | | | Project Location | JUC | | | |
| Place of the Incident/Injury | Auditorium Part -1 | | | Date of Incident | 04-12-2020 | | | Time of Incident | 07:40 AM | | | |

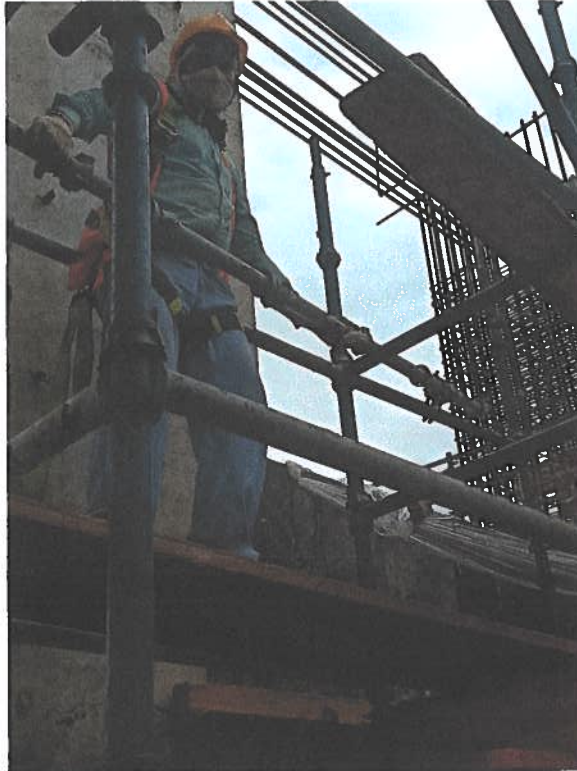
| Brief Description of the Incident/Injury | while working in part 1 dismantling scaffolding, he is receiving the dismantled scaffolding tube from the 3rd level and while receiving the tube in his level (2nd) he couldn't control the tube and tube hit to another scaffolding tube and his left ring finger crush between two scaffolding tube's while receiving the scaffold. | | | | | | | | | | | |

| Immediate Cause/s of the Incident/injury: His finger crushed between two scaffolding tubes. | | | | | | | | | |
| Root Cause/s of the Incident/injury: incompetent person | | | | | | | | | |

| Engineering Control: All binding wire should be banded and sharp object must be controlled | | | | | | | | | |
| Administrative Control: Post signage relating to sharp object. | | | | | | | | | |
| PPE: Wear full selves cover all | | | | | | | | | |
