Initial Incident/Accident Report

Fill the Information Below	
Company: Rezayat company limited.	Date: 12/07/2021
Location: Wadi Sharma	Time: 10:40 AM
Project/ Site Name: Pipeline protection project(BGP)	Worst Potential Severity: 1 Actual Severity: 1
Person(s) Involved:	<input checked="" type="checkbox"/> Employee <input checked="" type="checkbox"/> Contractor <input type="checkbox"/> Others

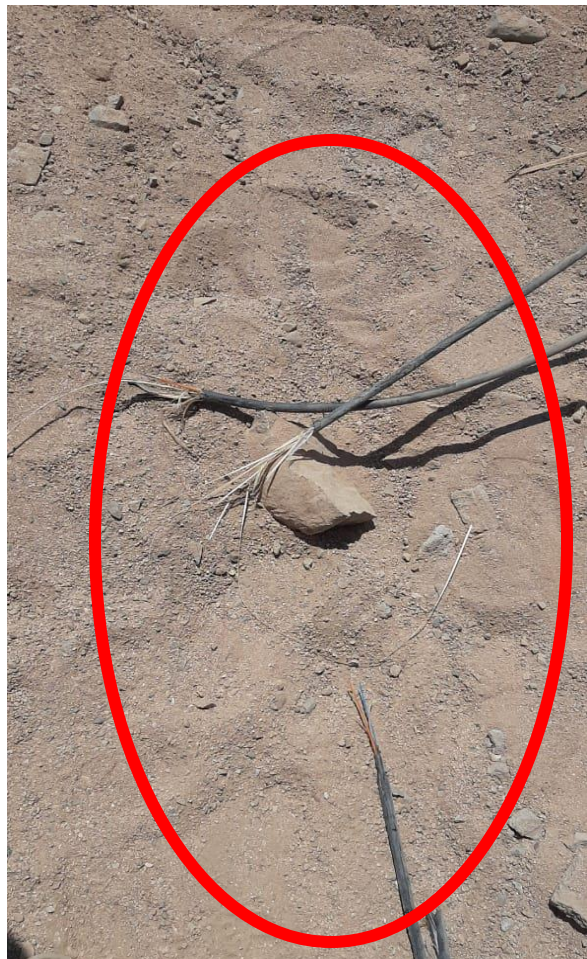
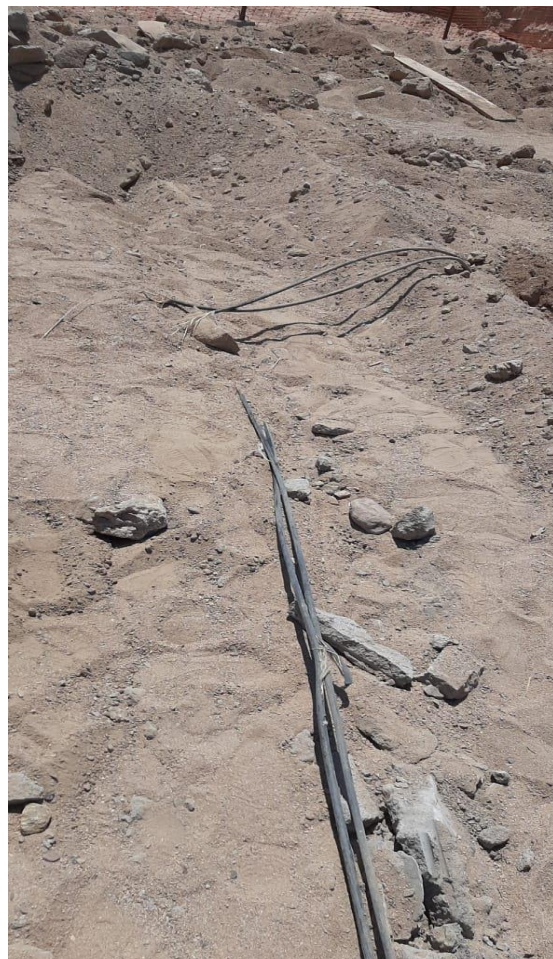
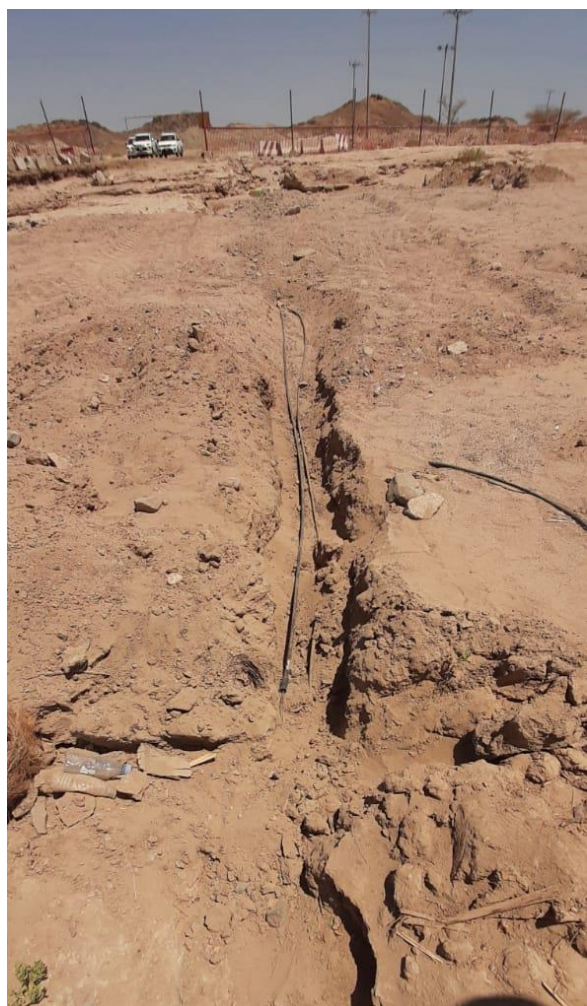
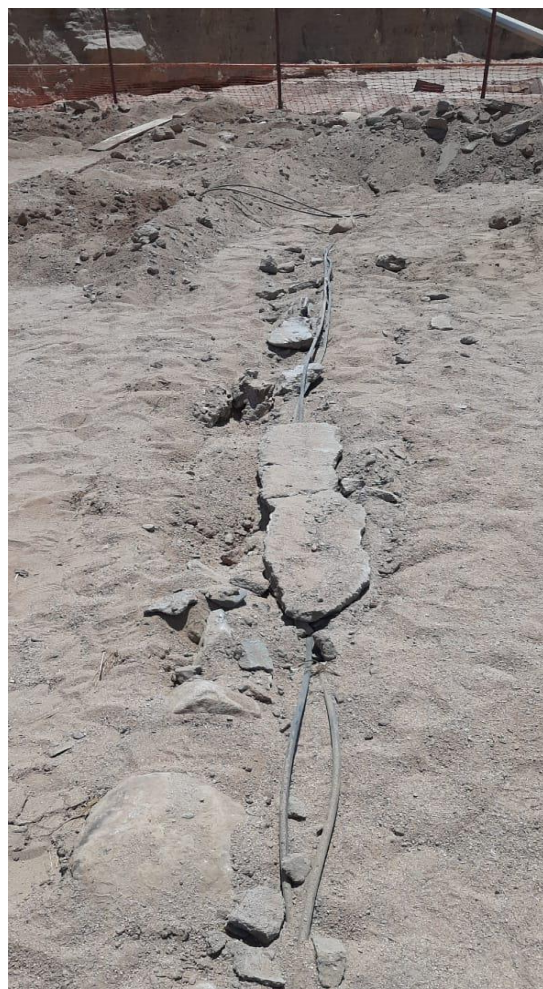
1. Faiz Alam CB.no:- 29806 2. Rolando Lacanaria CB.no:- 33617 3. Mohammed Waleed Mustafa (CB.no:- 36493)	
Type of Incident: Client property damage.	
Choose an item. Client Property damage.	
Injury Location by Body Parts (Select one or more if necessary):	
Head	Chest
Face	Leg
Neck	Abdomen
Back	Stomach
Nose/ Ears	Shoulder
Hand	Arm
Wrist	Elbow
Fingers/ Thumb	Toes
Type of Injury Sustained (Select one or more if necessary):	
Fracture	Cut/ Laceration
Loss of Sight	Loss of Consciousness
Dislocation	Crush Injury
Abrasion	Suffocation
Scalping	Bruising
Heat	Amputation
Cold	Other(s)
Burn	X
Immediate Cause(s) (Select one or more if necessary):	
Safety Rule Violated	Lack of Resources
Lack of Task Skill	Method Deviation
Lack of Supervision	Poor Weather Conditions
Improper Lifting (MH)	Lack of Task Knowledge
Not Paying Attention	Lack of Communication
Human Error	Incorrect Tools/Equip
Inadequate PPE	Defective Tools
Animals	Violence
Heat Stress	STF Above Ground

Misuse of Hand Tools	Grinding/ Welding
Hit by Static Machinery	Heavy Equipment
Stress	Fatigue
Drugs/ Alcohol Related	Poor Housekeeping
Inadequate Lighting	Poor Team Work
No Risk Assessment	Defective Equipment
Unprotected excavation	Improper Lifting (crane)
Unprotected Edge	Improper/ Poor Slings
Manual Handling	Hit by Vehicle
Other(s) :	
Equipment(s) Involved:	
Light Vehicle:	Heavy Vehicle:
Building:	Structure:
Other(s):	
Plant Equipment:	Static Plant Equipment:
Scaffold:	Excavation:
Description of the Event:	
Around 10:40 AM backhoe loader entered in to the prohibited area with the permission of supervisor to remove the soil heap which is collected from the excavated area which was instructed by assistant foreman Mr. Rolando. While the equipment clearing the soil from the location, the fiber optical cable was gets damaged which is buried 10cm below the soil. And it has not been reported to the site safety officer and PM by the supervisor. Client notice the shutdown of the connection in line and reached the location then reported to project manager.

Immediate Action(s) Taken to Prevent Reoccurrence (If Any):	
Barriaded the cable location. Rectified the damages with the support of technician assigned by client. (Amount paid by RCL PM 2,000 SAR)	
Person Created the Report:	
Name: Obeysullah	Position: HSE officer
Signature: [Signature]	Date: 12 / 07 / 2021
