Company: **Rezayat Company Limited**

Project/ Site Name: Catering Auditorium & Recreation Facilities : **097-C76R**

Type of Incident:

Near Miss

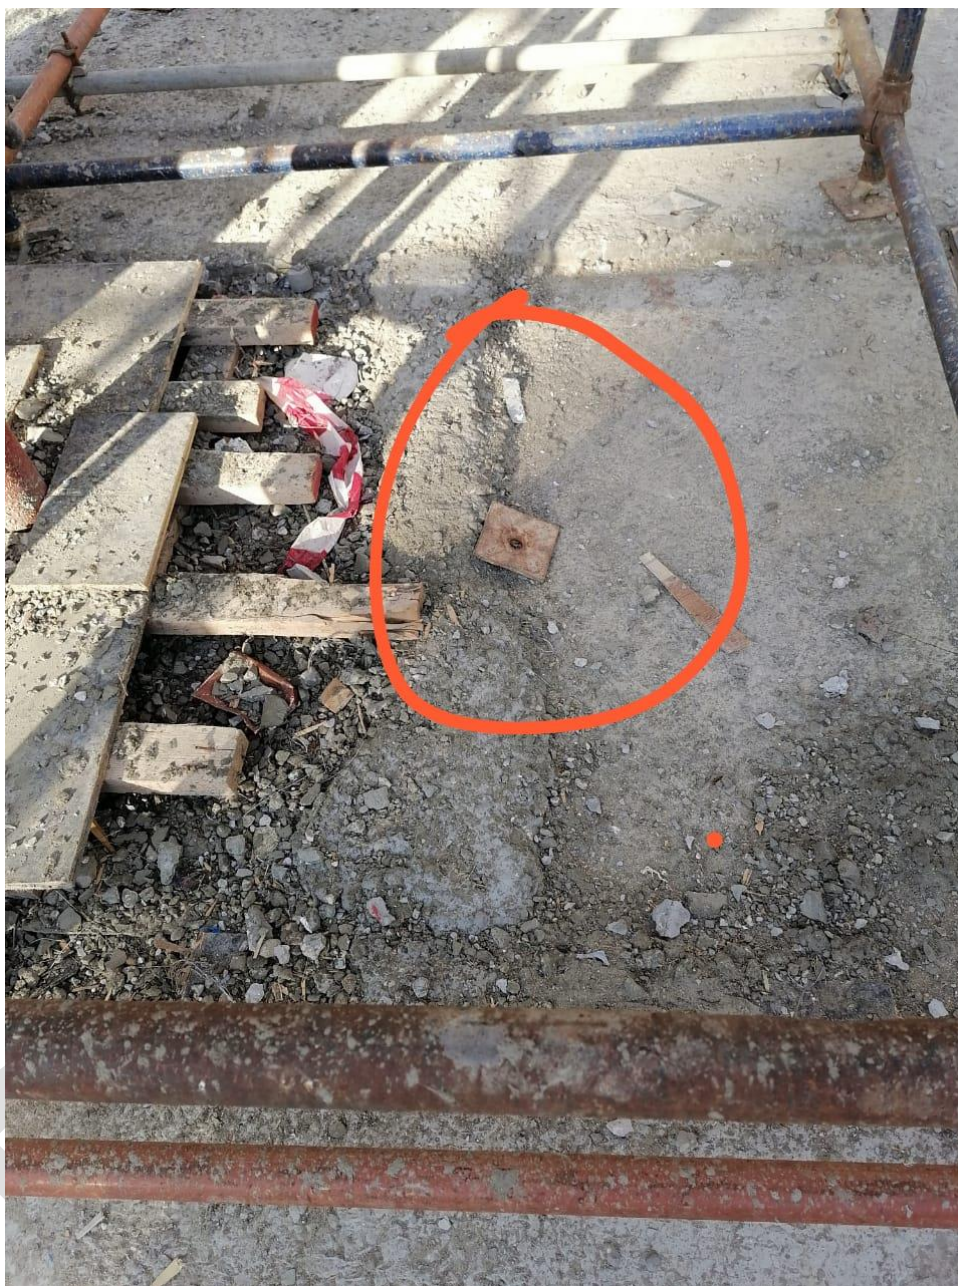
While performing housekeeping on the scaffolding platform, tie rod plate fell down from platform to bottom. Luckily area was barricaded and no one was there no injury or property damage was reported.

- Gaps on the platforms must be closed
- Take help of team. After finish his work removal loose material.
- Barricade the area from downside.
- Always depute one person downside to monitor pedestrian access.
