<b>Name of Employee</b>	Mukul Mandal	<b>Badge No.</b>	30038835	<b>Profession/ Designation</b>	Carpenter - Shuttering	
<b>Safety Awareness Training Date</b>	14-6-2020	<b>Proof of Training</b>	Induction			
<b>Name of Line Manager</b>	Amr Ahmed Mahmoud Mohamed	<b>Badge No.</b>	30104091			
<b>Name of Supervisor</b>	Abdur Rahman	<b>Badge No.</b>	31034537			
<b>Division / Department</b>	CIVIL Department	<b>Project Name</b>	097-C76R	<b>Project Location</b>	JUC	
<b>Place of the Incident/Injury</b>	Area 1 Part 2	<b>Date of Incident</b>	06-06-2021	<b>Time of Incident</b>	07:35 AM	
<b>Nature of the Incident/Injury</b>	<b>Occupational Incident/Injury</b>	Yes	No	✓	<b>Other, Please specify :</b>	
	<b>Road Traffic Incident/ Injury</b>	Yes	No	✓		
<b>Brief Description of the Incident/Injury</b>	Around 07:35 AM, scaffolding team was dismantling a scaffold structure in part 2, 3rd floor of corridor. While dismantling one scaffolder loosened the lower clamp of diagonal brace (length 2.5meter weight 7kg) first, then went for the second upper side clamp. As he opened the upper clamp he didn't hold the pipe, consequently the pipe swung clockwise and slipped out of the lower clamp, it hit the floor of the

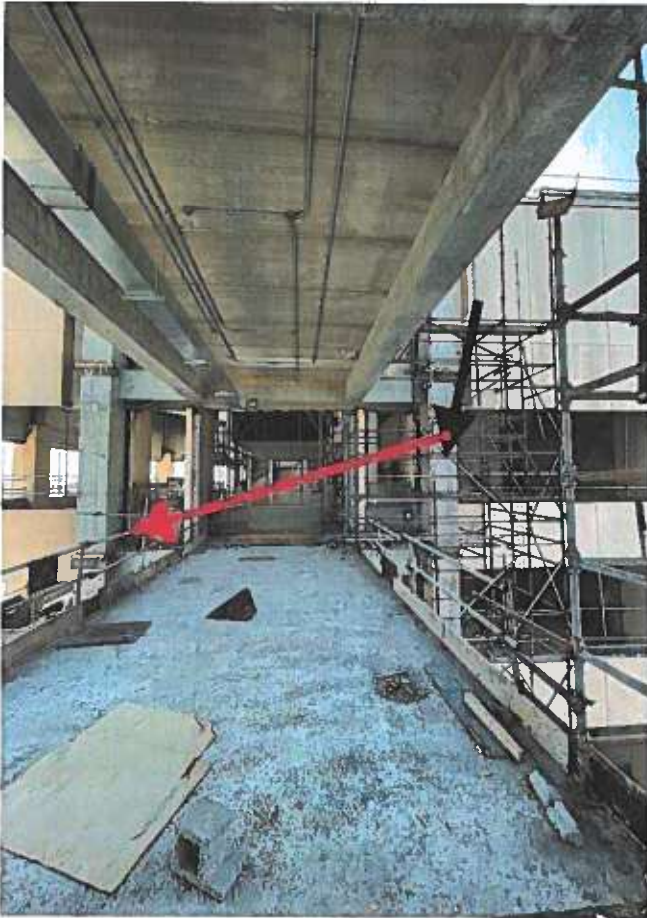
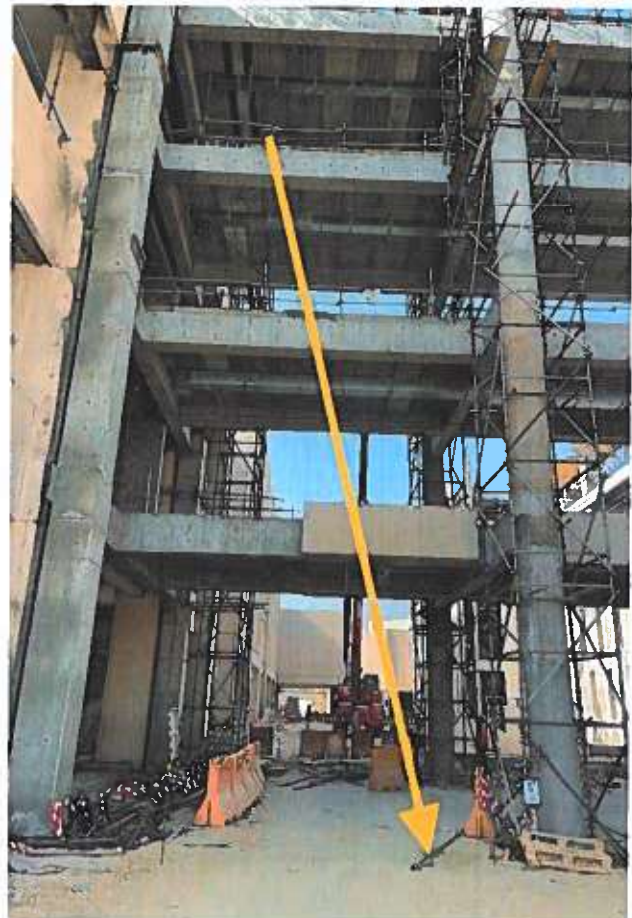
Was Pre- Task / Toolbox meeting conducted	Yes	<input checked="" type="checkbox"/>	No	Was the person using required Personal Protective Equipment (PPE)	Yes	<input checked="" type="checkbox"/>	No
Specify the Personal Protective Equipment (PPE)	Safety Gloves, Glasses, Helmet, Shoes, Safety Harness						
What was the injured person/employee doing at the time of the incident?	N/A						
What was the machine/equipment doing at the time of the incident?	N/A						
What was the material/s / substance/s doing at the time of the incident	Scaffold dismantling						
<b>Immediate Cause/s of the Incident/injury:</b> Unsecured scaffolding pipe slipped off from the scaffolding clamp							
<b>Root Cause/s of the Incident/injury:</b> People: Unsafe behavior, lack of attention and lack of supervision from worker and Foreman side. Process / Procedure: Not Followed safe dismantling of scaffolds procedure. Not holding the pipe while opening the clamp. Equipment: N/A Workplace: Workplace was okay as downside area was barricaded but it went onto fell on the other side of the corridor which was not barricaded.

<b>Corrective Action to prevent reoccurrence:</b> Elimination: N/A Substitution: N/A Engineering Control: Scaffolding pipe must not be left unattended while loosening the clamp. Use safe work procedures of scaffolding works. Administrative Control: Ensure to depute one person downside to monitor pedestrian access. Scaffolder was given warning for unsafe behavior. Ensure to Provide barricades and warning signs for downside working area. PPE: Safety Harness must be worn at all times.							
Were there any witnesses?	Yes		None	<input checked="" type="checkbox"/>	Type of witness/s	Employee	Public
Witness Details					Badge Number		Mobile Number
