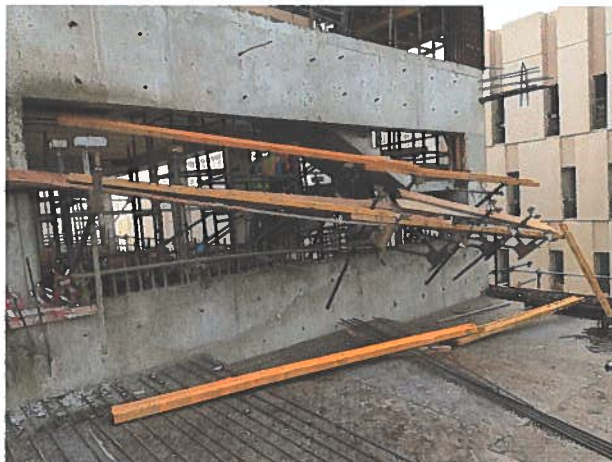
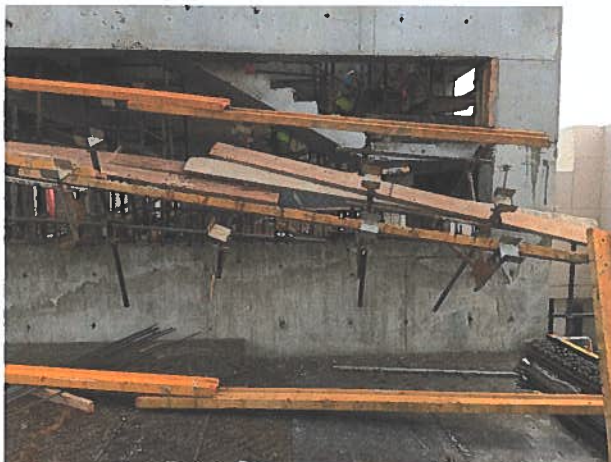
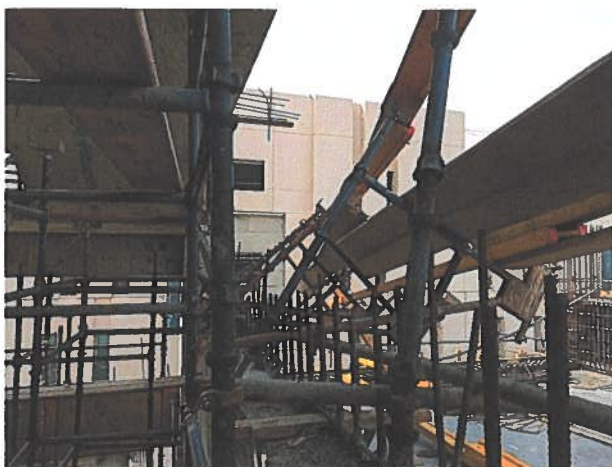
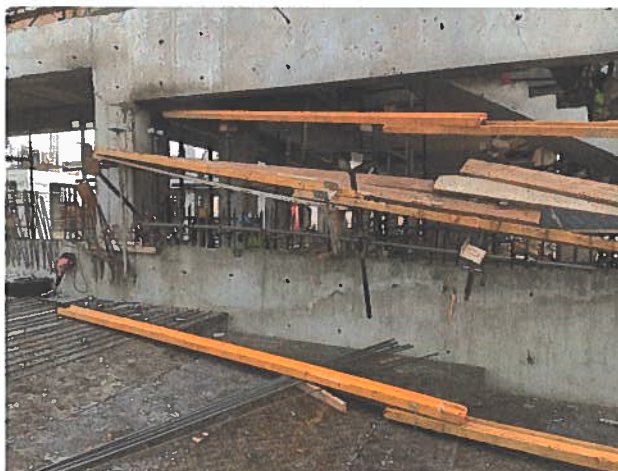
<b>Name of Employee</b>	Nadeem Yaseen			<b>Badge No.</b>	40978		<b>Profession/ Designation</b>	Carpenter			
<b>Safety Awareness Training Date</b>	13/2/2020			<b>Proof of Training</b>	Induction Register						
<b>Name of Line Manager</b>	Amr Ahmed Mahmoud Mohamed			<b>Badge No.</b>	30104091						
<b>Name of Supervisor</b>	Ibrahim Sabry Ibrahim Kheriba			<b>Badge No.</b>	31032055						
<b>Division / Department</b>	Civil			<b>Project Name</b>	097-C76R		<b>Project Location</b>	JUC			
<b>Place of the Incident/Injury</b>	Auditorium			<b>Date of Incident</b>	25-02-2021		<b>Time of Incident</b>	09:40 AM			
<b>Nature of the Incident/Injury</b>	<b>Occupational Incident/Injury</b>	Yes		No		<b>Near Miss</b>		<b>Other, Please specify : Dangerous occurrence</b>			
	<b>Road Traffic Incident/ Injury</b>	Yes		No		Yes	<input checked="" type="checkbox"/>	No			
<b>Brief Description of the Incident/Injury</b>	While the dismantling of DOKA I-beams, as the carpenter (Nadeem) was removing the I-beams and six pieces were left to dismantle, he felt some instability in the structure. He instructed the workers nearby to move away as the scaffolding is looking unstable. He quickly came down from the scaffolding and at that time the scaffolding collapsed (as shown in the picture). At the time of collapse no one was on the scaffolding or near the scaffolding.

Was Pre- Task / Toolbox meeting conducted	Yes	<input checked="" type="checkbox"/>	No		Was the person using required Personal Protective Equipment (PPE)	Yes	<input checked="" type="checkbox"/>	No	
Specify the Personal Protective Equipment (PPE)	Safety Shoes, Safety Goggles, Helmet, Vest, Gloves, Full body Harness								
What was the injured person/employee doing at the time of the incident?	Dismantling the DOKA I-beams								
What was the machine/equipment doing at the time of the incident?	N/A								
What was the material/s / substance/s doing at the time of the incident	DOKA I-beams were being dismantled.								
<b>Immediate Cause/s of the Incident/injury:</b> Unstable scaffolding structure, lack of supports on the scaffolding structure.									
<b>Root Cause/s of the Incident/injury:</b> <b>People:</b> Lack of supervision by the scaffolding supervisor. <b>Process / Procedure:</b> Procedure was not right as the scaffolders removed the scaffolding parts before the scaffolding was dismantled. Poor coordination between the scaffolding team and carpenter team before working on the scaffolding structure. <b>Equipment:</b> Lack of scaffolding materials at site was the reason why scaffolders removed the supports on the scaffolding. <b>Workplace:</b> Workplace was not OK as the scaffolding structure was unstable.

<b>Corrective Action to prevent reoccurrence:</b> <b>Elimination:</b> N/A <b>Substitution:</b> N/A <b>Engineering Control:</b> Scaffolding structure must be adequately supported and no one should be allowed to modify until it is dismantled. <b>Administrative Control:</b> Proper supervision from the scaffolding foreman/supervisor. No scaffolding must be modified without the knowledge of scaffolding competent person. Proper coordination must be exercised between scaffolding team and other crews who are going to use the scaffolding structure. Adequate scaffolding material must be supplied on the site. <b>PPE:</b> All necessary PPEs must be worn at site including safety harness.									
Were there any witnesses?	Yes		None	<input checked="" type="checkbox"/>	Type of witness/s	Employee		Public	
Witness Details					Badge Number		Mobile Number		
Witness Statement:
