Name of Employee	Ichara Malik	Badge No.	30038958	Actual Severity:	1		
Safety Awareness Training Date	10/16/2019	Proof of Training	Induction Training register	Worst Potential Severity:	4		
Name of Line Manager	Amr Algendy	Badge No.		Profession/ Designation	Area Suprintendent		
Name of Supervisor	Ibrahim Sabri	Badge No.					
Division / Department	Civil	Project Name	097-C76R	Project Location	JUC		
Place of the Incident/Injury	Area 1 (Part-2)	Date of Incident	1/28/2021	Time of Incident	10:00 AM		
Nature of the Incident/Injury	Occupational Incident/Injury	No	Near Miss	Other, Please specify :			
	Road Traffic Incident/ Injury	No	Yes				
Brief Description of the Incident/Injury	While removing the shuttering of the column in part 2, steel rod that was given as a support on the shuttering (as shown in the picture) fell onto the ground. The area was not barricaded and no one was present downside to monitor. Fortunately no injury and material damage was observed.

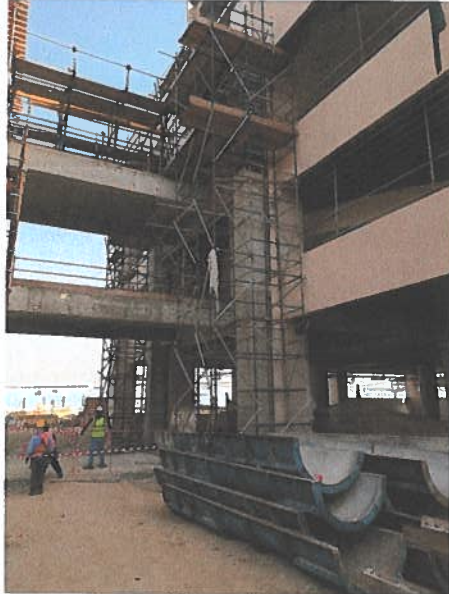
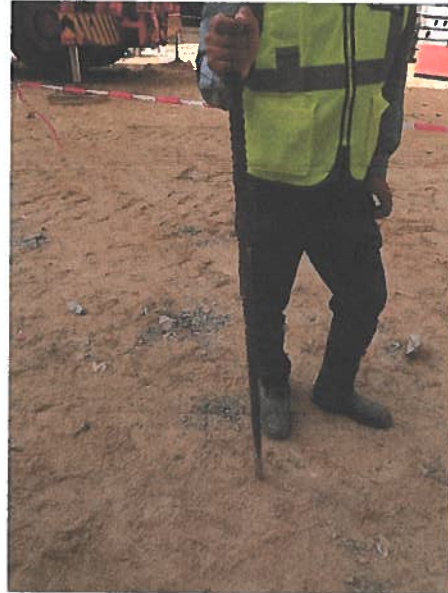
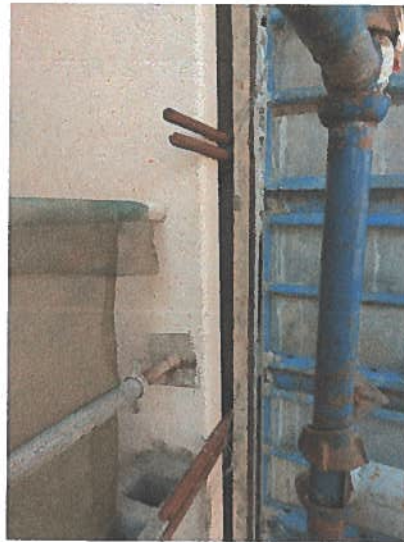
Additional Details:

Was Pre- Task / Toolbox meeting conducted	Yes	Was the person using required Personal Protective Equipment (PPE)	Yes			
Specify the Personal Protective Equipment (PPE)	Safety Shoes, Safety Goggles, Helmet, Vest, Gloves, Full body harness					
What was the injured person/employee doing at the time of the incident?	Removing the shuttering plate of the column					
What was the machine/equipment doing at the time of the incident?	N/A					
What was the material/s / substance/s doing at the time of the incident	Steel rods were used as a support for the shuttering					
Immediate Cause/s of the Incident/injury: While the steel rod was removed, the worker cut the binding wire from one side and he didn't grabbed the steel rod, hoping that the other side binding wire will hold the steel rod. The Steel rod slipped from the binding wire on the other side.						
Root Cause/s of the Incident/injury:	People: No proper supervision from the foreman.

Process / Procedure: Procedure was not OK as the worker did not grabbed the steel rod while cutting the binding wire.					
	Equipment: Equipment was Ok.					
	Workplace: Workplace was not OK as the area was not barricaded.					
Corrective Action to prevent reoccurrence:	Elimination: N/A					
	Substitution: N/A					
	Engineering Control: Before removing the shuttering, tie the supporting rod with binding wires to avoid falling. Hold the rod					
	Administrative Control: Proper supervision must be ensure. While working at height, area must be barricaded from downside. Signage must be provided with the barrication or one person must stand downside for warning the pedestrians.					
	PPE: Necessary PPEs must be worn. In this case helmet and safety shoes were important for the people on the ground level.					
Were there any witnesses?	None	Type of witness/s	Employee		Public	
Witness Details		Badge Number		Mobile Number
