Name of Employee	Abdur Rahman	Badge No.	34537	Actual Severity:	N/A		
Safety Awareness Training Date	10/19/2019	Proof of Training	Induction	Worst Potential Severity:	N/A		
Name of Line Manager	Mustafa Ali	Badge No.	3104094	Profession/ Designation	Project Manager		
Name of Supervisor	Ibrahim Sabry	Badge No.	31032055				
Division / Department	Civil Department	Project Name	097-C76 R	Project Location	JUC		
Place of the Incident/Injury	Auditorium part 1	Date of Incident	12/16/2020	Time of Incident	1030		
Nature of the Incident/Injury	Occupational Incident/Injury	No	Near Miss	Other, Please specify :			
	Road Traffic Incident/ Injury	No	Yes				
Brief Description of the Incident/Injury	At 1030 hours scaffolding team was erecting a platform beneath the other yellow tagged platform. One scaffolding pipe (length 1meter) fall from the yellow tagged platform where steel team was working and hit the ground near to the scaffolder who was working over there. Fortunately no injury or property damage happened.

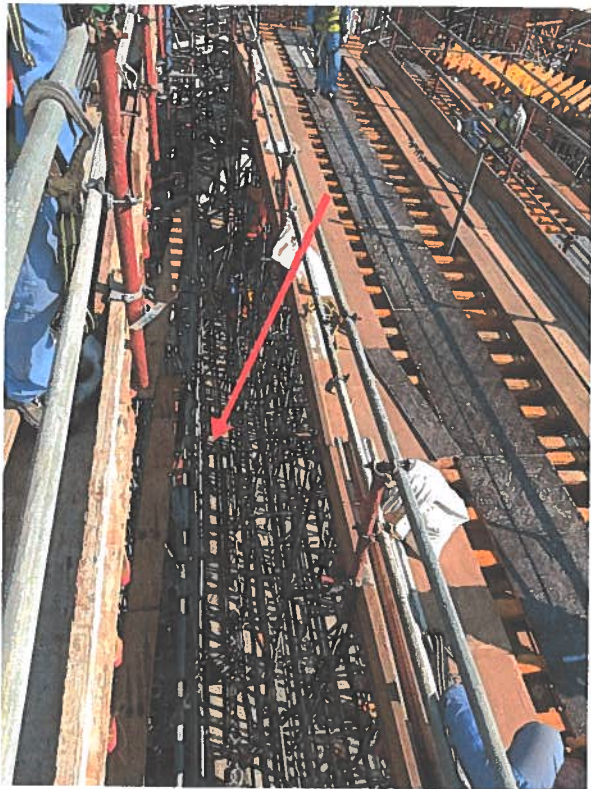
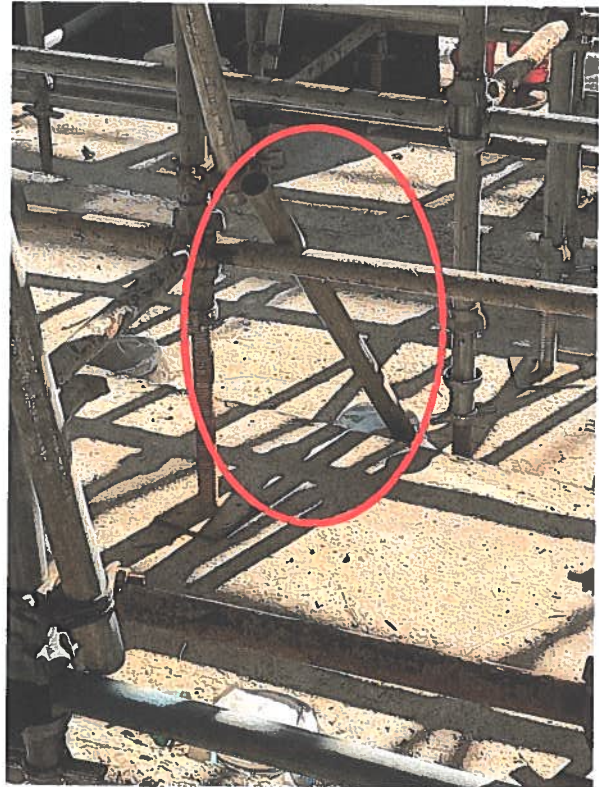
Was Pre- Task / Toolbox meeting conducted	Yes	Was the person using required Personal Protective Equipment (PPE)	Yes			
Specify the Personal Protective Equipment (PPE)	Helmet, safety shoes, vest, gloves and goggles					
What was the injured person/employee doing at the time of the incident?	N/A					
What was the machine/equipment doing at the time of the incident?	N/A					
What was the material/s / substance/s doing at the time of the incident	Scaffold pipes lying on the scaffolding platform					
Immediate Cause/s of the Incident/injury: Loose material kept on scaffold near the open gaps						
Root Cause/s of the Incident/injury:	People: Lack of supervision and carelessness from the scaffolders to leave the loose scaffolding materials on the scaffolding after finishing their job					
	Process / Procedure - Loose material on platform, poor housekeeping					
	Equipment: N/A					
	Workplace: Workplace was not Ok as there were gaps in the scaffolding.

Corrective Action to prevent reoccurrence:	Elimination: N/A					
	Substitution: N/A					
	Engineering Control: Close the gaps on platform as much as possible.					
	Administrative Control: Housekeeping, removal of scaffolding materials after erecting the scaffold. Avoid working downside of the working platform, barricade the area to restrict any movement of workers.					
	PPE: All necessary PPEs at site must be worn, in this case helmet and safety shoes must have to be worn if there is any person downside.					
Were there any witnesses?	Yes	Type of witness/s	Employee	✓	Public	
Witness Details - Mehar Zaman		Badge Number	40754	Mobile Number		
Witness Statement : As per witness they were erecting scaffold structure beneath the platform when one of scaffolding tube fell from height near to them.
