Fill the Information Below

Company: **Rezayat Company Limited**

Location: **Auditorium**

Project/ Site Name: Catering Auditorium & Recreation Facilities : **097-C76R**

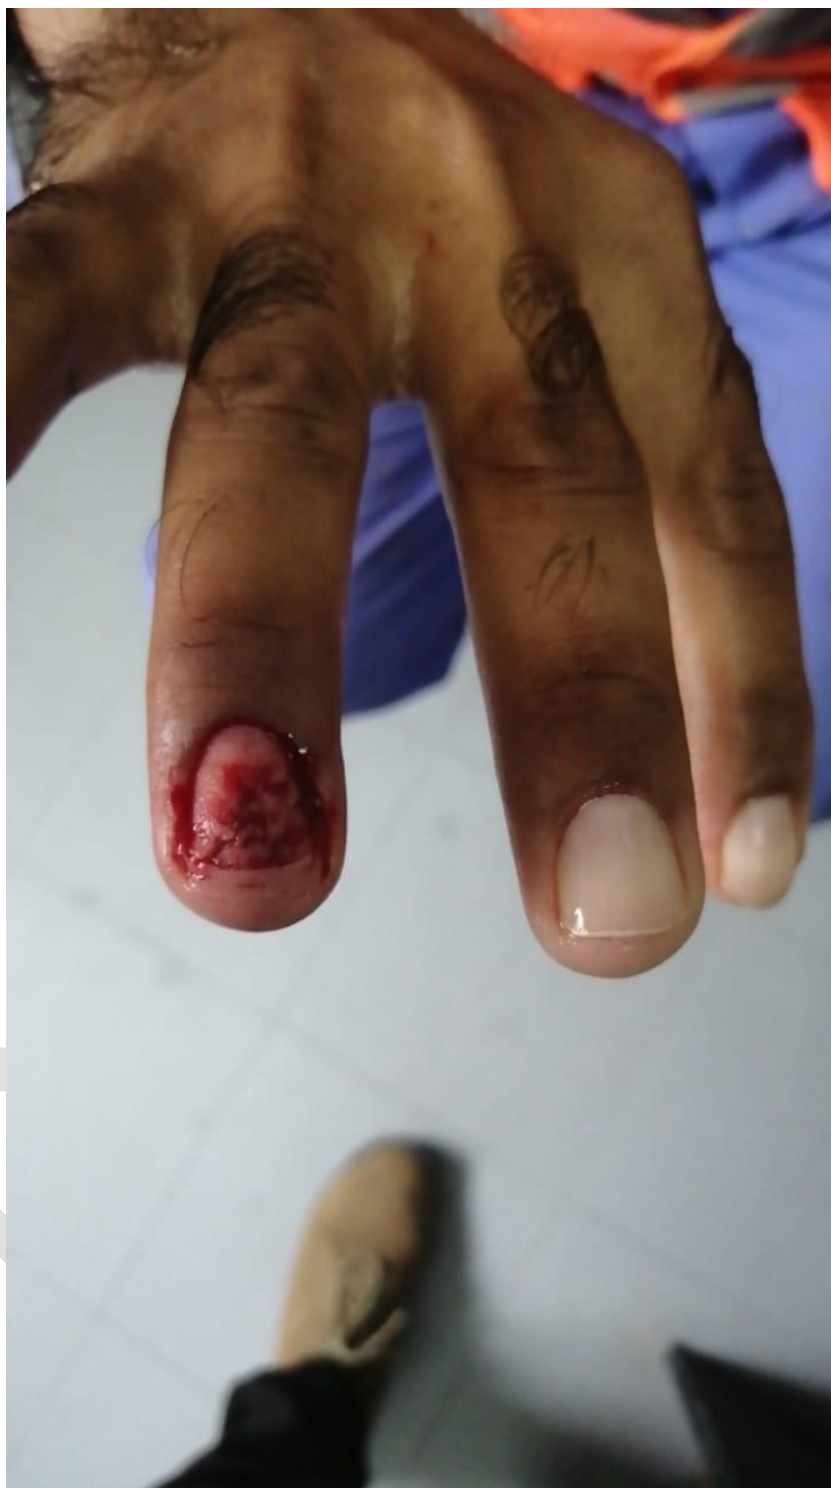
Location of Incident

While shifting the shuttering plates, 3 workers were involved in lifting the shuttering plate. While putting one shuttering plate on the top of other, two workers on one side of the shuttering plate pulled it towards their side. Consequently the IP on the other side whose hand were placed down side of the plate (as shown in the picture) pinched his hands between the two shuttering plates.

Supervisor was instructed to use manual handling aids to lift heavy materials.

Supervisor was instructed to use as many workers as possible if manual handling aid cannot be used in some location. 1 worker should lift only 20 kg of weight.

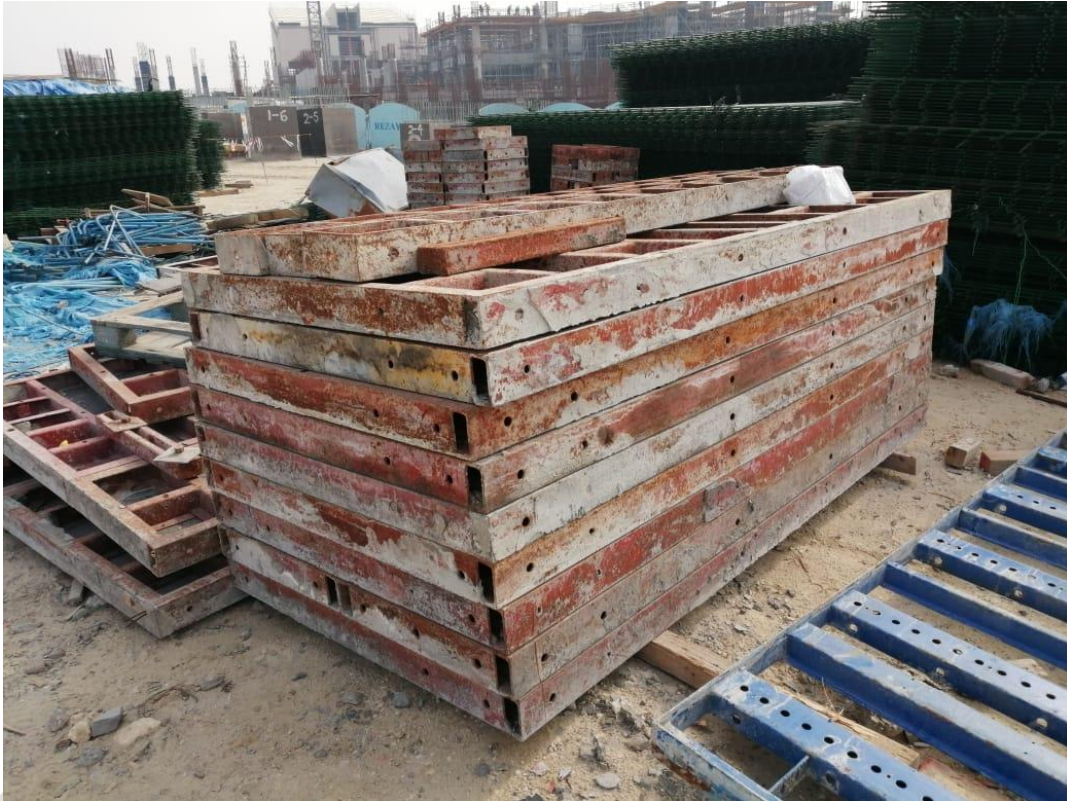
Pulled
towards this
side

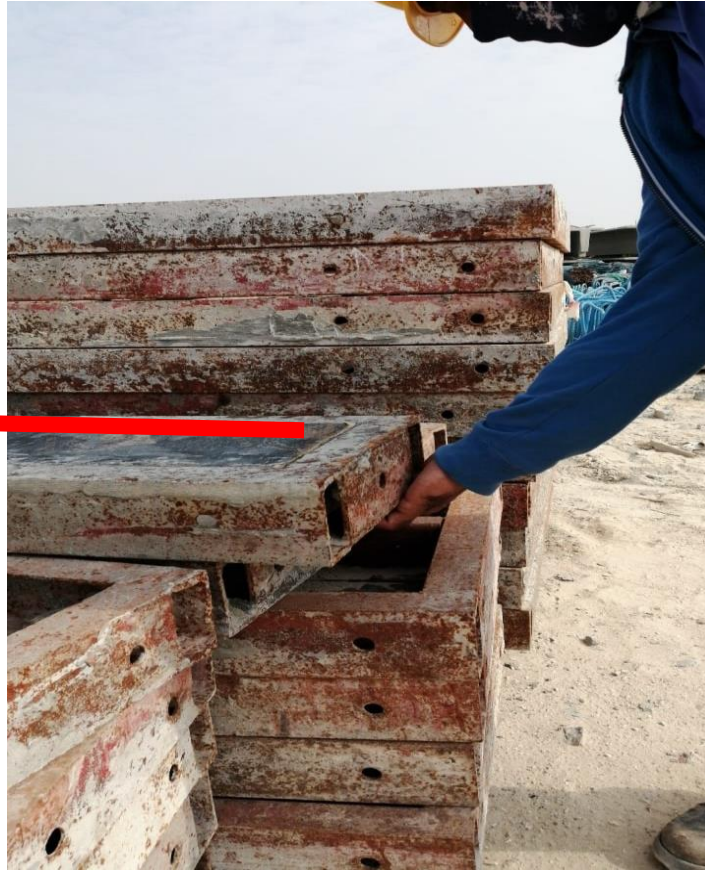
His right hand ring finger's nail got dislodged from the nail bed.
