## MSP430F5529 Device Erratasheet

### 1 Revision History

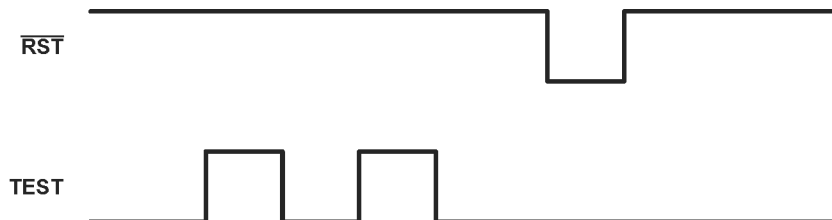
To exit the BSL one of the following methods must be used.

- A Power cycle
- or
- Toggle the TEST pin twice when nRST is high and after 50us pull nRST low.

Note: This toggling of TEST pins is not subject to timing constraints. The appropriate level transitions on TEST pin, followed by a RST pulse after 50us, are sufficient to trigger an exit from BSL mode.

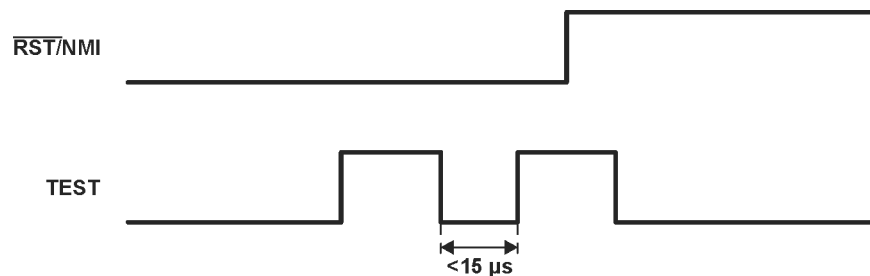
**Function** BSL entry sequence is subject to specific timing requirements

**Description** The BSL entry sequence requires that the low phase of the TEST/SBWTCK pin does not exceed 15us. This timing requirement is faster than most PC serial ports can provide, as shown in the following picture. If this requirement is not met, the entry sequence fails and the SYSBSLIND is not set.

**Workaround** An external hardware solution is recommended to provide the appropriate BSL entry sequence. See [http://processors.wiki.ti.com/index.php/BSL\\_\(MSP430\)](http://processors.wiki.ti.com/index.php/BSL_(MSP430)) for recommendations on available BSL hardware.
