Mk 3S+ & MMU2S/MMU3 firmware update troubles

Printer 3.13.0, MMU 3.0.0 and up

H v Ooijen, 17-11-2023,
Glad to show you my results now.

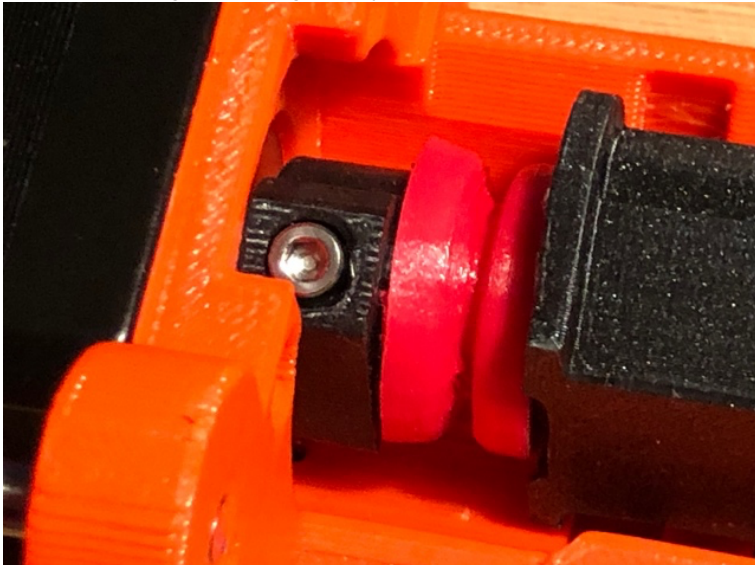
Attempt 1:

Some time ago I changed my MMU2S with a flexible coupling between shaft and idler drum.

This changed the sound, but not enough to avoid the repeated homing attempts. Only after the release of the motor-mount screws the homing cycle went successful. My conclusions: my flexible coupling was not soft enough.

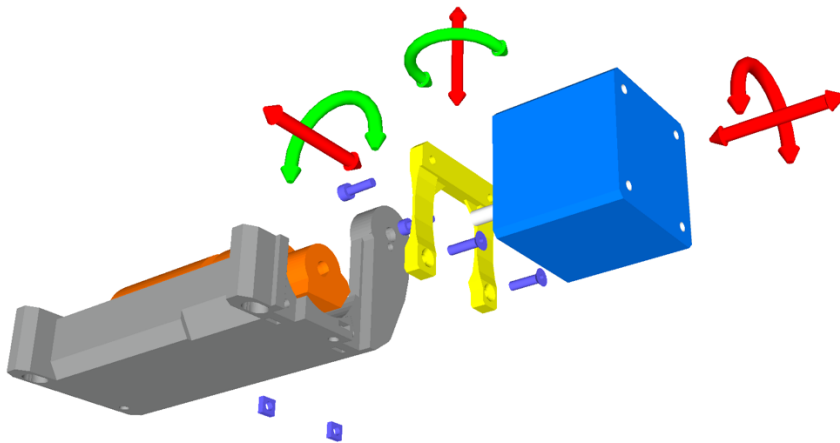
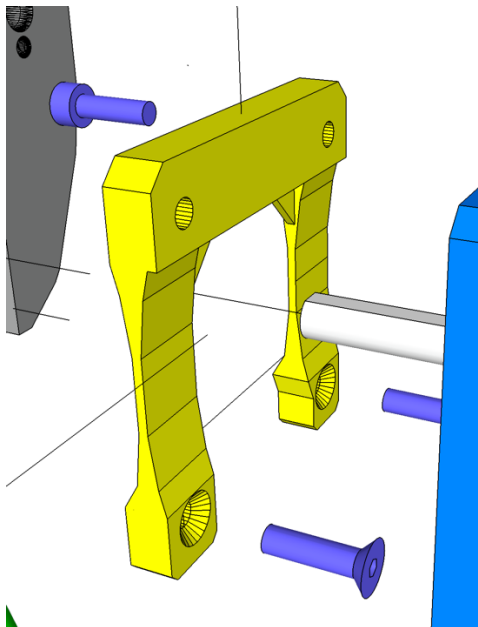
Attempt 2:

The red vectors are stiff, the green vectors are flexible and eliminate unpredictable internal stresses. You can see it clearly on https://www.youtube.com/watch?v=82_PybeUpl where the motor is wobbling when rotating. The wobble is caused by the inevitable misalignment of the motor shaft-idler drum.

This misalignment is, in the original situation, causing a torque variation during the rotation which is bringing the troubles.

I then made the motor mount flexible and used the stiff connection between shaft and idler drum using the original MMU2 drum with the 2 screws.

I tried several flex motor mountings and I'm now using this one (the yellow one, printed black)
