Crackterized Result

The image characterized as: Contains Crack

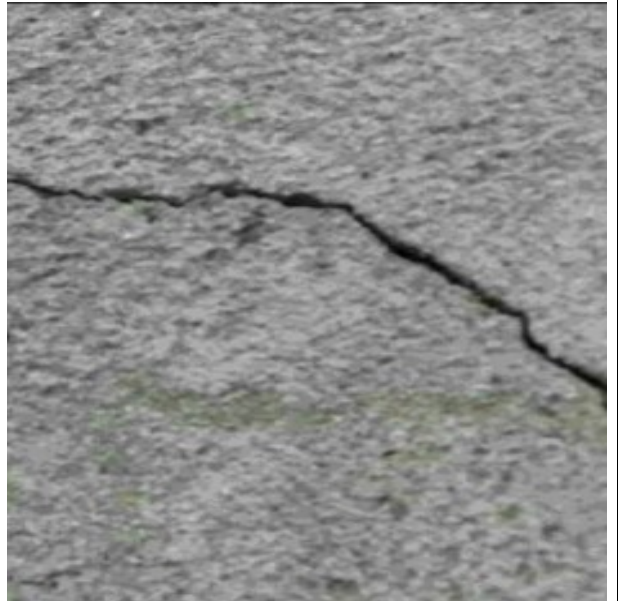
Length: 0.11

Width: 0.02

Positive Crack Probability: 59.21%

Negative Crack Probability: 40.79%

Location of Crack: Corner Crack/s

Crack Type: Drying Shrinkage Crack/s

Crack Progression: Creep Crack Growth
