## Crackterized Result

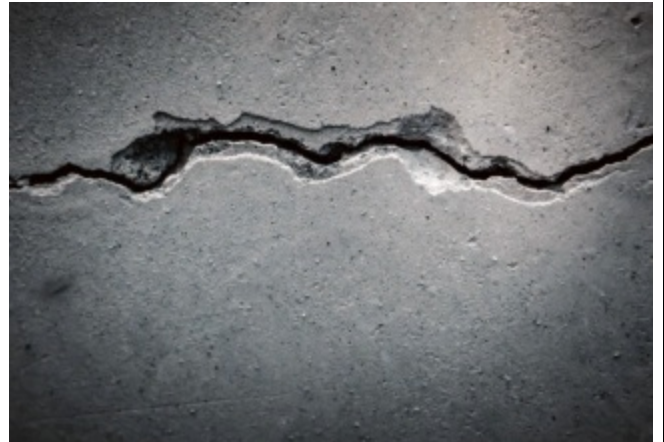
The image characterized as: Contains Crack

Length: 7.46

Width: 15.94

Positive Crack Probability: 73.03%

Location of Crack: Horizontal Crack/s on Wall

Crack Type: Structural Crack/s

Crack Progression: Environmental Crack/s
