Some Uncertainties in Embankment Dam Engineering¹

Victor Milligan²

Abstract: In the design and construction of embankment dams, our current capability for precise mathematical analysis and modeling of induced stresses and deformations, or of potential seepage patterns, far exceeds our capability to make judgments of comparable accuracy concerning, for example, the site and geology or how the soil properties may be affected by the weather or by the contractor's methods. In addition, there is often a lack of adequate communication between the design and the supervision of construction. These uncertainties or doubts about the actual performance of the dam when constructed are discussed in the paper and illustrated by case history examples, with particular reference to the uncertain effects of cold weather, to the use of broadly graded soils (tills) as core and to problems in the placement, and segregation of tills and filter materials.

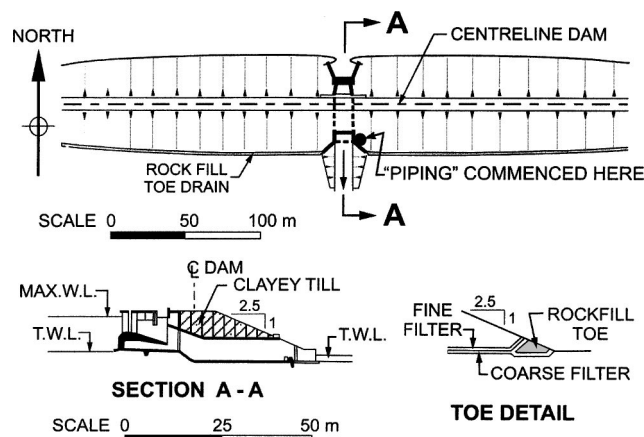
Fig. 1. Kelso Dam plan and sections

Following construction of the dam, the lake level was raised in early Spring to over half of full height and maintained there for about 2 years. Some seepage was observed at the toe of the dam adjacent to the east side of the outlet structure, but the quantity was modest. At the end of the summer season, the level of the lake, which was relatively small, was lowered almost completely to permit maintenance of the gate structure. Impounding did not then take place until late in the following Spring. This impounding was relatively rapid and, as it took place, seepage markedly increased in the same place as before at the toe of the dam such that, as the lake level approached full height, local erosion at the toe became extreme and a “pipe” of almost a meter in diameter on the downstream face rapidly developed despite the outlet having been opened. Fortunately, flooding damage in the recreational area downstream was not extensive.

Detailed examination and investigation of the area of embankment adjacent to the side of the outlet structure showed that a “piping tunnel” had developed along the east side of the concrete structure and, gradually reducing to much smaller size, extended through the embankment to the upstream face. Thin patches of ice were evident on some parts of the exposed concrete face and the till material, where still present within about a meter of the wall, was wet, ranging in water content from about 20% to as high as 40%, the average water content being about 25%. This is in contrast to the water content of the fill material elsewhere in the embankment; for example, the average water content of the fill about 3 m distant from the east wall was about 15%, which was about equal to the original placement water content. These data are illustrated in Fig. 2.

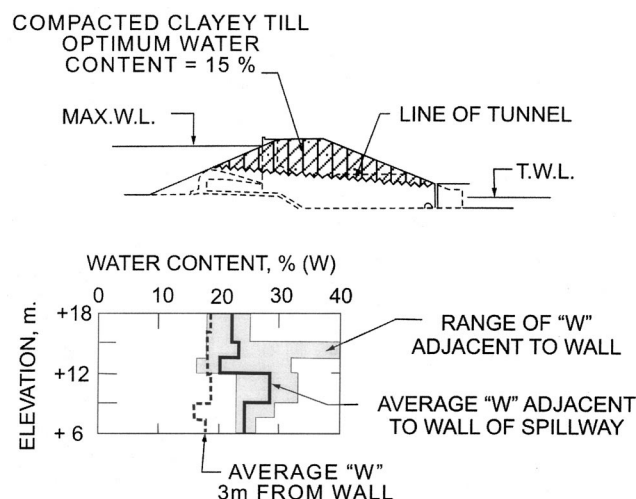
Fig. 2. Water content of frozen core material

It is obvious that the fill material adjacent to the east wall of the outlet had been frozen. The fill elsewhere and even adjacent to the other side of the outlet structure exhibited no signs of having been frozen. This freezing occurred during the winter when the lake was empty. That winter had been extremely cold and the prevailing wind was from the northwest. Since the axis of the conduit is north-south, it acted, in a sense, as a wind tunnel with the east face of the concrete structure being exposed to freezing winds for a considerable period. As a result, the frost susceptible till adjacent to the exposed concrete wall became frozen and it is most likely that ice lenses developed in the till. With the onset of

warmer weather and then impounding, thawing of the ice lenses and of the frozen material led to seepage and subsequent erosion and piping.

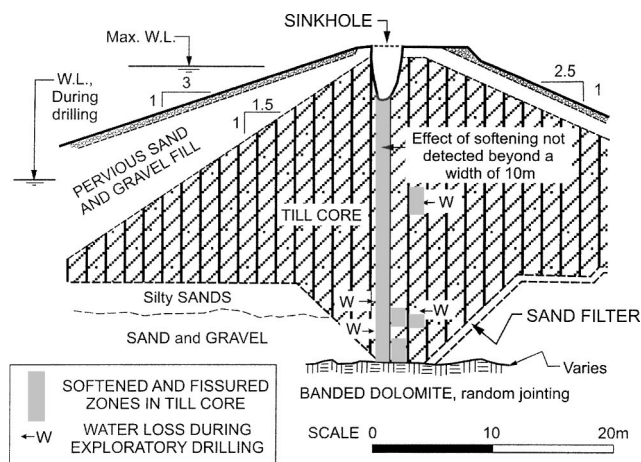
Fig. 4. Conestogo Dam: cross section

Shortly after impoundment, a local depressed area and cavity developed in the crest at about the mid point of the embankment. This was filled in and over the next 2 years further settlement took place, the rate of settlement apparently increasing as the reservoir was drawn down. No unusual seepage or seepage losses downstream were observed at any time, but a hole then developed in the asphalt road surface at this location. Further investigation showed that a sinkhole about 1 m in diameter and 1.5 m deep existed. Investigatory cased boreholes, using wash boring methods to advance the holes, also indicated that there was a localized zone of disturbed and softened core material throughout the full depth of the embankment. Occasional fissures were encountered and at depth within the core, wash water flowed freely into the fill, the loss of water continuing until bedrock was penetrated. However equilibrium water levels in the holes were invariably at reservoir level. There were no indications of any significant connection to the tailwater downstream and the embankment was not in any danger. A summary of the conditions as observed is illustrated in Fig. 4.

The most likely cause of the softening and erosion of the core leading to the development of the sinkhole arises from the condi-

Remedial grouting of this part of the core and of the bedrock directly underlying was carried out. The dam has since performed well for several decades without any signs of further erosion.

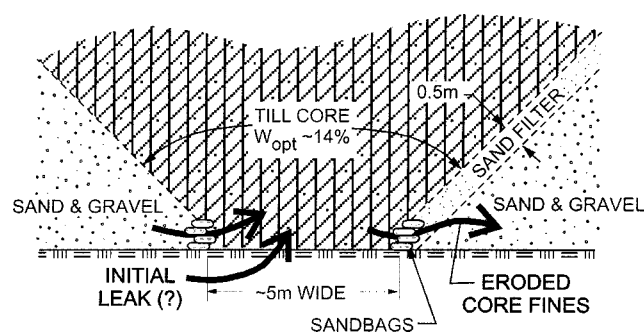
Fig. 5. Core trench detail

tions during construction. Considerable difficulty was experienced in unwatering the core trench excavation. The excavation was locally widened and water pumped from perforated pipe drains in the existing sand and gravel deposits. Sand bags were used to retain the toe of the excavation in some places. [Traces of these sand bags were found in one of the exploratory borings on the upstream side of the core trench (Fig. 5)]. In hindsight, it seems likely that pervious zones connecting directly to the reservoir existed in the upstream part of the foundation. Through gaps between sand bags, these zones could impinge directly on the unprotected core within the trench and could have led to an initial leak causing local softening and erosion of fines into coarser zones of the downstream gravel deposits.

The defect / uncertainty in this case appears to be related to the doubtful nature of the foundation treatment and limitations in the provision of a downstream filter rather than solely to any inherent instability of the core material. In many cases of dams with a cut-off trench beneath the core, the hydraulic gradient across the core is greatest in the cut off. Design measures to prevent migration of core particles in this region are particularly important. For example, where the cut-off trench is within rock, shotcreting of the sides and base of the trench is a necessary measure, together with ensuring that the downstream filter extends to the base of the core.

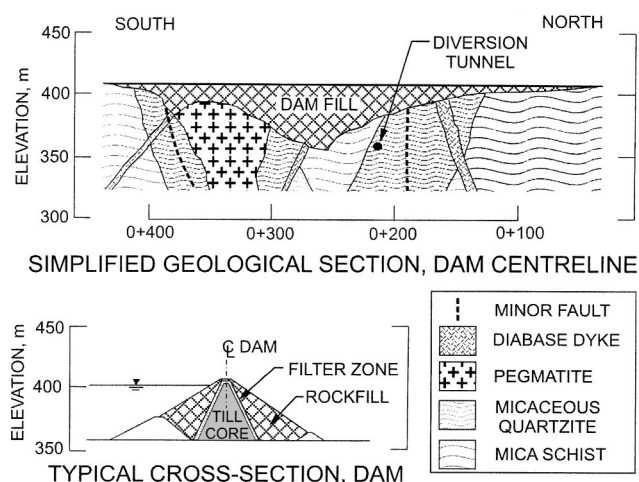
Fig. 6. Incident 1—Site geological section (looking upstream)

A longitudinal section of the dam, looking upstream, and a simplified geologic section along the centerline are shown on Fig. 6. Core and filter gradations are given on Fig. 7. Blanket grouting to a depth of more than 6 m was carried out along the complete core/foundation contact area, but not up the abutments.

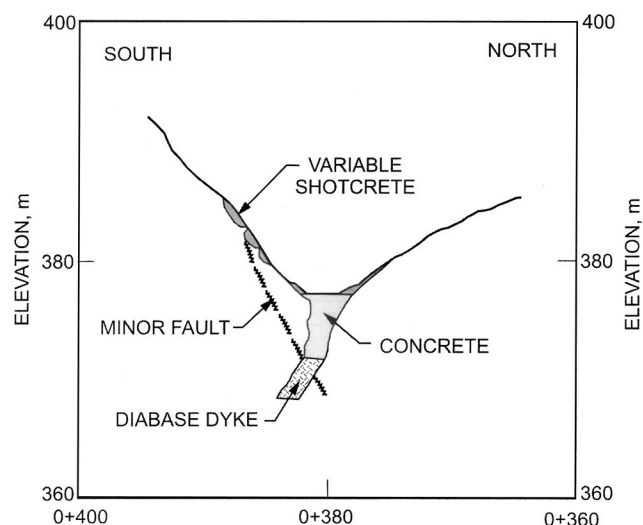
Fig. 8. Incident 1—Section through gully (looking upstream)

During construction, attention was given to the treatment of the foundation and to the placement of core and filter in a steep gully located high on the south abutment (Fig. 8). The weathered upper part of the diabase dyke was excavated and replaced with concrete, irregular rock faces were cleaned and scaled. Some shotcreting of exposed rock surfaces was also carried out, but the extent of this treatment was incomplete. Additional foundation grouting was carried out to treat the minor fault zone that had been exposed during excavation. Because of concern about possible differential settlements in this section, the downstream filter was increased to over 4 m width.

During initial impounding, when the reservoir level approached within about 4 m of the crest, seepage was observed at the toe of the downstream shell in the lower part of the gully referred to above (Fig. 9). The rate of seepage rose abruptly to about 200 L/s (6 cusecs). The water was relatively clean and contained little sediment. No seepage was evident elsewhere along the toe of the dam and seepage was apparently confined to this local area.

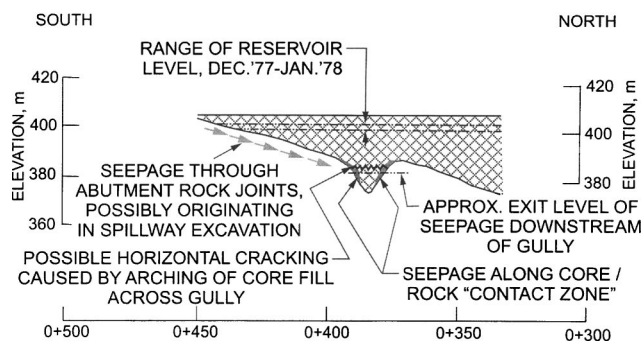
Fig. 10. Incident 1—Possible explanations of seepage

- Horizontal cracking in the core caused by arching of the core fill across the gully;
- Seepage through joints in the foundation rock, possibly opened by blasting for the emergency spillway excavation, and connecting directly to the reservoir at a relatively high elevation; and
- Seepage at the core/foundation contact zone within the gully leading to fines being washed out from the core material, which were not retained by the coarsely graded downstream filter.

The fact that seepage did not take place elsewhere in the dam, even where water pressures were substantially greater, strongly suggests that the irregular profile of the gully, the difficulties in treating the rock foundation and in placing the core material in this area are probably the primary causes of the seepage. It is likely that because of inadequate treatment of the foundation, open joints in the rock, possibly affected by blasting for the adjacent emergency spillway channel, could expose parts of the till core to high hydraulic gradients and leading to erosion of the till in some places.

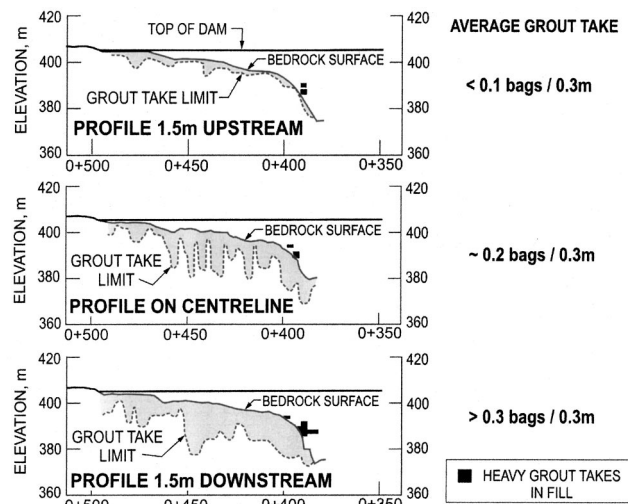
Fig. 12. Incident 1—Details of remedial grouting

A synthesis of the grout takes recorded in lines of grout holes located respectively along the centerline, 1.5 m upstream and downstream of the centerline, is plotted on Fig. 12. While these grout takes are relatively modest, it is interesting to note that grout takes in the rock consistently increased in a downstream direction, probably reflecting the heavily jointed character of the rock adjacent to the gully. It should also be noted that the significant large takes of grout backfill within the core, under gravity

pressures only, occurred only on the south side of the gully, providing a further indication of the deficiencies in the core/rock contact in this local area.

augers to penetrate the core, drilling from crest level. (This method was adopted in order to avoid possible hydraulic fracture, which might be induced by wash boring methods.) The borings indicated the core to be intact throughout its depth except for soft zones close to the contact with the underlying foundation in several borings located on the south side of the gully area. Other borings taken into rock in the same area indicated significant water takes within about 10 m of rock surface. Low-pressure cement grouting was then carried out in rock over about a 100 m length, extending from the gully to the south abutment; holes within the dam fill were backfilled with sand/cement/bentonite grout under gravity head. The effectiveness of the grouting is demonstrated in Fig. 11; the reservoir level was then raised to full height with no further incidents of seepage.

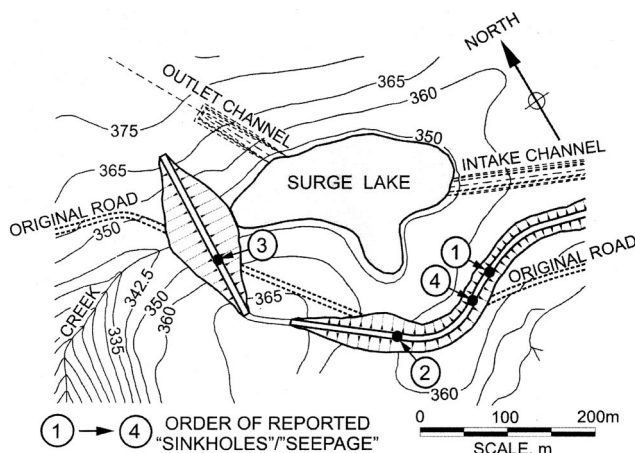
Fig. 13. Incident 2—Site plan

About 2 months following initial impoundment, minor seepage was observed in a local area at the downstream toe of the longer dyke (Fig. 13). This quickly increased to over 15 L/s, the water becoming cloudy. More importantly, a small sinkhole developed at the upstream edge of the crest, followed the next day by a similar sinkhole at the downstream edge of the crest. The reservoir was then drawn down and it was decided to carry out additional grouting of the foundation from the crest of the dam and partially remove the downstream shell and filter to permit inspection and possible replacement of the filter and shell in this area. During the initial progress of this work, jamming of the diversion tunnel gate occurred and the water level rose rapidly overnight causing increased "dirty" water seepage at several locations in the general area of the previous seepage. The concentration of flow in one location caused severe erosion of exposed

filter material locally remaining on the steep downstream slope of the core material. The total seepage rate was estimated to be about 250 L/s or more.

This section of the embankment was completely removed and the exposed foundation rock in the core trench, which was weathered and fractured, was excavated by backhoe for about a meter, then grouted to a depth of over 10 m. Grout absorption in the rock was extremely low (corresponding to cement takes of less than 0.05 bags/30 cm); additional water testing confirmed the extreme tightness of the foundation. The embankment was reconstructed with a slightly wider downstream filter than before using the same materials, and the water level raised.

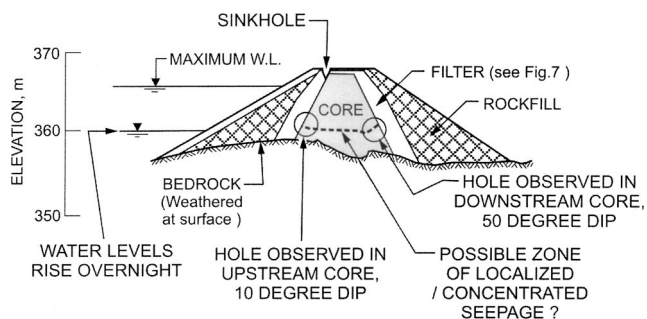
Fig. 14. Incident 2—Cross section showing locations of “piping”

dirty. The pond level was again drawn down and an investigation shaft was excavated through one of the sinkholes at the contact between the filter and core. In the lower part of the shaft, extensive “washing” of the core and filter was evident in some zones close to foundation level such that only large size cobbles and coarse gravel remained.

Because of the relative tightness of the foundation at the location of the first incident, the seepage and sinkholes there seem to be related to causes other than the condition of the rock; however at the other locations, the foundation rock was observed to be jointed and fractured and this could have led to the later sinkholes. An initial leak could have developed through open joints in the untreated rock in the foundation near the downstream edge of the core; water would then flow upwards washing the fines in the core into and through the coarse downstream filter. In the first incident, a lack of compaction or improper placement in some layers of the till core material above the foundation could have created random loose pervious zones, which led to the subsequent piping at the elevation shown.

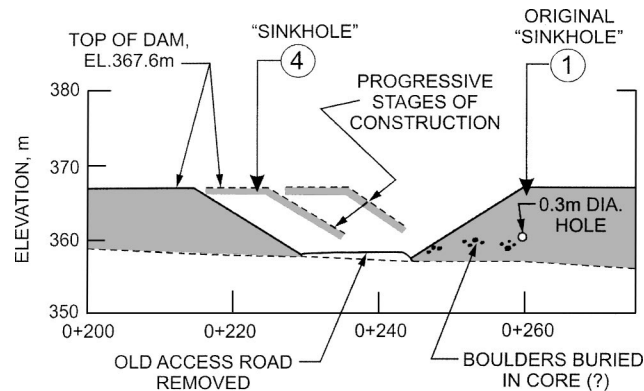
Fig. 15. Incident 2—Illustration of filling gaps across access road

- Was all road bed material excavated such that the foundation below it was cleaned, washed and treated comparably to other sections of the embankment?
- Were the edges of the road bed partially covered with spilled till material from the sloping core ramping upwards on both sides of the road?
- Did cobble sizes and segregated till material tend to accumulate along the lower part of the ramps during subsequent filling of gaps?

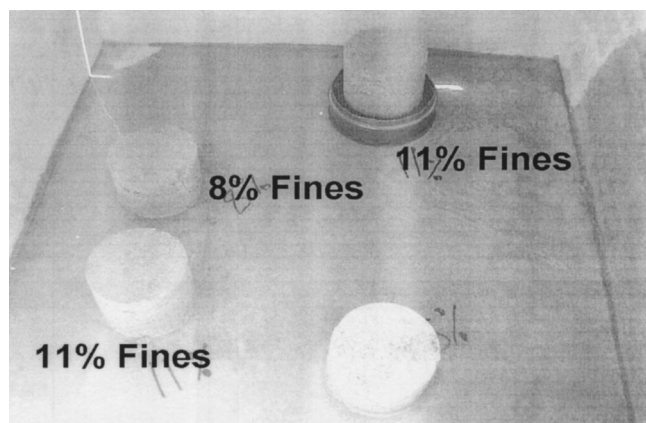
Fig. 21. Compacted filter samples—not flooded

A simple but effective test to check the potential collapsibility of compacted filter materials has been proposed by Vaughan and Soares (1982). A sample of the compacted material is taken from a split mold, placed in a basin, which is then slowly filled with water; as the water level rises, any capillarity in the sample is destroyed and the sample collapses. This laboratory test procedure has been used by the writer to examine the behavior of wetted filter samples used on a number of dams, which were then checked by observing their behavior in test pits dug into the same material when placed in the embankment. Occasionally, as the test pits were filled with water, the walls in some pits did not collapse as expected, but quickly filled with water and remained flooded for some time, ranging from minutes to hours; after the water level fell, the pit slopes were still intact. This result was surprising in that the laboratory samples had exhibited satisfactory collapse. Sampling of the material in the embankment invariably disclosed a high relative density in situ and a higher fines content than that specified. It was apparent that the material, as originally processed, differed from the material, after placement. This can arise if the contractor is permitted to use the filter zone as an occasional haul road. Core borrow material may then be spilled on the filter zone and the combined effect of traffic and of spillage from haul trucks can produce a rigid fill mass markedly different from the design intent.

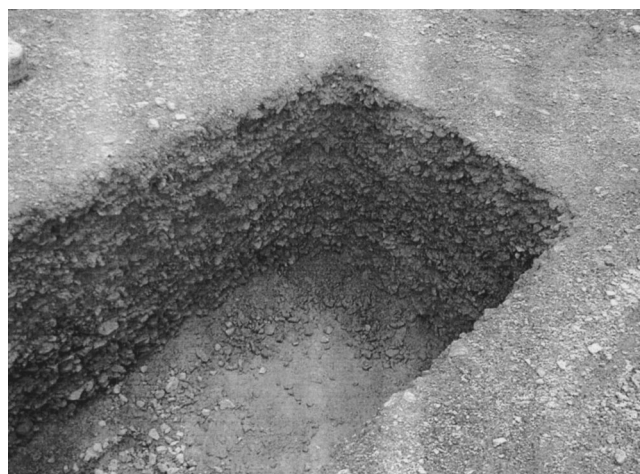
Fig. 23. Test pit (a) in filter—after flooding

Even where traffic over the filter zone is carefully controlled, the effect of truck hauling to the site and consequent compaction may lead to some breakdown of particle sizes and thus a detrimental increase in fines content. This is particularly the case where filters are derived by processing of quarried hard rock. An example of this effect was observed in the recent construction of an embankment dam in Peru. The rock fill dam proposed was to be about 200 m in height; it would be located in a highly active seismic zone; relatively large deformations could be anticipated on first filling and possibly subsequently. It was considered to be essential that the filter materials be ample in width and also be unable to sustain a crack. Local river deposits were not available and the filter material had to be obtained from crushed hornfels some distance from the site. The filter gradation initially proposed is shown in Fig. 20. Satisfactory collapse tests were carried out on laboratory samples, even where the fines content exceeded the specified maximum of 8% (Figs. 21 and 22). However, flooding of material meeting the specified gradation, when placed and compacted in a test fill, clearly indicated no corresponding collapse of the pit sides (Fig. 23); however, the behavior of another test pit, excavated to form a cylinder of compacted material, indicated some collapse (Fig. 24). Sampling of the fill material indicated a higher fines content in situ than that of the originally

processed material. The increase in fines was the result of particle crushing and breakdown caused principally by the effects of placement, handling and compaction of the material on site.
