Investigation of dam incidents and failures

Alan L. Warren BScEng, DIC, MSc, CEng, FICE
Chief Engineer (Dams), Halcrow Group Ltd, Swindon, UK

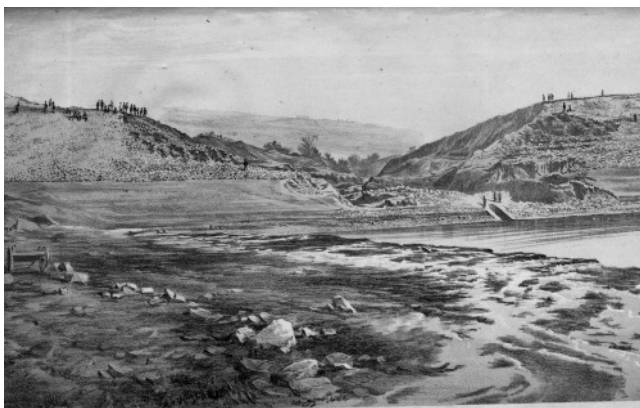
In the UK, one of the most devastating historical dam failures was the Dale Dyke disaster (Figure 1), which left 244 people dead in the vicinity of Sheffield. The Dale Dyke dam failed during the first filling of the reservoir on the night of 11 March 1864. The Home Secretary, Sir George Grey, appointed two civil engineers, Robert Rawlinson and Nathaniel Beardmore, to assist in the inquiry into the cause of the catastrophe. A leader in *The Times* on 17 March 1864 argued that those threatened by reservoirs could not be expected to defend themselves and needed protection. The verdict of the jury at the inquest on 24 March 1864 included the statement:

Figure 1. Postcard photograph of the Dale Dyke dam breach (courtesy of ICE)

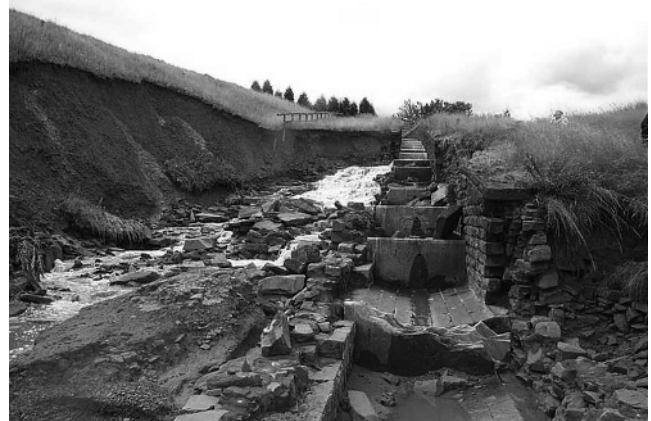
Ulley reservoir was created in 1873 by the construction of a 16 m high embankment dam. The reservoir is owned by Rotherham Borough Council and is used for amenity purposes as part of a country park. During flood events, overtopping of the embankment was prevented by allowing water to flow down a spillway channel. However, in passing the significant floodwater that resulted from severe rainfall in June 2007, the wall of the spillway channel failed. As the channel was located adjacent to the earthfill forming the downstream side of the embankment, the failure of the wall led to rapid erosion of the dam earthfill material behind the wall. This erosion threatened the overall stability of the dam embankment. In response to the incident, the M1 motorway was closed and residents thought to be at risk downstream of the reservoir were evacuated. Emergency action was taken to:

Figure 2. Ulley reservoir 25 June 2007: the masonry stepped spillway structure on the dam mitre fails to prevent major erosion of the adjacent dam embankment, threatening the stability of the dam
©Jim Claydon, courtesy of Rotherham Borough District Council

- (a) divert flow from the damaged spillway
- (b) lower the reservoir using temporary pumps
- (c) import rockfill to fill the eroded section of embankment.

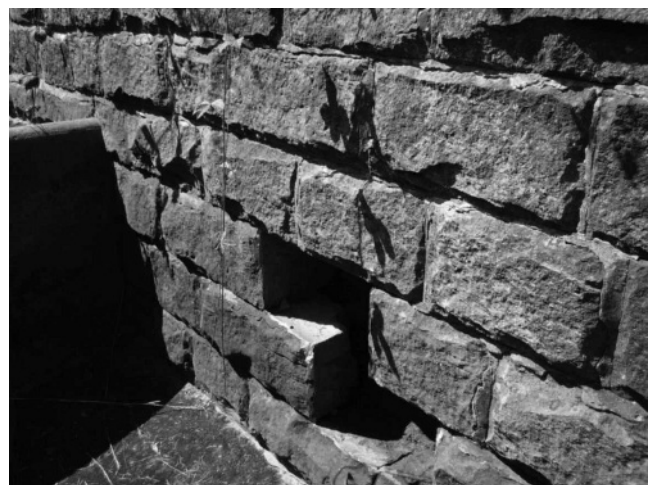
Second, the exact physical mechanism by which the spillway wall collapsed under high-flow conditions could not be determined with certainty. Research was later carried out on the pressures that can be exerted on masonry blocks from within wall joints on a stepped spillway configuration. It was postulated that the spillway wall collapsed due to pressure

Figure 3. Ulley reservoir 2007–2009: investigations and research found that masonry stepped spillway walls might have been prone to block displacement and collapse under high-flow conditions
©Halcrow

differentials sufficient to pluck out masonry blocks, thus causing the wall to collapse. Recent research has confirmed this mode of failure to be feasible and new guidance on the inspection and maintenance of stepped masonry spillway channels has been published to aid dam owners and engineers (Winter *et al.*, 2010) (Figures 2–4).

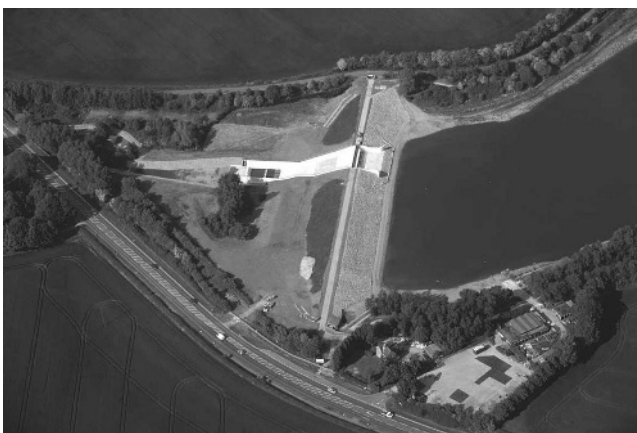
Figure 4. Ulley reservoir 2010: the dam received major repairs including a new spillway structure located near the centre of the dam. New legislation to improve provisions for emergency planning was passed ©Peter Smith Photography, courtesy of Arup consultants

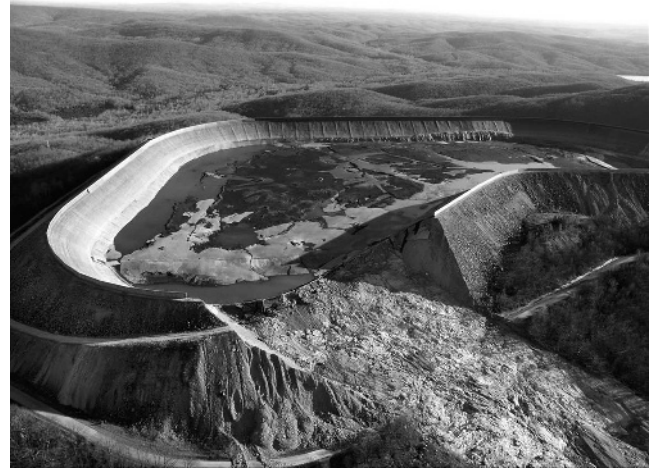
Figure 5. Taum Sauk reservoir 14 December 2005: catastrophic failure of the embankment led to the release of over 5 million cubic metres of water in less than about 25 minutes (photograph courtesy of Ameren)

failure mechanism was a stability failure caused in turn by saturation of the embankment through overtopping of the reservoir rim (Paul C Rizzo Associates, 2006). A number of contributing factors relating to the geotechnical characteristics of the dam material were also reported. Human error led to misplacement of the high-water alarm sensors such that overfilling of the reservoir was not communicated to the control centre. This led to overtopping of the perimeter parapet wall and instability of the embankment.

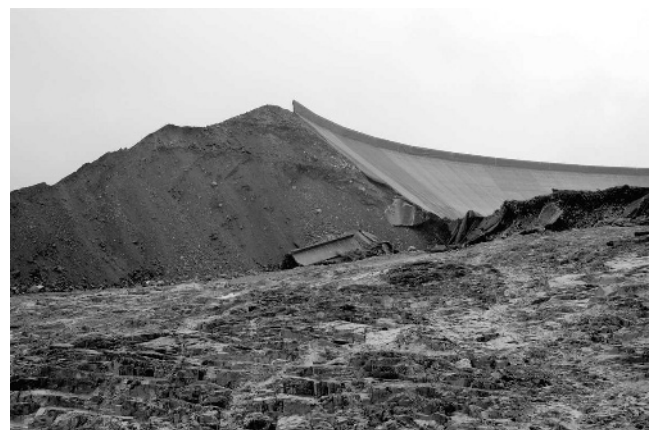
Figure 6. Failure of Taum Sauk reservoir (photograph courtesy of Ameren)

the overtopping of the parapet wall (FERC, 2006). However, the FERC investigation differed on the failure scenario, suggesting that erosion below the parapet wall was the cause of the instability rather than internal water pressure within the embankment alone.

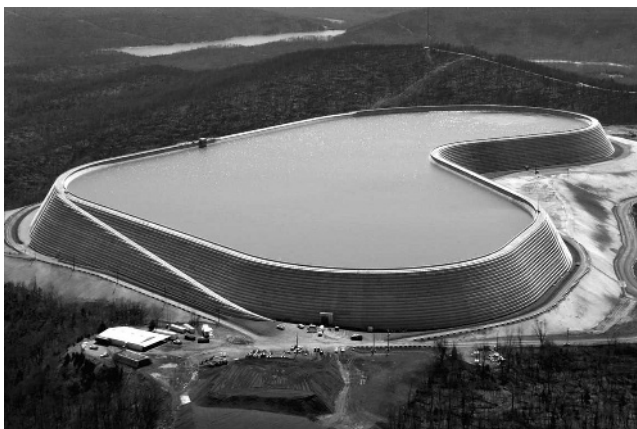
Figure 7. Taum Sauk reservoir 2010: the dam embankment has been rebuilt using roller compacted concrete (photograph courtesy of Ameren)

Investigations were also conducted by other agencies including the Missouri Public Service Commission, Missouri Highway Patrol and the Missouri Attorney General's Office. The investigations resulted in no criminal charges against the reservoir owner and operator (Ameren) but did require a payment of fines to the FERC. Ameren entered into a consent judgement with the State of Missouri to settle all environmental and natural resource damage claims. The original dam has recently been replaced with a dam of roller compacted concrete construction, the largest of its type in North America (see Figures 5–7).
