Experience of Ammonia Converter with Catalyst Leakage and Repairs

Muhammad Aleem Khan

Fauji Fertilizer Co., Ltd., Goth Machhi, Pakistan

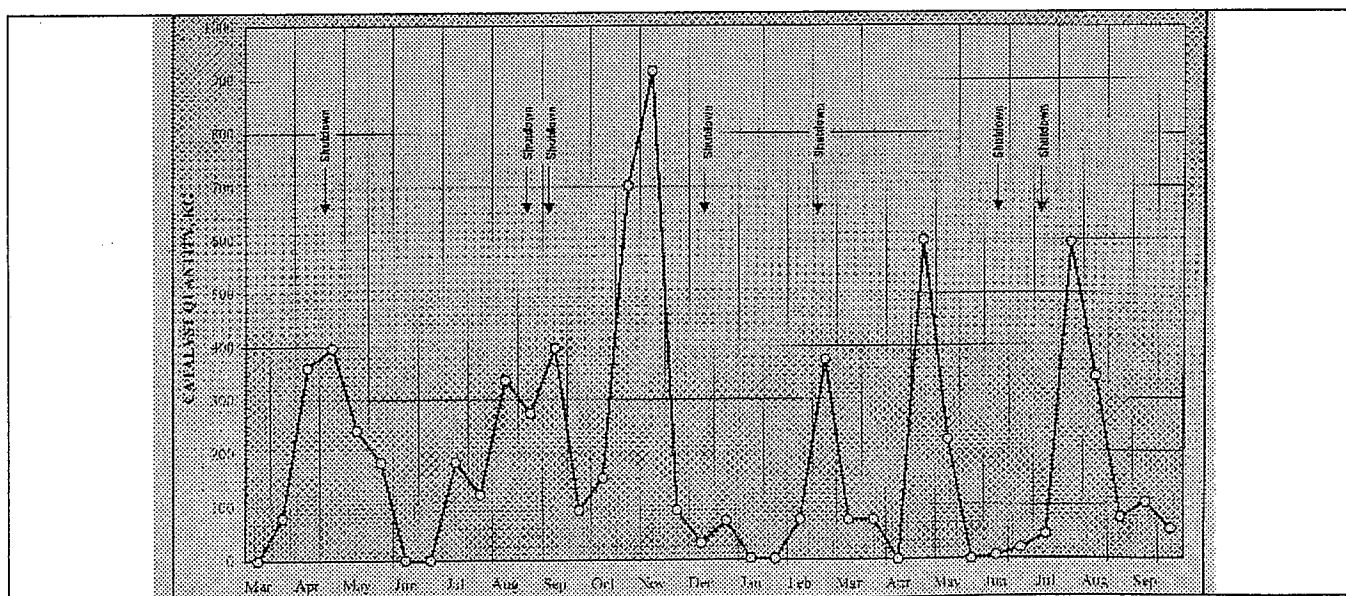
In order to answer most of the questions listed above, a high-pressure catalyst separator (filter) was installed on the drain line of the ammonia separator V-4501 with an arrangement to remove the catalyst during normal plant operation (see Figure 3). After installation of the filter, the catalyst leakage rate from the converter is generally found to be 4–5 Kg/day.

However, the problem was observed to aggravate after plant shutdown (see Figure 4).

Figure 4. Ammonia converter catalyst removed through filter (March 1997–September 1998).

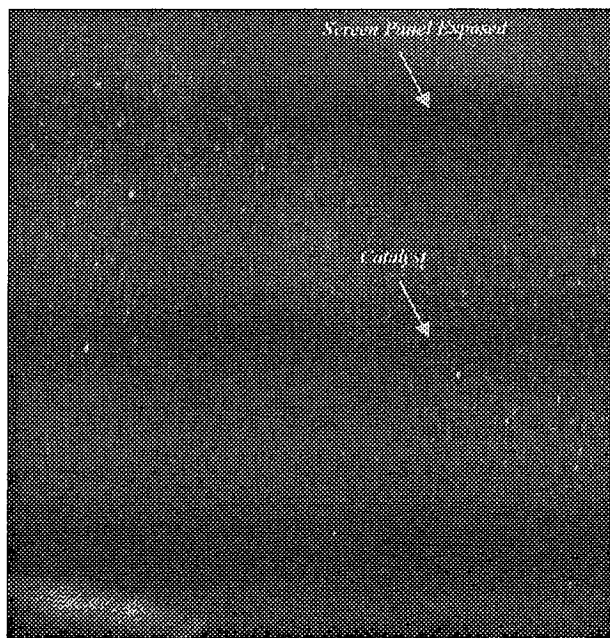
bed cover was removed for catalyst unloading activity, a crater of ~2 m was observed, and the catalyst was far below the unperforated portion of center screen all around the one-half of the bed circumference (as seen in Photo 1). The catalyst on the other side of the crater was ~0.4 m below the top cover plate of the bed.

Photo 1. Center screen exposed due to decrease in catalyst level in second bed.

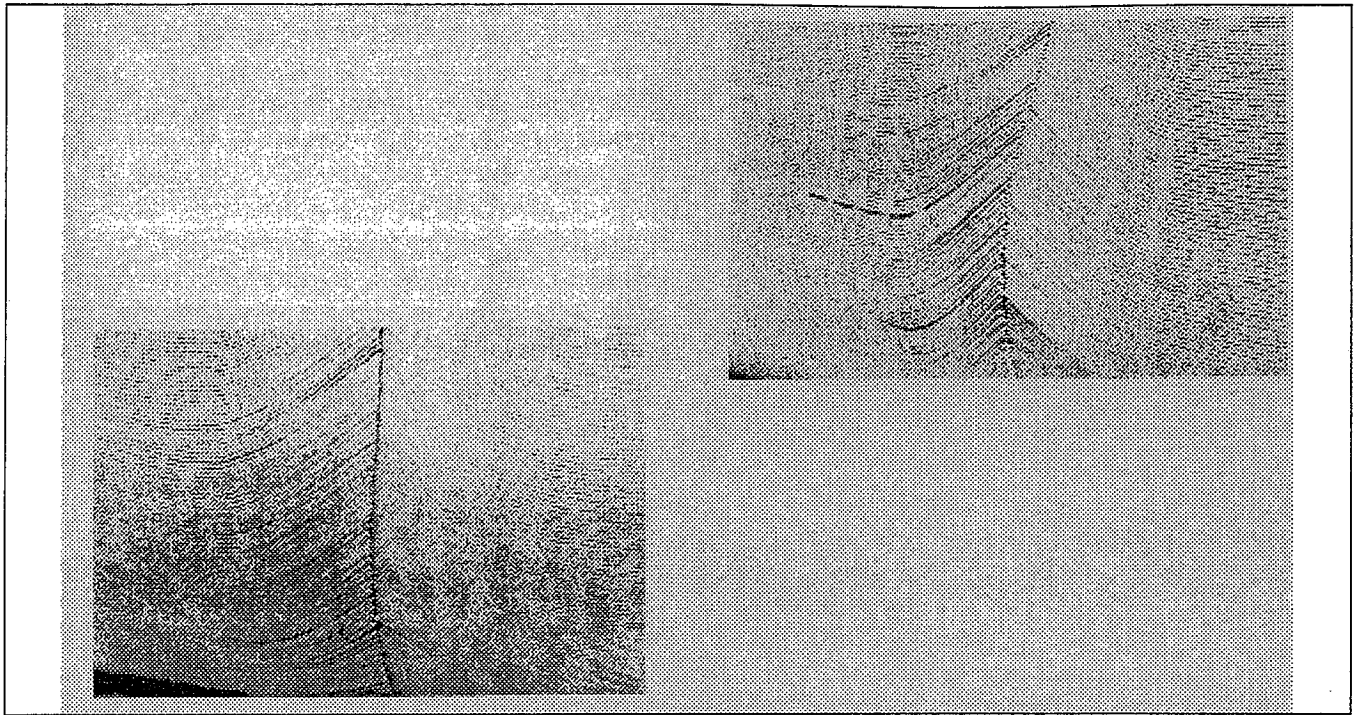
Inspection of the center screen was carried out after removal of all the catalyst. The screen was found damaged at two locations (see Figure 5). It was severely damaged at about 3.2 m from the bottom (at the third circumferential joint). The screen wires were found twisted and a few wires were also torn apart allowing passage for catalyst leakage (see Photo 2).

The damage to the center screen at the bottom, as shown in Photo 2, indicates that the screen wires exhibited excessive compression stresses due to the fact that the upper section of the center screen was restricted in expanding thermally. These stresses resulted in high axial load causing failure of either the weakest circumferential joint or failure in the lower portion of the screen. At the second location, the screen was sheared off circumferentially due to axial tension, as shown in Photo 3.

Photo 2. Damaged center screen at 3.2 m from the bottom.

The new modified center screen of the second bed, with higher strength against the axial load, is also designed by Haldor Topsøe (see Figure 7). A perforated liner of Inconel 600 was welded to the inner side along the entire length of the center screen. There are holes provided on the liner for the passage of gas without posing additional differential pressure. In order to provide radial (collapse) strength, the screen wires were welded to the circumferential rings at each point. These rings are provided in-between the liner and

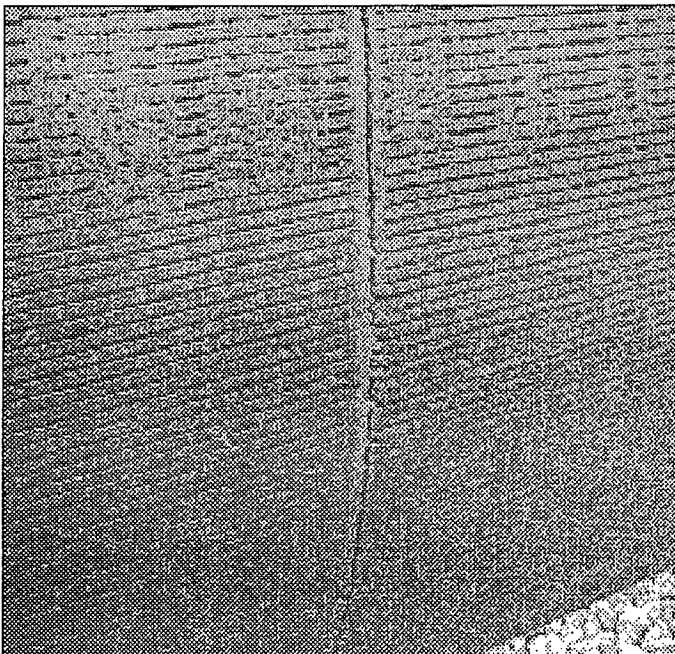
The second damage was found at about 8.8 m from the bottom (at the seventh circumferential joint). At this location, the two sections of the screen were torn apart from circumferential weld, while the wires were intact and straight (see Photo 3). All other joints were OK, and no denting or bulging was observed on the screen.

Photo 3. Damaged center screen at 8.8 m from the bottom.

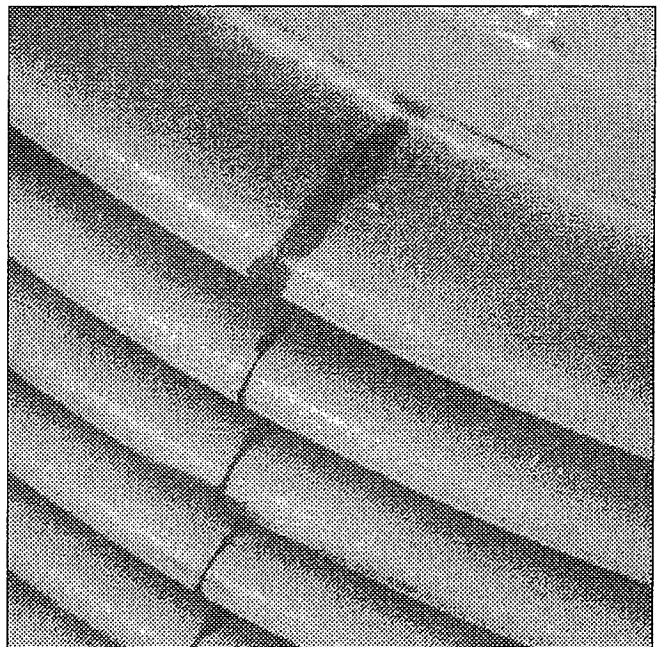
The old expansion bellows was removed from the center screen and some cracks were also observed (see Photo 4).

Photo 4. Damaged expansion bellow.

The new center screen was provided in two sections; therefore, the same was welded circumferentially from the inner and outer sides by the welder from Johnson's filtration system (France). The new expansion bellows were welded to the upper flange of the center screen before installation. Prior to this, a dye check of all the welding joints of the screen was carried out and some defects were observed at four locations on the circumferential weld joints. The same was repaired by grinding and welding before installation.
