A Case Study of Feedwater Heater Life Management

This paper describes the methodology of life management and its application to a feedwater heater at KCPL. A life management case study is presented which focuses on KCPL's LaCygne power plant, Unit No. 2, first-point extraction, high-

pressure feedwater heater no. 21. LaCygne Unit No. 2 is a 630-MW generating unit which was upgraded to 710 MW in 1991. Feedwater heater no. 21 is a three-zone horizontal hemi-head heater containing 1568 U-tubes constructed of SA-556 C2 carbon steel.

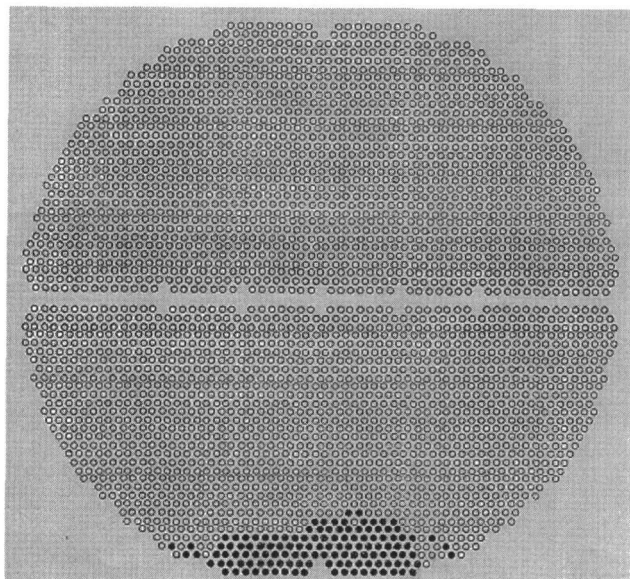
Fig. 2 La Cygne Unit No. 2, feedwater heater no. 21 tube plug map as of August 1990, 128 Tubes plugged

In August 1990, 13 tubes failed in the lower periphery of the drain cooler region. These 13 tubes were plugged and due to the excessive number of previous failures in this region, 49 additional tubes were insurance plugged at the same time. Figure 2 gives a plug map for feedwater heater no. 21 which illustrates the 128 tubes which had been plugged in the drain

cooler zone as of August 1990. By the end of 1990, feedwater heater no. 21 had experienced two more outages due to the failure of 10 more tubes in the drain cooler region. By the end of 1990, 138 tubes had been plugged out of 1568 total tubes. Table 2 summarizes the tube failures experienced by feedwater heater no. 21 during the period April 1988 through January 1991.

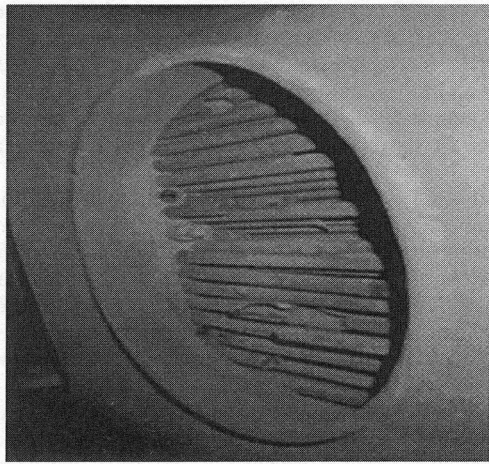
Therefore, during the period February to April 1991, 219 U-tubes were replaced in feedwater heater no. 21 in the area directly above the drain cooler inlet riser. This riser was an early design which utilized a round pipe instead of the square inlet design which is currently used. It was determined that a standing vortex emanating from the round inlet riser had eroded the tubes in this vicinity. This problem was identified and resolved during the 1991 retube by inserting a 1-in. bar across the diameter of the inlet riser. Figure 3 illustrates the type of tube damage found in the drain cooler zone of La Cygne Unit No. 2, feedwater heater no. 21 during the 1991 retube project.

Fig. 3 Tube damage in the drain cooler zone of La Cygne Unit No. 2, feedwater heater no. 21

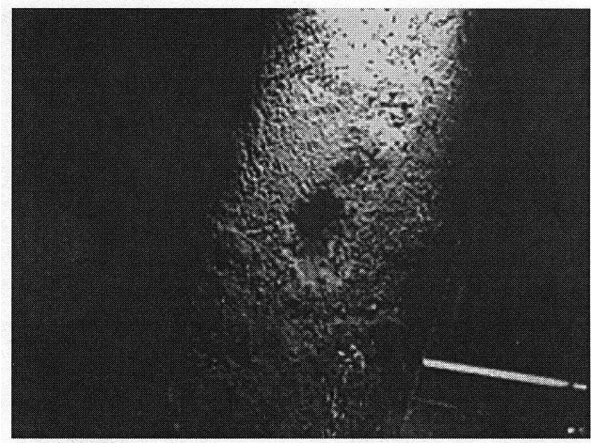
Fig. 6 Pit found on the outside surface of the retube sample

found on the inside surface of the same tube. Figure 6 shows a severe pit found on the outside surface of the retube sample. Figure 7 gives a cross section of the same pit which indicates the presence of a failure in the tube wall.

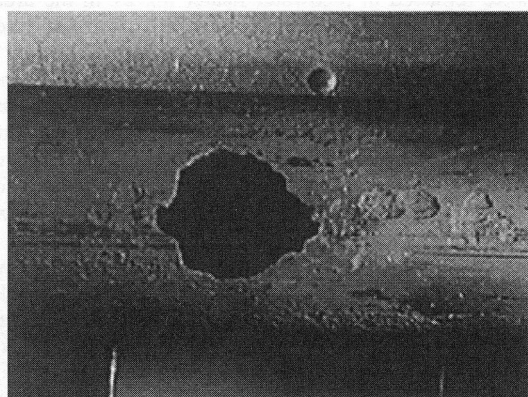
present and pitting was noted on the outside of the tube. It was hypothesized that turbulent steam flow near the baffle plate was eroding and pitting the tube surface, with corrosion compounding the problem. Yokell (1995) states that uncondensed saturated steam entering the drain cooler zone, through the annular spaces between the holes in the end plate and the tubes, leads to the erosion of the holes in the end plate and baffles. This steam then condenses within the drain cooler zone resulting in an implosion effect which causes localized pitting on the outside surface of the tubes.

Fig. 4 Localized pitting and wall failure found on the outside surface of the original, 16-yr-old tube sample

failed tubes, one from the retube area and one original tube, were removed from the drain cooler zone for metallurgical testing. The two tubes were inspected with a stereo microscope. Pitting was noted on the outside surface of both samples with deeper pitting found near the end plate. There was also evidence of crevice corrosion which is often associated with water containing small concentrations of dissolved solids. Figure 4 illustrates the localized pitting and wall failure found on the sample from the original, 16-yr-old tube. Figure 5 exhibits the corrosion

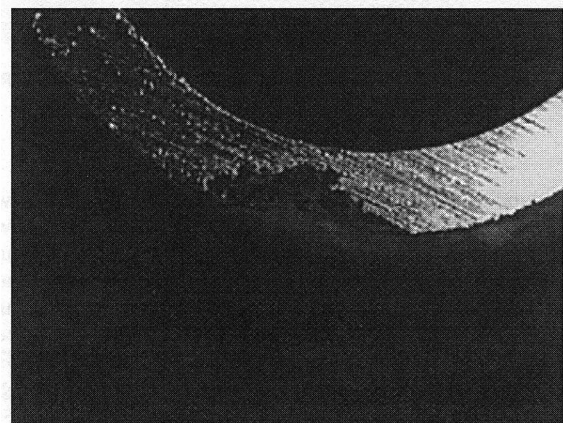
Fig. 7 Cross section of pit on retube sample

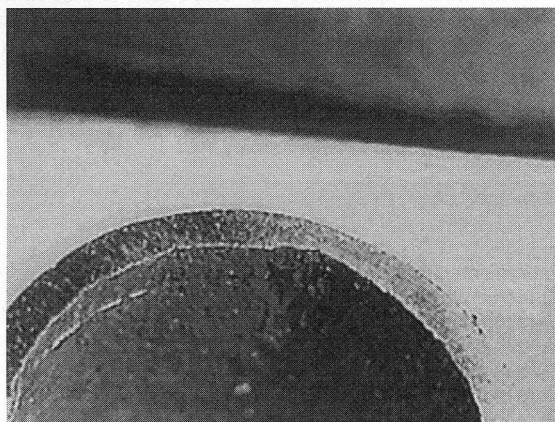
Fig. 5 Corrosion found on the inside surface of the original, 16-yr-old tube sample

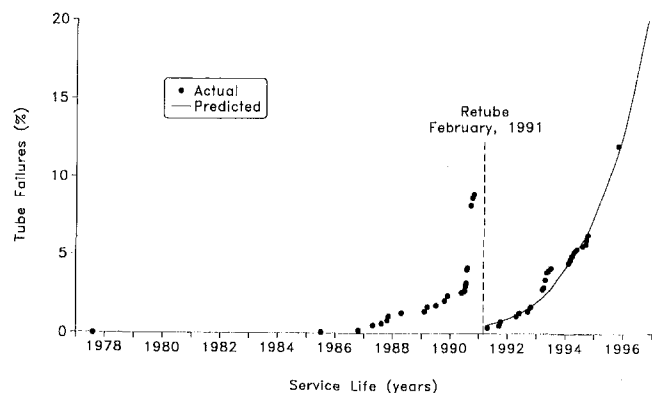
Fig. 8 Actual and predicted tube failures for feedwater heater no. 21

During the next 16 mo, feedwater heater no. 21 was out of service 14 times due to tube leaks resulting in 37 additional U-tubes being plugged. At this time, the useful life of the feedwater heater was predicted by using an exponential function to fit the tube failure data. As shown in Fig. 8, this prediction indicated

that 10 percent of the tubes would be out of service by September 1995. During the period August 1994 to September 1995, 86 additional tubes were plugged. Figure 9 gives the final plug map for feedwater heater no. 21 as of September 1995. It illustrates the 184 plugged tubes, 12 percent of the 1568 total tubes. Table 3 summarizes the tube failures experienced by feedwater heater no. 21 during the period from February 1991 through September 1995.
