PROBLEM STATEMENT

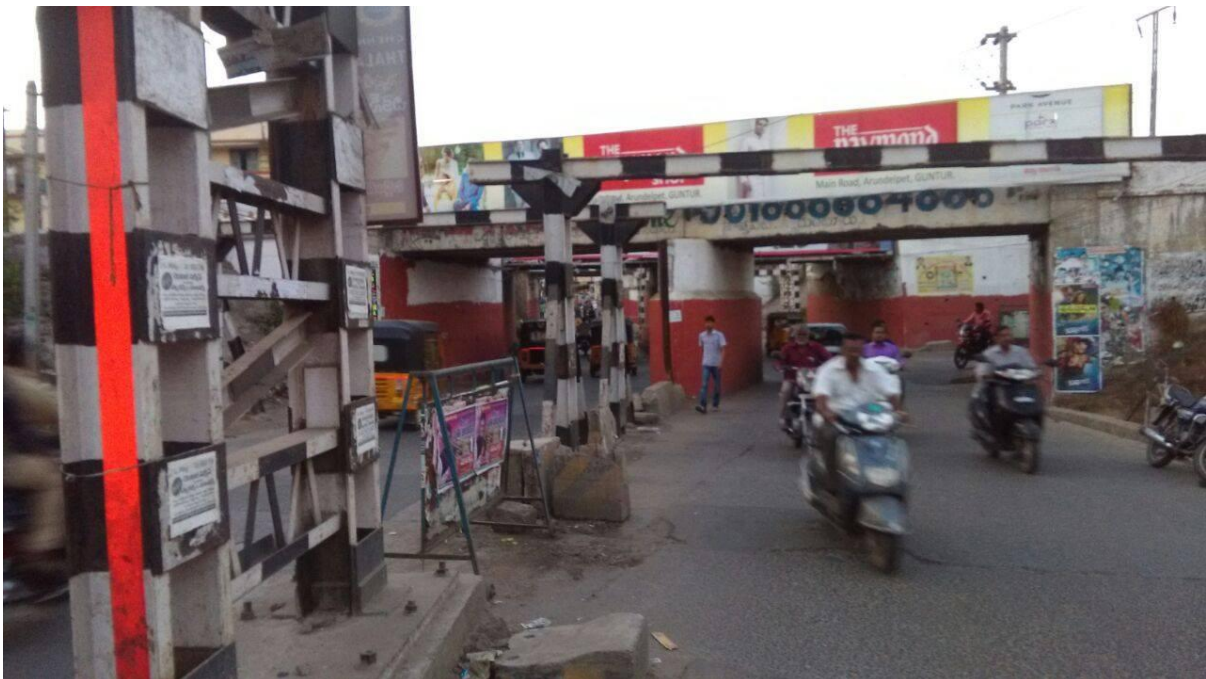
The road shown in the below picture is from “Mudu Vanthenalu” area of Guntur city. Since 2002 the pavement has been replaced many times which got damaged every rainy season. The road has got a drainage system beside it. Every rainy season rain water gets stagnated, gets mixed with drainage water and surface course gets damaged. In addition to this, due to the presence of drainage system the subgrade portion of road is getting disturbed. The waste from Nehru nagar and nearby areas is being dumped here. There is no chance of increasing the road thickness as there is a railway bridge over the road. So, we require a solution which is economic, innovative, without disturbing the other parameters or structures around road.
