Some Investigations of Fukushima Dai-ichi Accidents from the Viewpoints of Human Factors

Abstract. Many problems were posed in the Fukushima Dai-ichi NPS accident, including recognizing the situation in the plant, information sharing in/out of the power station, decision making, emergency response, education and training on daily basis, instrumentation/control facilities and work environment of the plant, etc. A voluntary group in the division of Human-Machine System of Atomic Society of Japan reviewed the problems suggested in various reports from the viewpoint of human factors. This paper reports the outline of some results of the review based upon some accident reports published after the accident and the information published by the defunct Nuclear and Industrial Safety Agency. The severe situations due to the loss of all power resulted in unsuccessful operation. However, the staffs on the site seem to have taken flexible approaches based on their knowledge and experience. As for the fields of communication and information sharing, there found some problems among two groups, operation groups, or order-givers and takers. On the other hand, in the analysis of emergency response

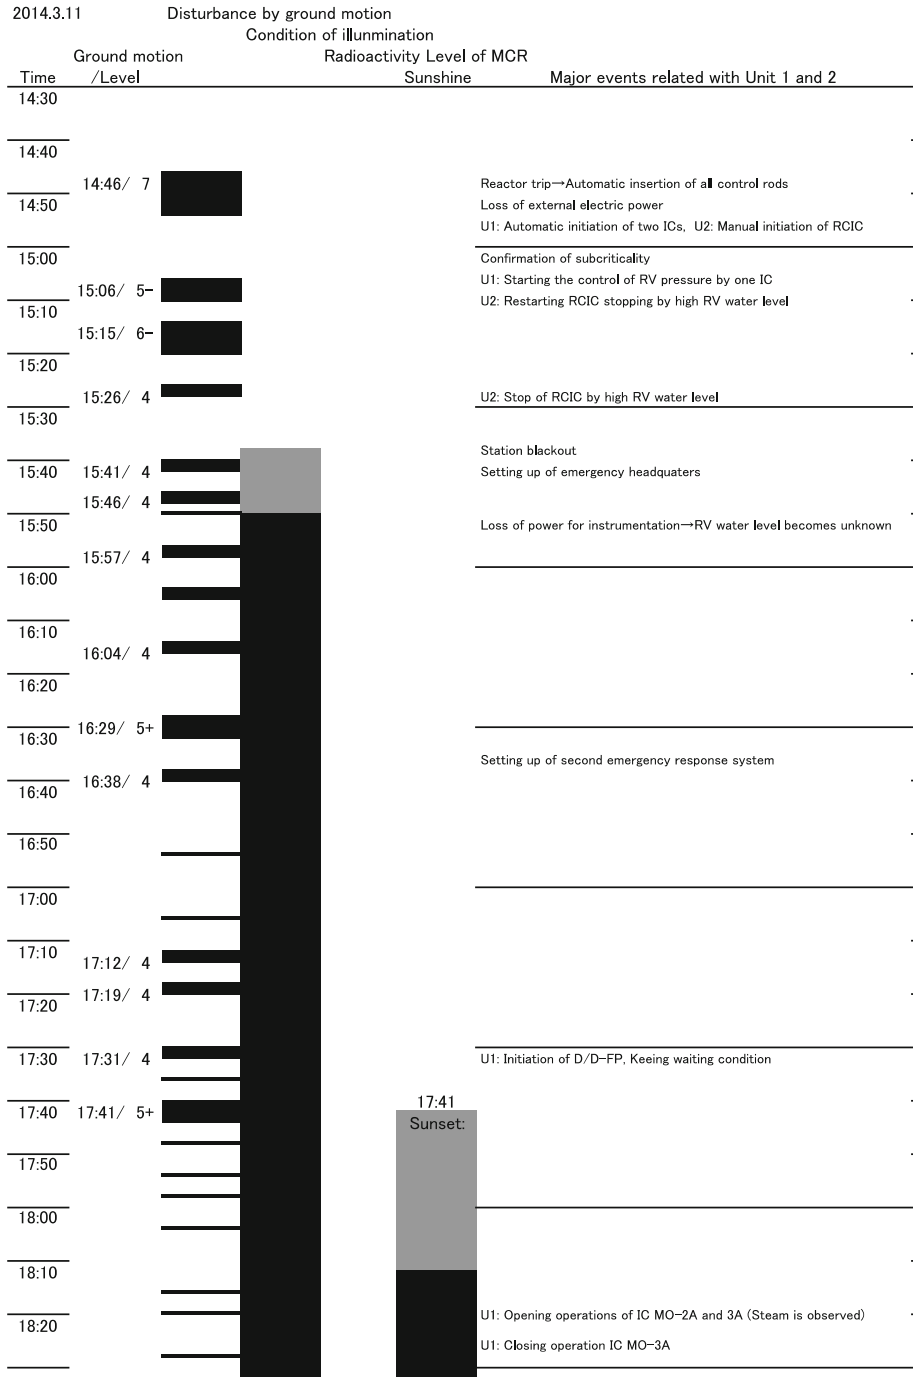
The work condition of operators is visualized for the four factors. Figure 1 shows the work condition and major events related with Unit 1 and 2 from 14:30 to 18:30 on March 11, 2011 as an example of the visualization. The figure is drawn under the following assumptions as to the influences by after-shocks, illumination condition and the light outside the building. The level of earthquake is indicated by Japan Meteorological Agency seismic intensity scale because it expresses the level of ground motion and there are many monitoring posts all over Japan. The measured level at the

As seen from Fig. 1, after-shocks frequently happened. This means that the working condition of operators was not good and they often had to postpone their works in some minutes. After the station blackout, the working condition became greatly worse. They needed flashlights to continue their works. By the station blackout, operators lost their methods to know plant condition. The sun set after two hours later. It became dark outside the building resulting in making difficulty in observing the condition of facilities from the distance. Considering the bad work condition, the operators are supposed to recognize plant condition as summarized in the next subsection.

Fig. 1. Work environment of MCR operators from 14:30 to 18:30 in March 11, 2011

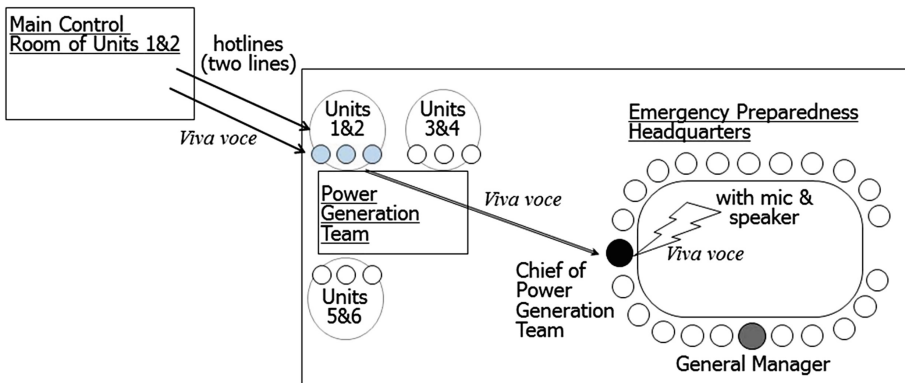
Information on Unit 1 operation status and situations was not fully shared with the EPH. Figure 2 shows the process of the communication from the MCR to the EPH. Using hotlines, information of the MCR was transmitted verbally to the Power Generation Team of the EPH. The information which the team received was given orally to the Chief of Power Generation Team. Finally, the information is given to entire Headquarters using a microphone from the Chief. The information about detailed operations (e.g., valve controls) and sound they heard (e.g., generation of steam) was communicated to the entire Headquarters. The information might prove IC was functioning. However, the information opposed to it was not transmitted from the MCR to the Headquarters for some reason. The reason has not been revealed. As the result, there was a period of time that the operators in the MCR understood “IC’s not functioning,” while the members of the Headquarters recognized the situation as “IC’s functioning” [2] (p. 323 and Appendix 8–10).

Fig. 2. Flow of information from the main control room of units 1&2 to the emergency preparedness headquarters (Source: Reference [2], Appendix 8–10, p. 2).

TEPCO proposed four measures in the report: (a) to understand the situation visually, communication form (e.g., simple diagram) should be used for communicating plant and system status, (b) the common template, e.g., dedicated sheets on white boards, should be set both in the EPH and the MCR, (c) communications should be exchanged whenever information is updated, (d) the use of these methods should be trained through disaster drills [2] (pp. 344–345 and Appendix 16–3).

In situations where old information was recorded on the template at the Headquarters, it is difficult for the members of the Headquarters to find out the operators forgot to convey new information. To address this problem, they need to compare records on the both templates. A feasible measure is using a hardware that the Headquarters can visually confirm the template in the MCR with. A software measure
