# Elevation Change After the Edenville Dam Failure

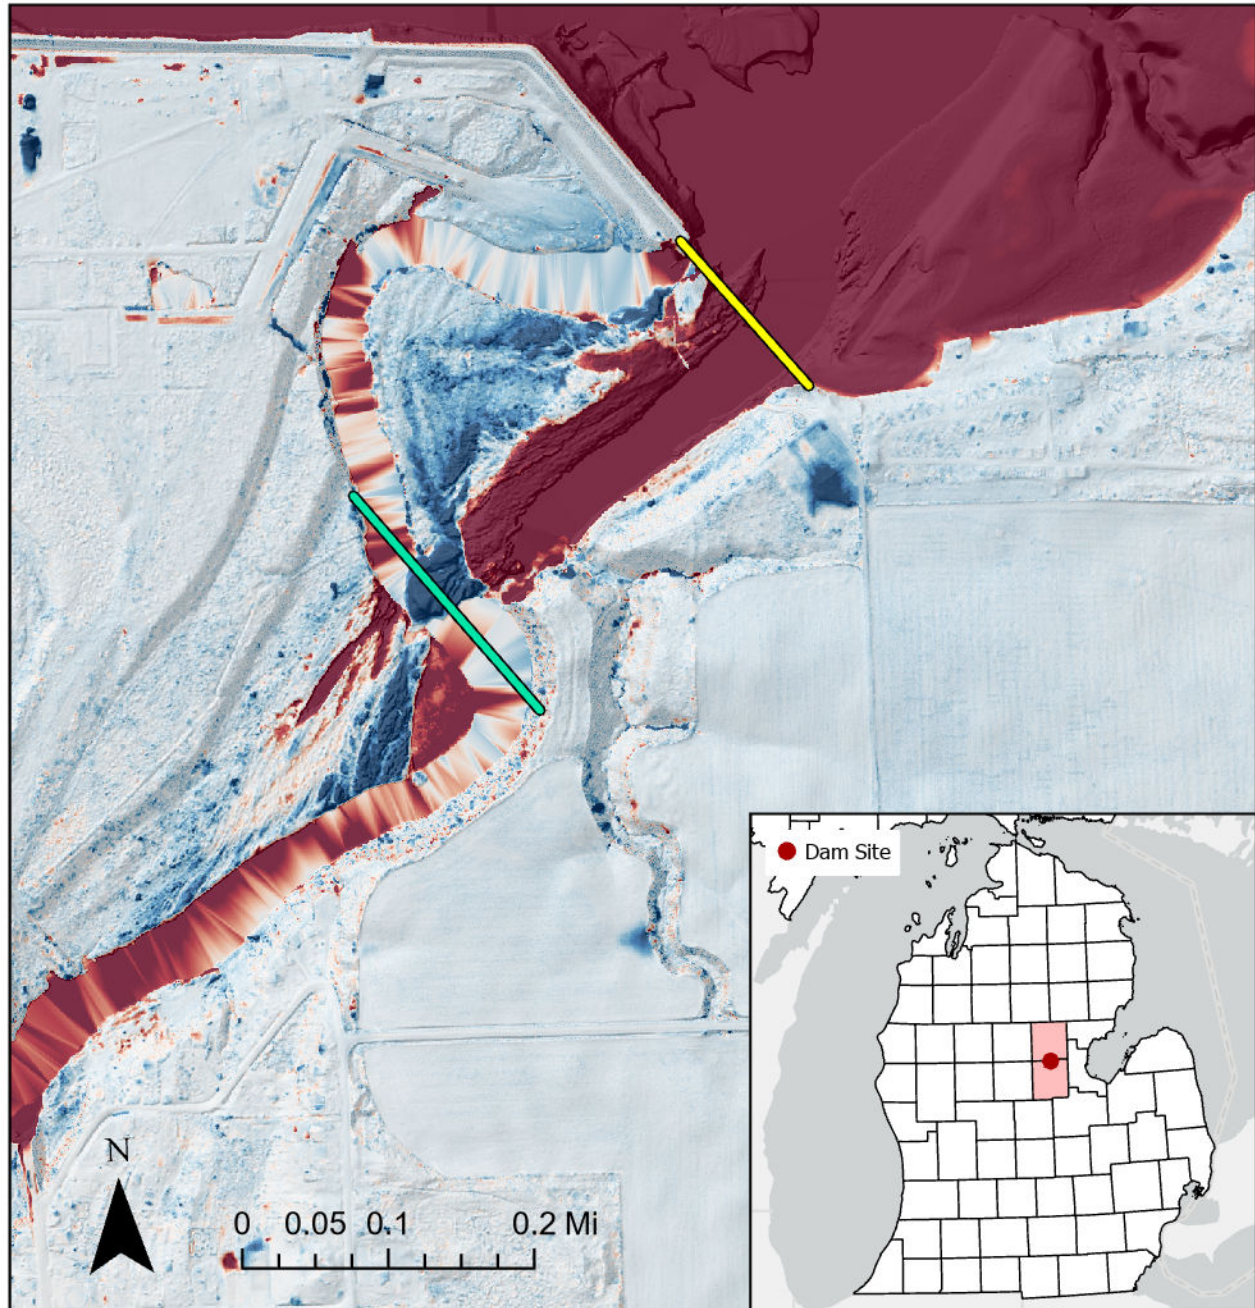
This map shows the elevation change resulting from the Edenville Dam failure in Michigan. Using Lidar data and DEMs, I compared pre- and post-flood rasters to calculate surface change. There is elevation loss at the breach point, and elevation gain in the downstream cross-section indicating sediment deposition.
