# ILOC Faulty Trip Supervision Relay

HOL011 ILOC DEF/OOC during Feeder OCEF Injection

Dated 14/07/2023

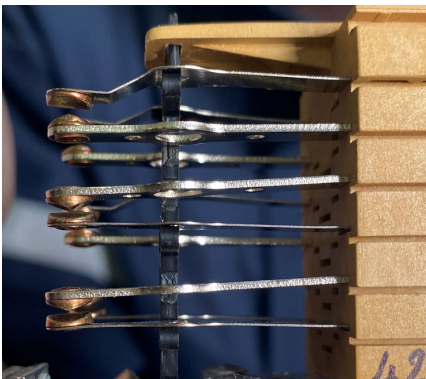
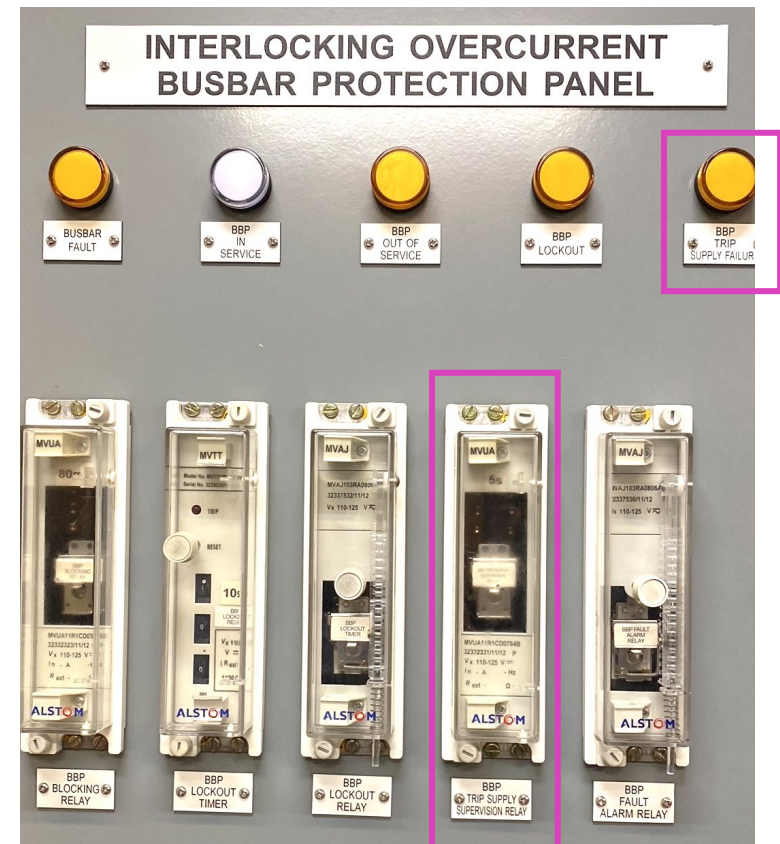
- On 14/07/2023, SCE informed that **ILOC DEF/OOC alarm** was activated during **11kV Feeder OCEF Injection Test**.
- The alarm was NOT activated with **10s delay** (for BBP lockout relay) due to prolonged injection.
- After site investigation, it was discovered that **BBP Trip Supply Supervision LED blinked** when site engineers (NR) performed OCEF timing test.
- There was **NO lockout** activated during the injection.
- The ILOC DEF/OOC alarm was activated due to **bad contact** of trip supply supervision relay MVUA11.

Bad Contact of MVUA11 Relay  
(Contact 5-7, 9-11 in Closed Status)

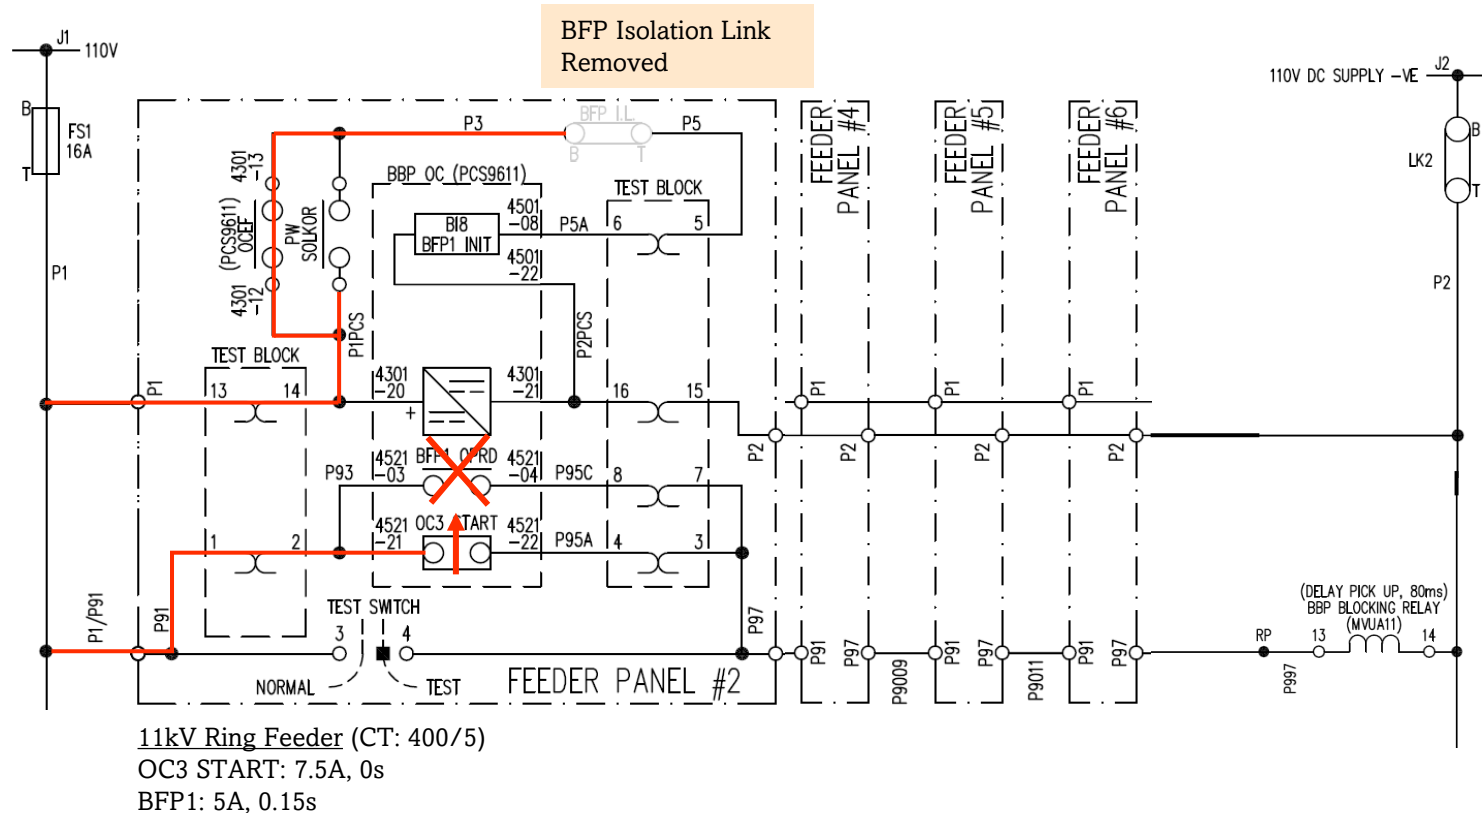
After **OC3 START** operated, no contact will be reconnected for BBP Blocking Relay.  
 → Breaking of P91 – P97 path

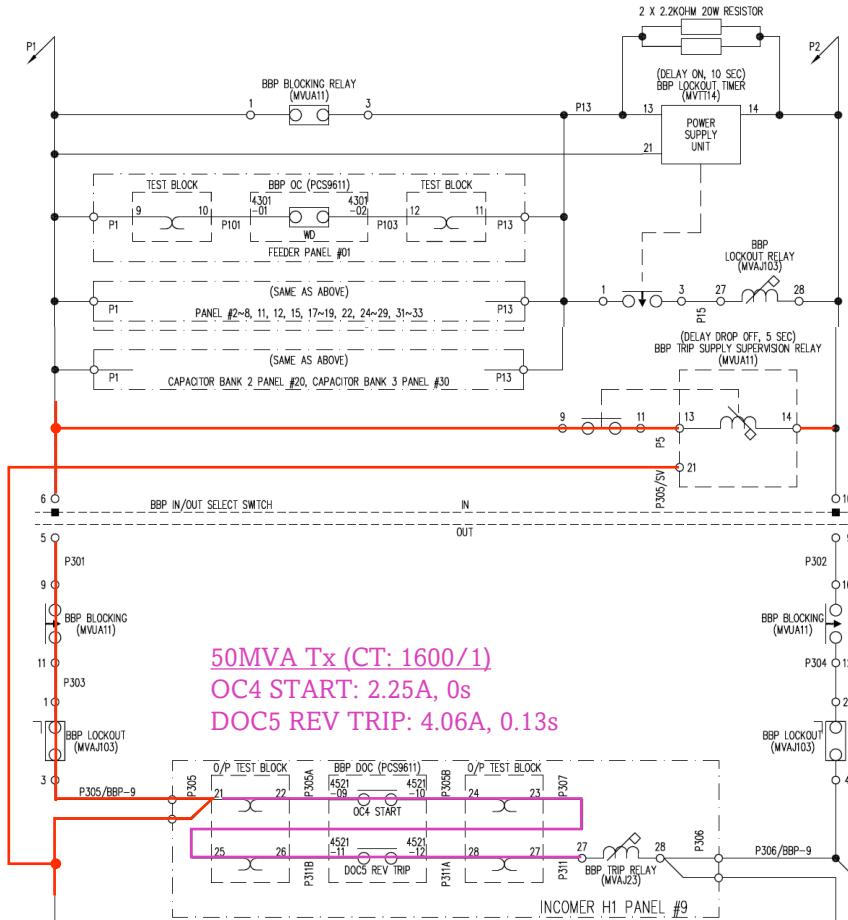
Before BBP Blocking Relay De-energized -

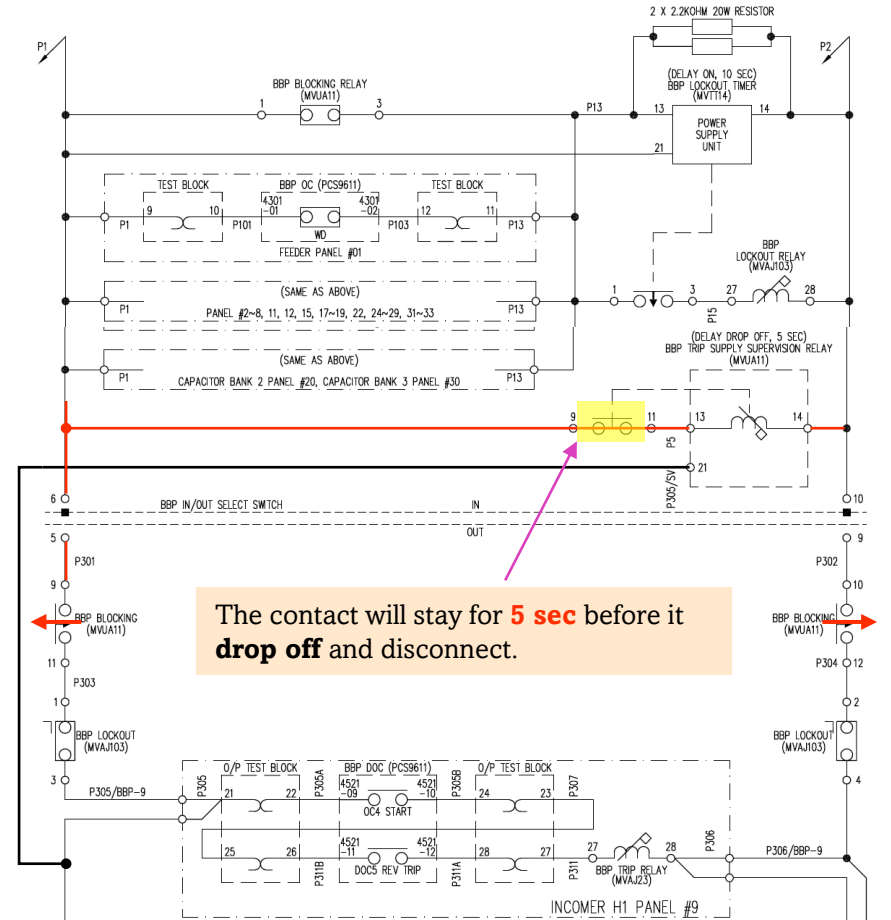
After BBP Blocking Relay De-energized -

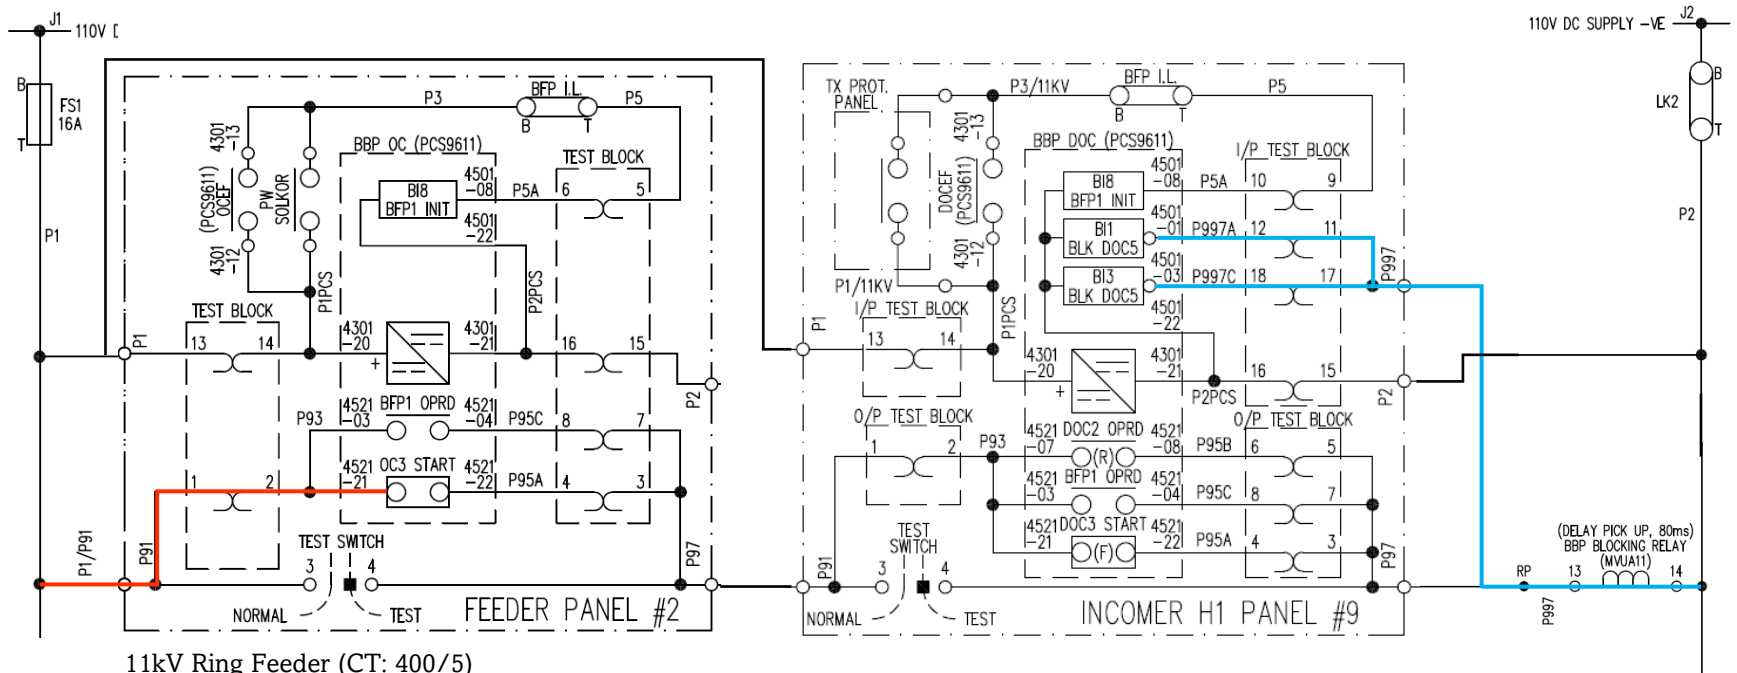
After **OC3 START** operated, no contact will be reconnected for BBP Blocking Relay.

→ Breaking of P91 – P97 path

→ BI1 & BI3 for **Blocking DOC5 REV** will be initiated.

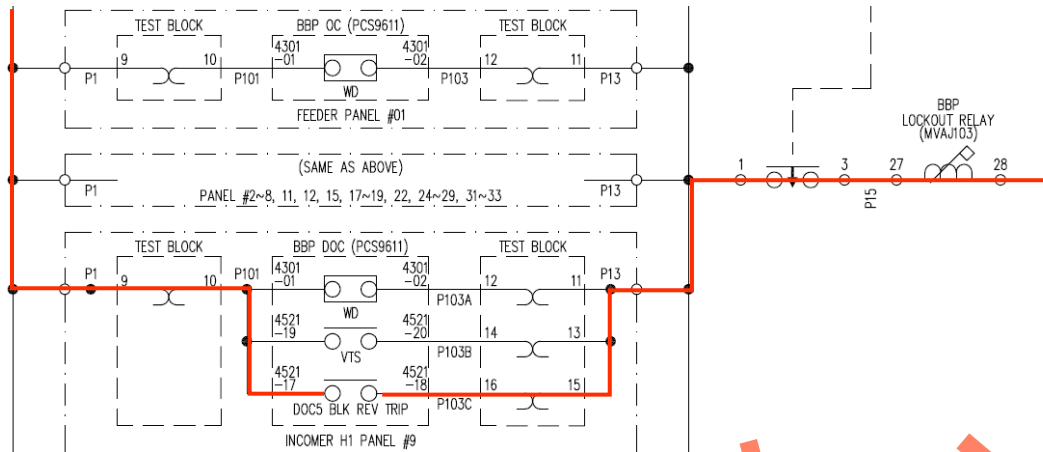
## DOC5 BLK REV TRIP

(activated with broken P91-P97 path)  
in the **LOCKOUT** circuit will lead to lockout  
if it was activated continuously for **10s**.

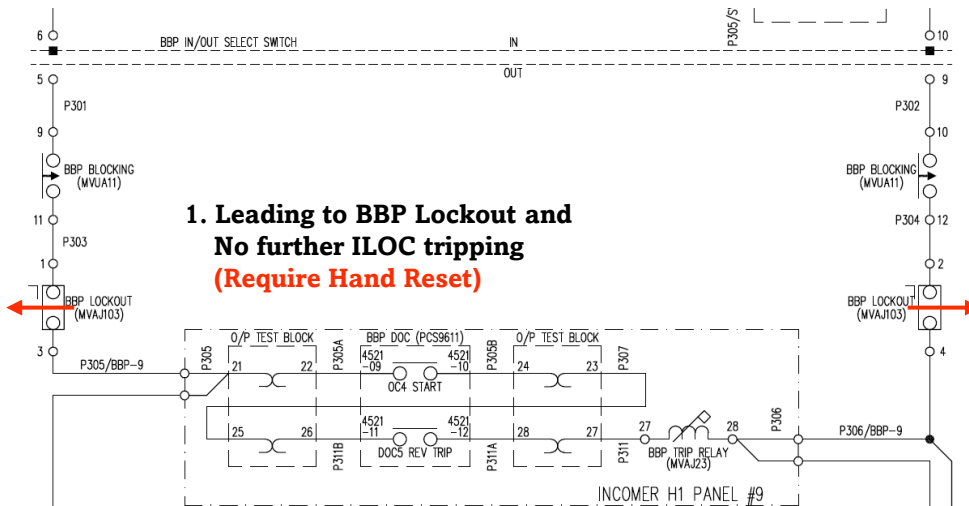
**1. Leading to BBP Lockout and  
No further ILOC tripping  
(Require Hand Reset)**

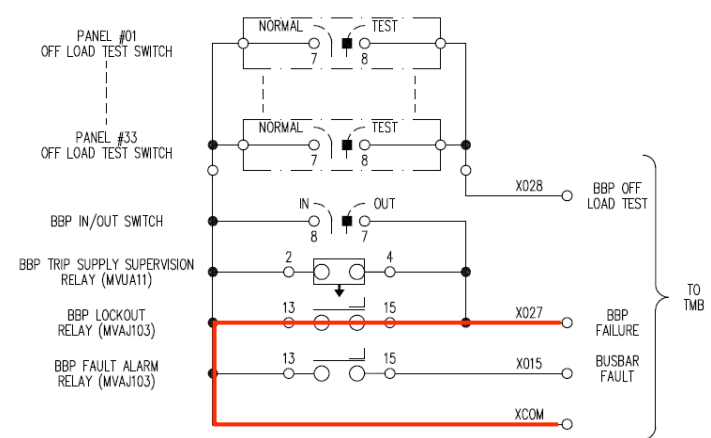
**2. Leading to BBP DEF/OOC alarm**
