## Detection Report

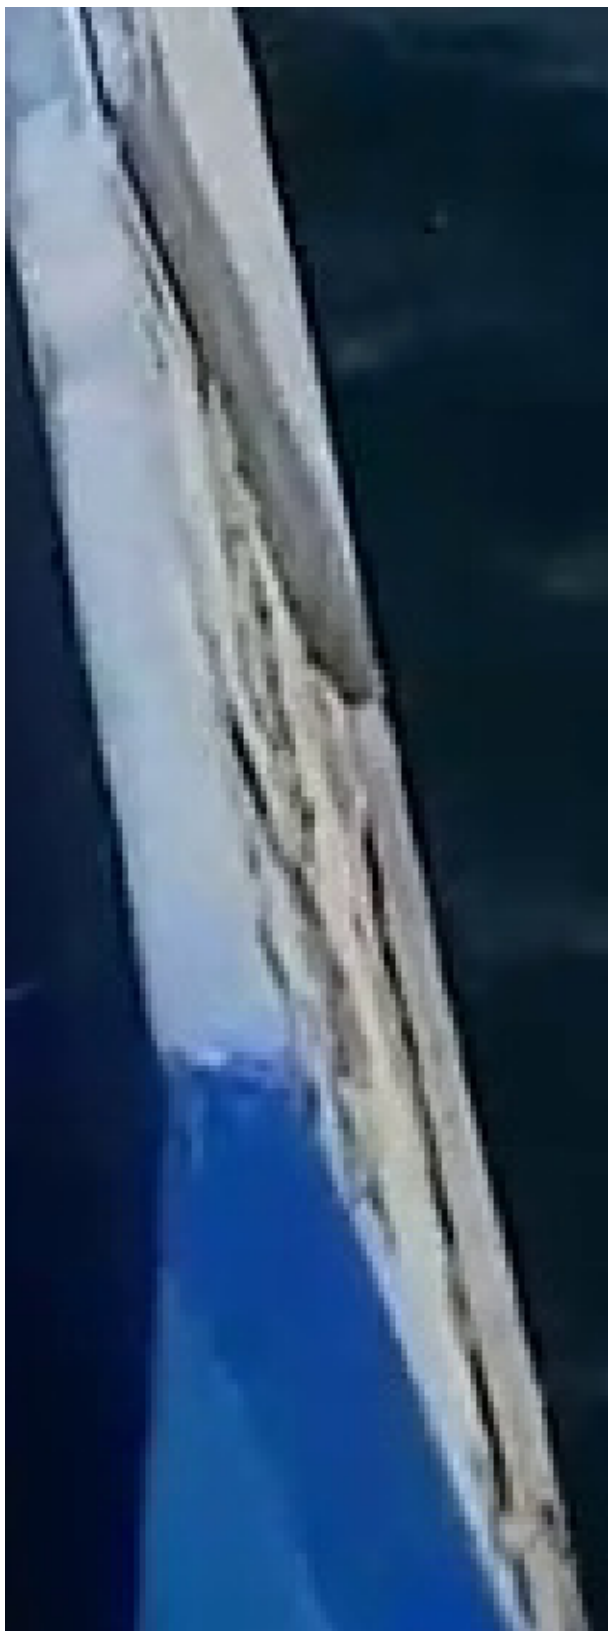
Cropped Image

Fender ID	Defect ID	Timestamp	Class	Confidence	Bounding Box	Frame Number
1	1	3.233	Missing plate	0.599	(1091.771, 598.786, 1187.942, 874.432)	97

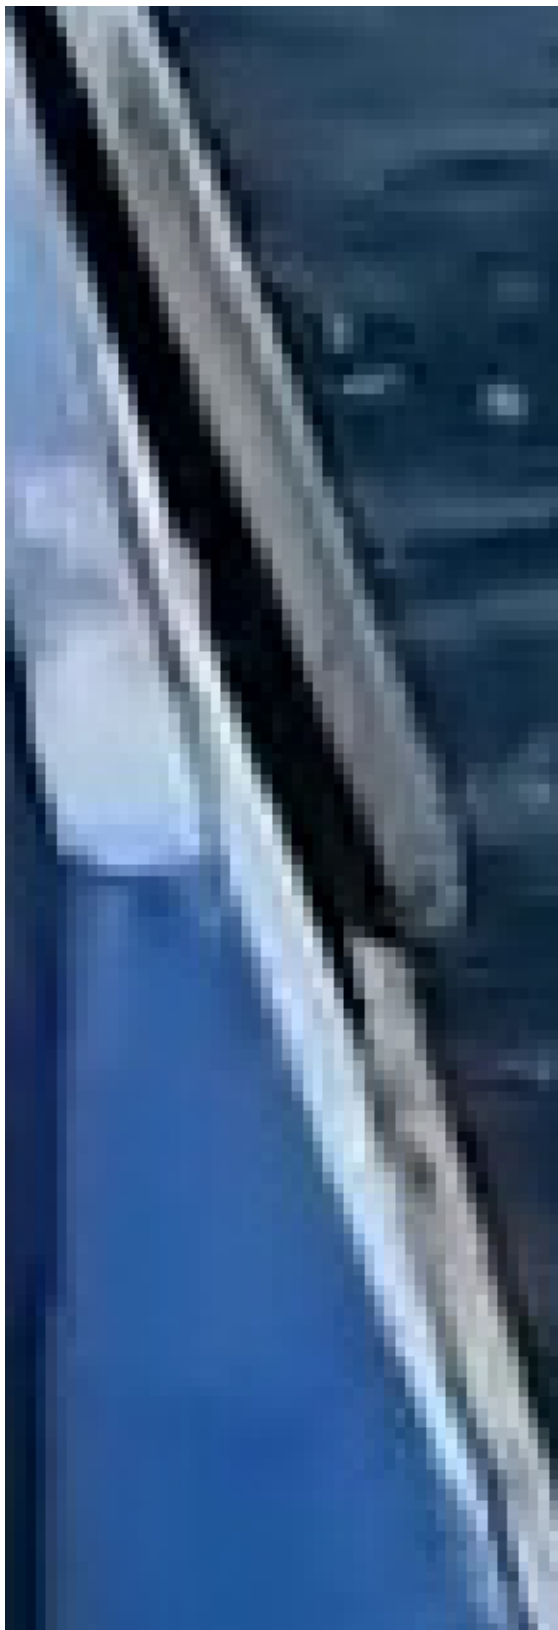
Cropped Image

Fender ID	Defect ID	Timestamp	Class	Confidence	Bounding Box	Frame Number
1	2	6.833	Missing plate	0.27	(1073.213, 337.165, 1115.99, 483.438)	205

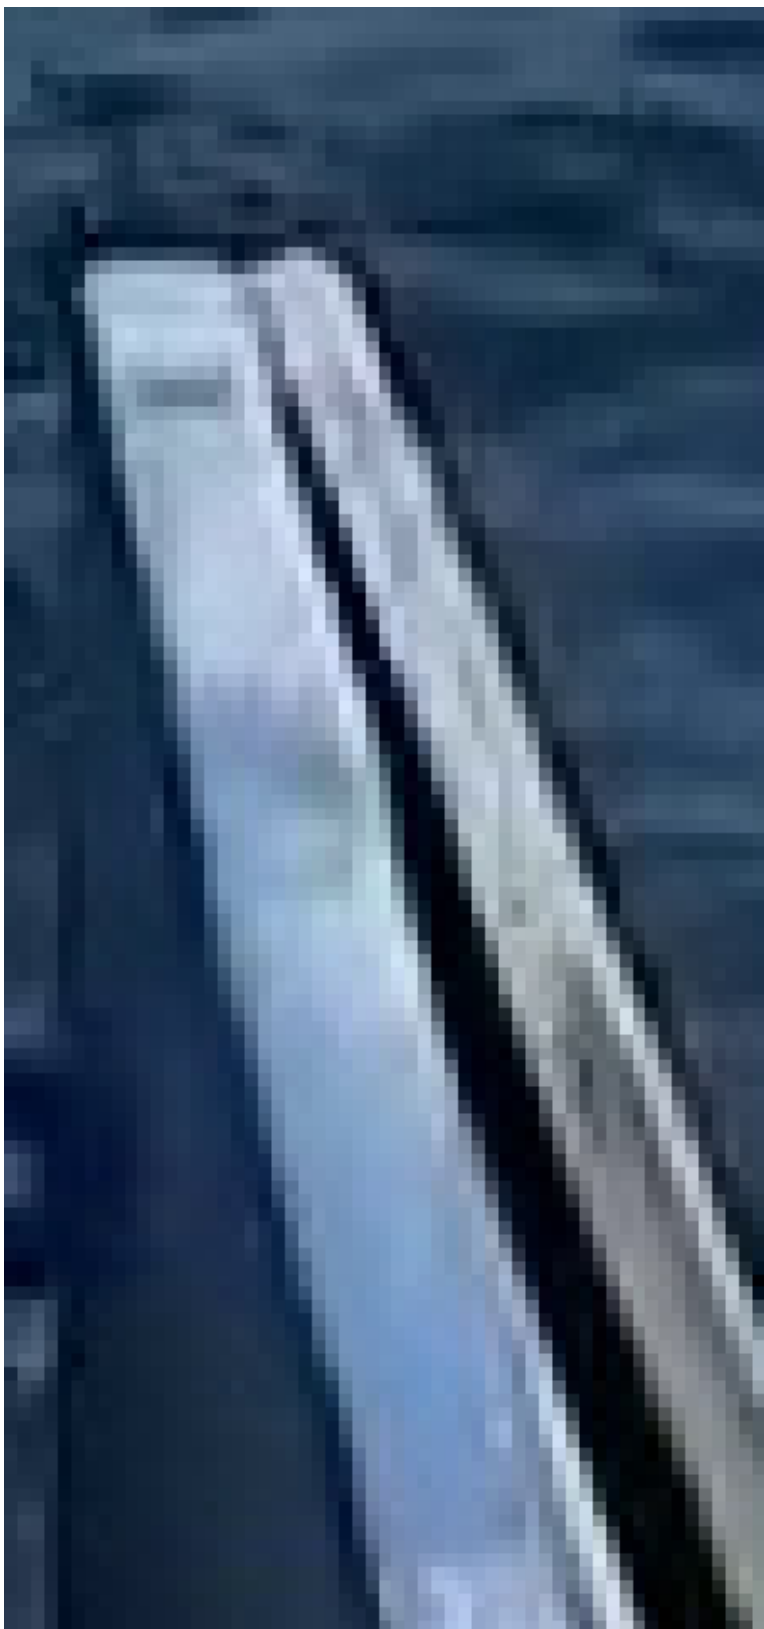
Cropped Image

Fender ID	Defect ID	Timestamp	Class	Confidence	Bounding Box	Frame Number
1	3	7.0	Loose plate	0.255	(1047.939, 289.87, 1094.46, 399.043)	211

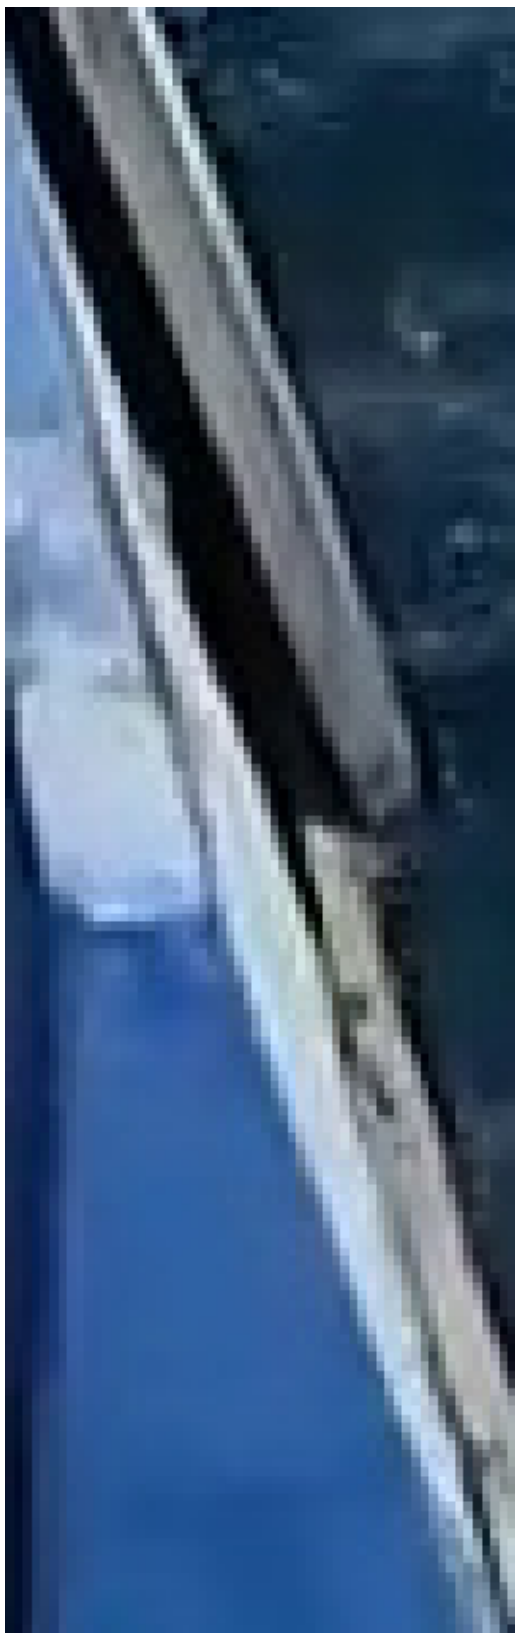
Cropped Image

Fender ID	Defect ID	Timestamp	Class	Confidence	Bounding Box	Frame Number
1	4	7.467	Missing plate	0.264	(1102.574, 442.43, 1150.099, 613.725)	225

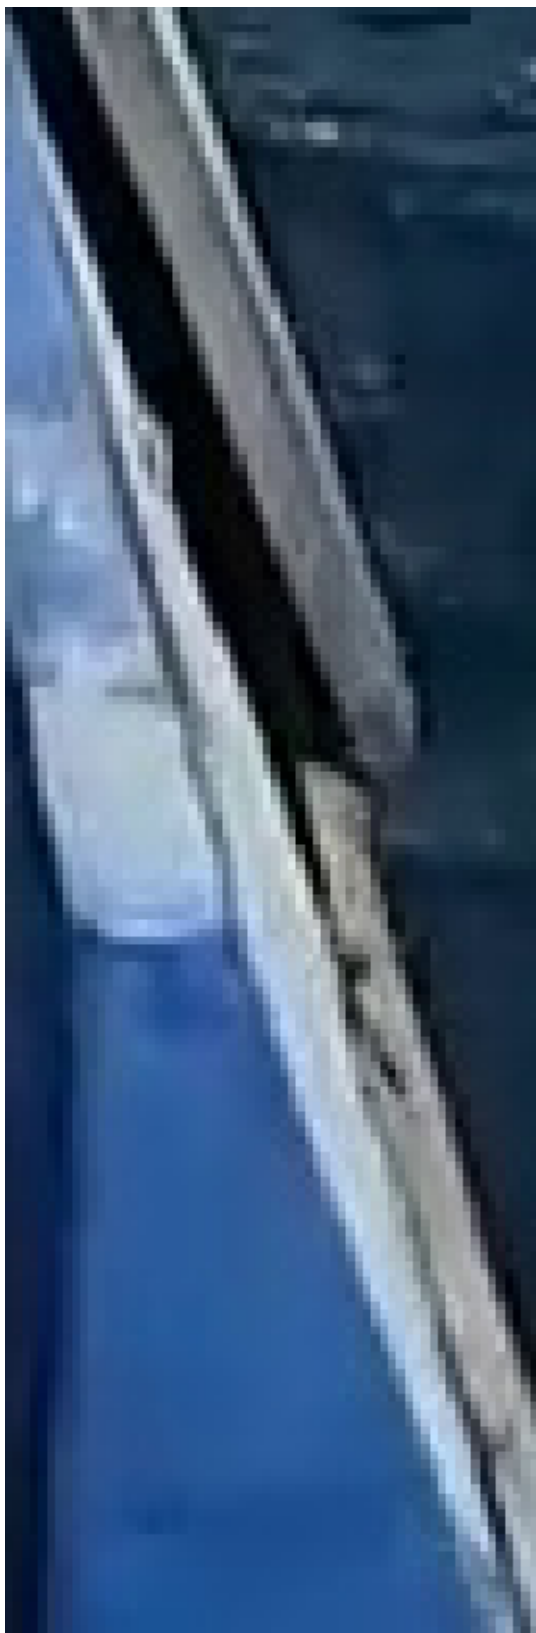
Cropped Image

Fender ID	Defect ID	Timestamp	Class	Confidence	Bounding Box	Frame Number
1	5	7.667	Missing plate	0.254	(1114.5, 485.426, 1167.469, 667.938)	231

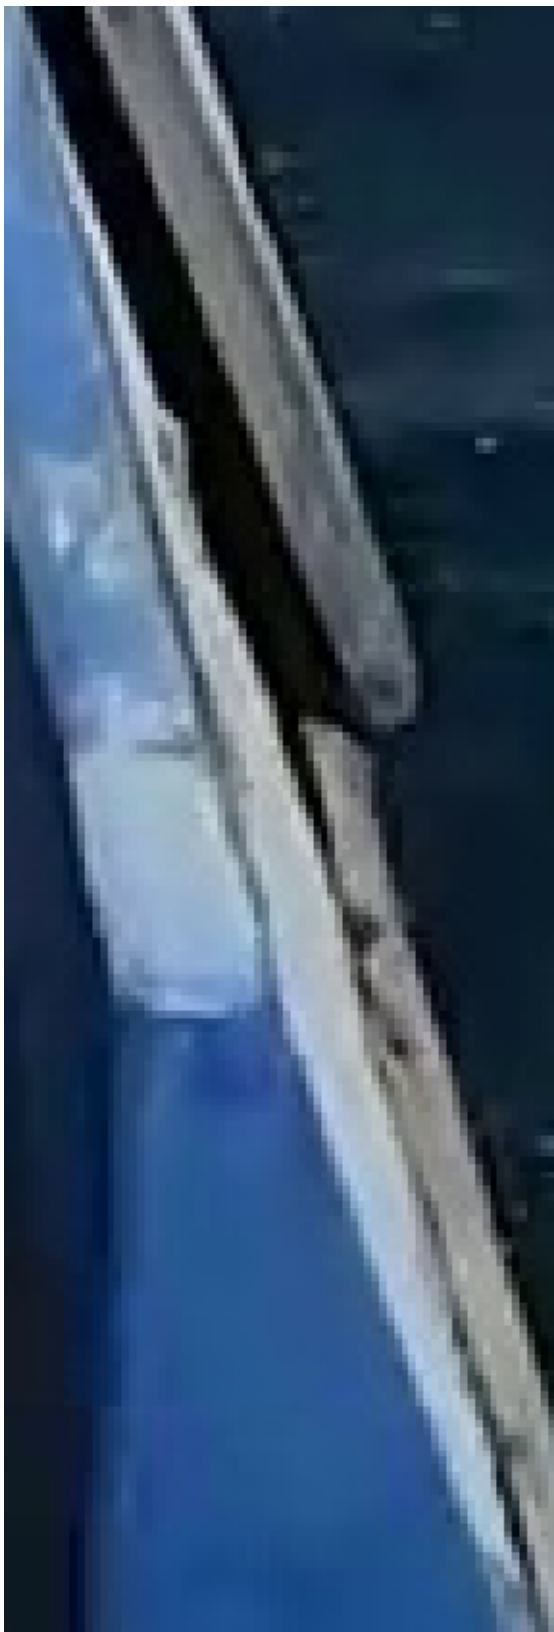
Cropped Image

Fender ID	Defect ID	Timestamp	Class	Confidence	Bounding Box	Frame Number
1	6	7.967	Missing plate	0.263	(1130.006, 552.129, 1194.09, 760.207)	240

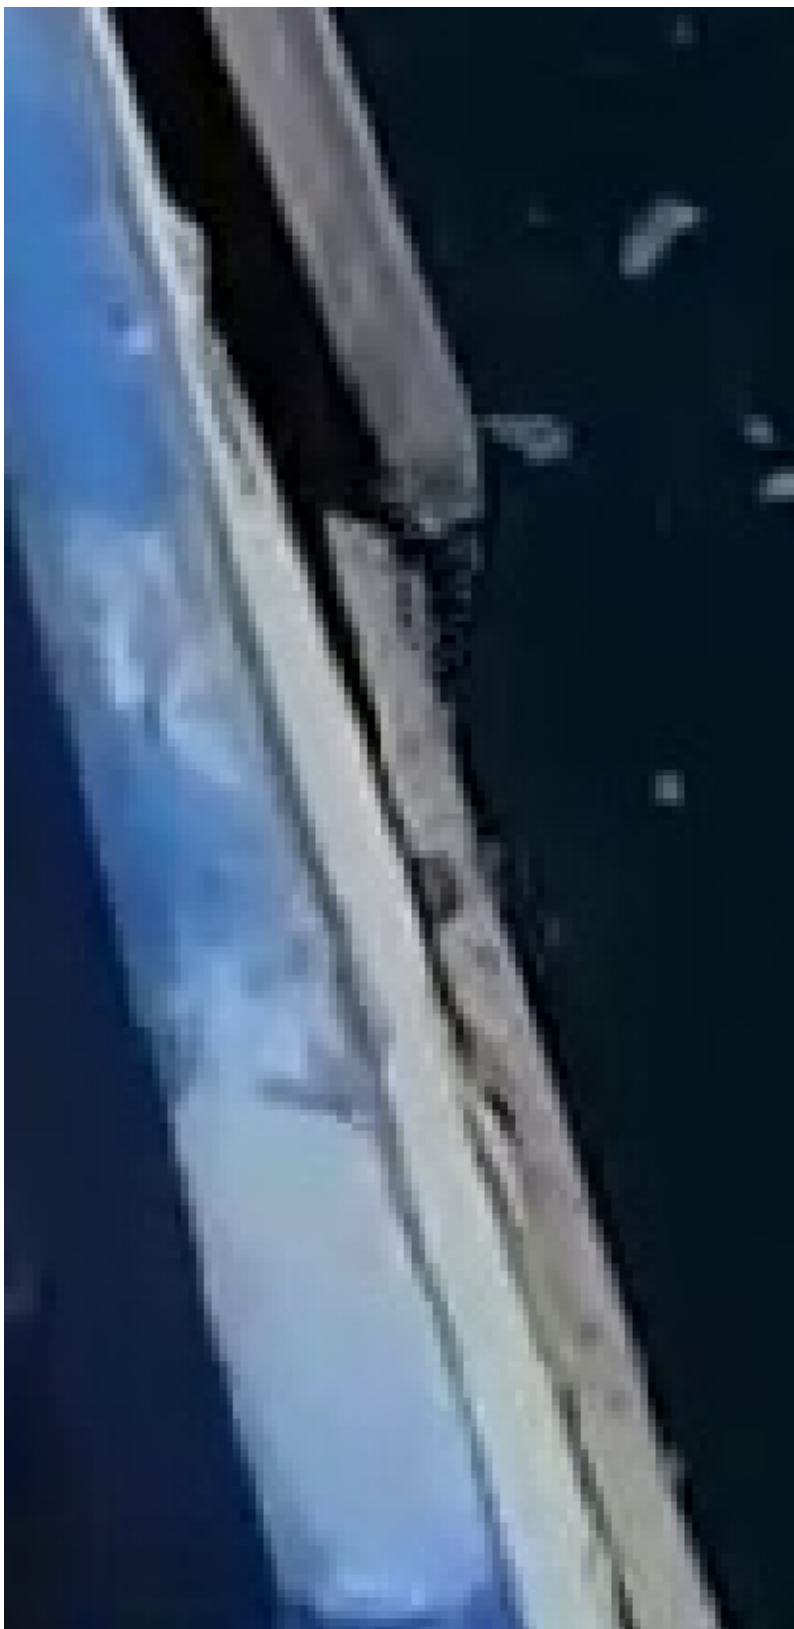
Cropped Image

Fender ID	Defect ID	Timestamp	Class	Confidence	Bounding Box	Frame Number
1	7	8.833	Missing plate	0.386	(1225.257, 869.698, 1321.212, 1072.354)	265
