BLACK ROCK WEEKLY REPORT

Weekly PSD Report
EPIROC SA

Weekly Service Report – Black Rock Mine Operations

Report type:	Weekly	Submitted to:	Sello Taku and Sipho
Week Date:	21 July 2025	End Date	27 July 2025
Reported By:	Philip Moller		
BEV:			
Service Tech:	Ivan Phiri	Service Tech:	Lukas Serumola
Service Tech:	Patricia Mazinyo	Service Tech Assistant:	Patrick Yoko
Specialist:	Frikkie van der Walt (Leave)		
Field Service:			
Service Tech:	Alpheus Mareke	Service Tech:	Mathews Mosemane
CAS Project:			
Team Leader:	Bradley Nast	Service Tech:	Phineas Sibanda
Service Tech:	Julius Manamela	Service Tech:	
Certiq Project:			
Team Leader:	Segunda Fernando	Service Tech:	
Mobilaris:			
Team Leader:	Rupert Grobler

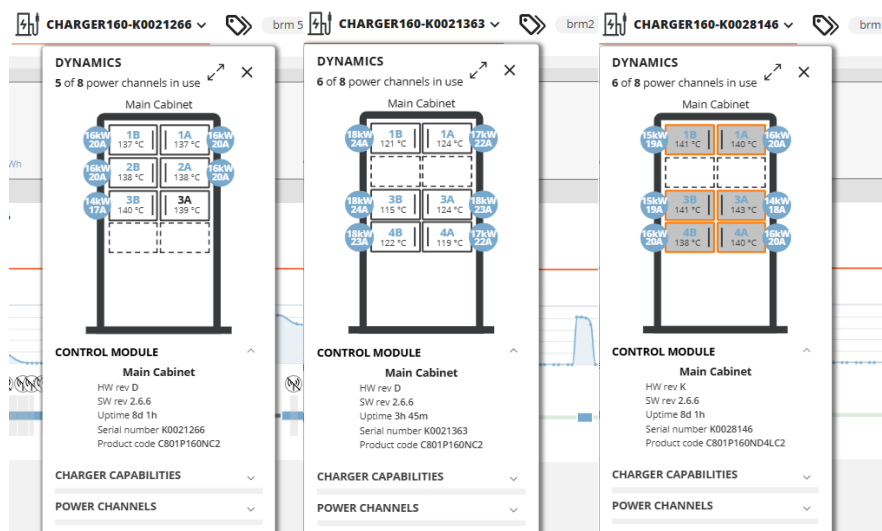
- Module 4 was found to be the fault on charger 7, charger module needs to be replaced.
- Charger 1 has a faulty fan that need to be replaced.

Figure 1: Chargers 2, 5 and 7 are missing 1 module each

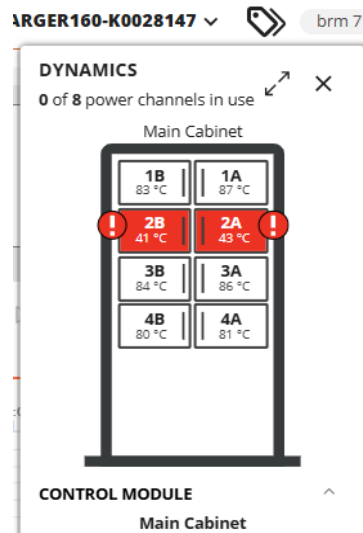
Figure 2: Chargers 1, 8 and 7 have faulty fans that need to be replaced
