Inspection Report

Inspector Express

616 Aberdeen St
Marseilles, IL 61341

Date: Oct 24, 2018

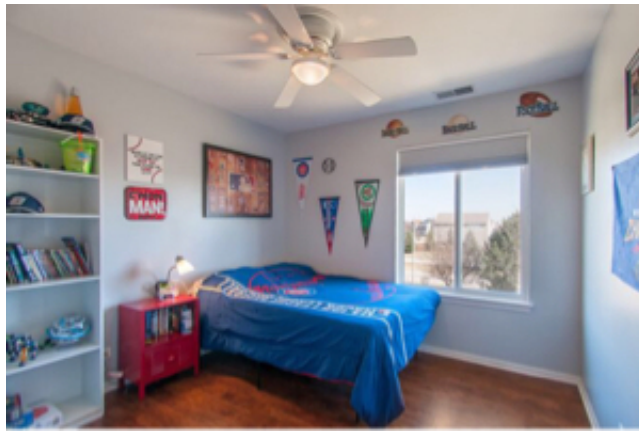
Location : Front, Right

Condition: **Cracked pane** - Window-pane is cracked. This is a potential hazard and should be corrected as soon as possible.

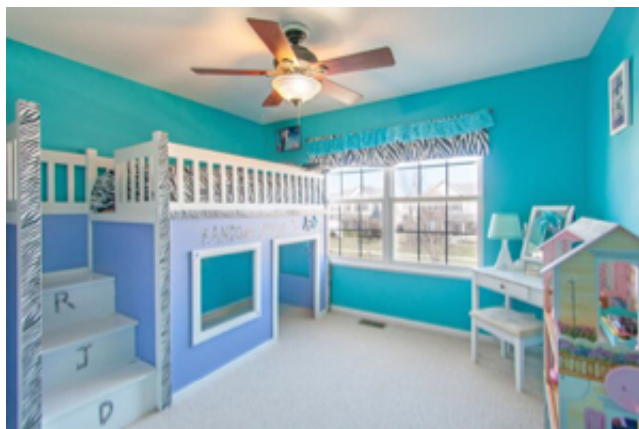
Location : First Floor

Damaged screen - Screening is damaged and in need of repair.

Ratings : Maintenance required

Ratings: Defective

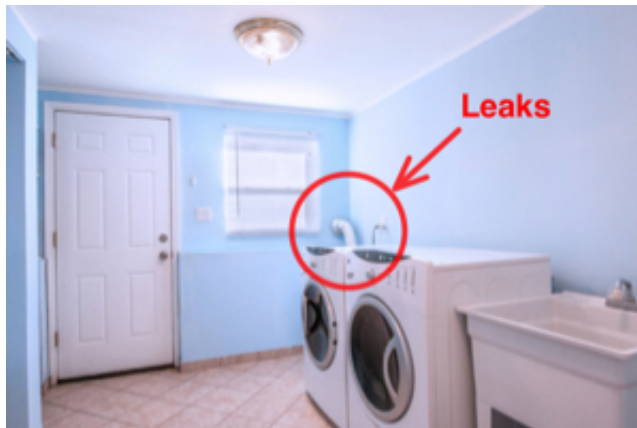
Location : Basement

Condition: **Pump leaks** - Leaking was noted at the pump and should be repaired.

Ratings : Needs to be serviced

Ratings: Defective

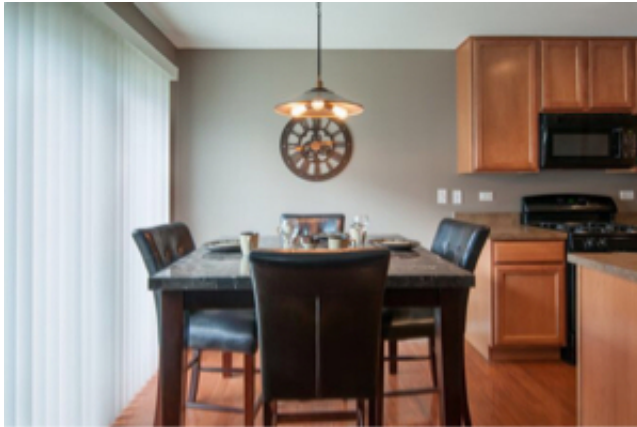
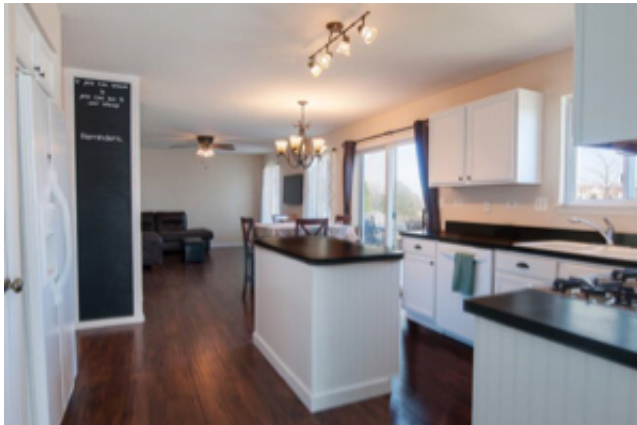
Location : First Floor, Front

Condition: **Loose countertop** - Countertop is loose and should be secured properly.

Ratings: Minor defect

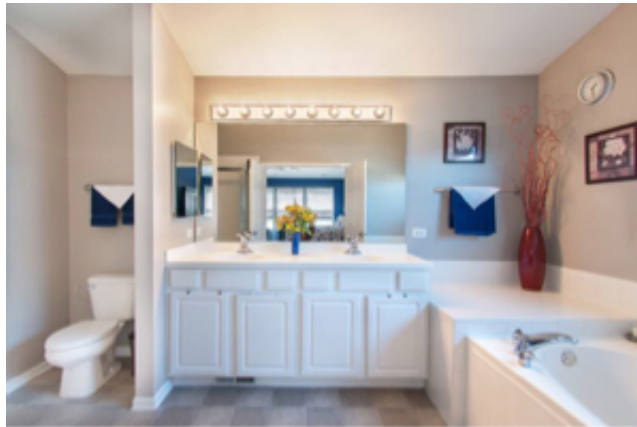
Location : First Floor

Condition: Bathroom safety glazing - Doors and enclosures for showers, tubs, saunas, whirlpools, and windows within enclosures should be safety glass to minimize possible injury to persons in the event of cracking or breaking. Replace if not safety glass.

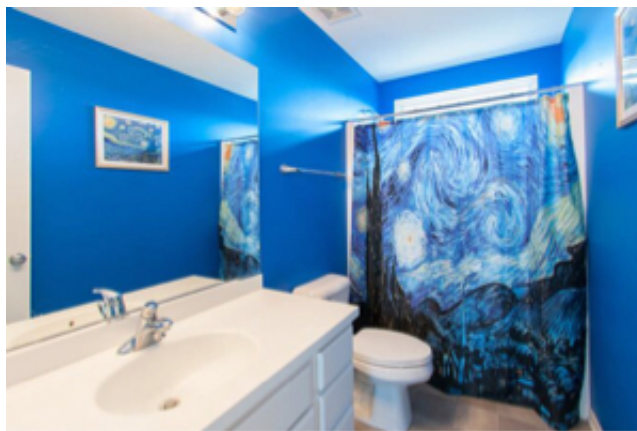
Location : Second Floor

Fixture water off - Water to the fixture was off at the time of the inspection and was not fully inspected. Recommend testing when fixture is reactivated.
