CRACK INVESTIGATION AND PROPOSING REMEDIES : A CASE STUDY IN “JEEWAKA” HOSTEL, BORELLA

Abstract—This paper discusses the crack investigation and the proposed corrective and preventive measures for the newly constructed 3-story building named “Jeewaka” hostel in Borella. The building was found to have many cracks, including thermal cracks in the joints between the masonry wall and the RCC (Reinforced Cement Concrete) columns and beams, and shrinkage cracks below the window openings. This paper outlines the type of crack and the cause and suggests preventive and corrective measures to improve building safety and usability. Causes, corrective measures, and preventive measures were taken from expert interviews and analysed using the Delphi technique. According to the findings, it is strongly recommended to provide a chicken wire mesh between the RCC and the masonry joint before starting plaster work. In addition, expansion and construction joints are recommended as good practises. Furthermore, the findings reveal that most cracks under the windows are shrinkage cracks, and it can be recommended to have preventive measures such as providing the sill beam, avoiding the use of rich cemen

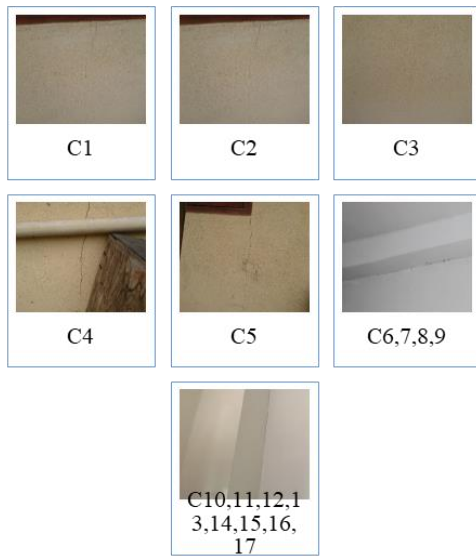
Fig. 3. Ground floor cracks

Crack No.	External/ Internal	Crack Type	Structural/Non structural	Width	Location/Description
C1	External	Vertical	Non-Structural	Less than 1mm	Crack in the wall starting from window sill level to down
C2	External	Diagonal	Non-Structural	-do-	-do-
C3	External	Vertical	Non-Structural	-do-	-do-
C4	External	Vertical	Non-Structural	-do-	-do-
C5	External	Vertical	Non-Structural	-do-	-do-
C6	Internal	Horizontal	Non-Structural	-do-	Crack in the wall at the joint of beam and wall
C7	Internal	Horizontal	Non-Structural	-do-	-do-
C8	Internal	Horizontal	Non-Structural	-do-	-do-
C9	Internal	Horizontal	Non-Structural	-do-	-do-
C10	Internal	Vertical	Non-Structural	-do-	Crack in the wall at the joint of the column and the wall
C11	Internal	Vertical	Non-Structural	-do-	-do-
C12	Internal	Vertical	Non-Structural	-do-	-do-
C13	Internal	Vertical	Non-Structural	-do-	-do-
C14	Internal	Vertical	Non-Structural	-do-	-do-
C15	Internal	Vertical	Non-Structural	-do-	-do-

C16	Internal	Vertical	Non-Structural	-do-	-do-
C17	Internal	Vertical	Non-Structural	-do-	-do-

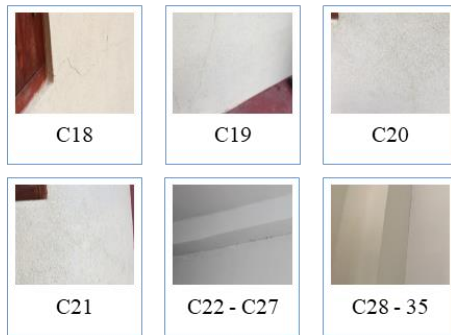
Fig. 4. First floor cracks

Crack No.	External/ Internal	Crack Type	Structural/Non structural	Width	Location/Description
C18	External	Diagonal	Non-Structural	Less than 1mm	Crack in the wall starting from window sill level to down
C19	External	Diagonal	Non-Structural	-do-	-do-
C20	External	Diagonal	Non-Structural	-do-	-do-
C21	External	Diagonal	Non-Structural	-do-	-do-
C22	External	Horizontal	Non-Structural	-do-	Crack in the wall at the joint of beam and wall
C23	Internal	Horizontal	Non-Structural	-do-	-do-
C24	Internal	Horizontal	Non-Structural	-do-	-do-
C25	Internal	Horizontal	Non-Structural	-do-	-do-
C26	Internal	Horizontal	Non-Structural	-do-	-do-
C27	Internal	Horizontal	Non-Structural	-do-	-do-
C28	Internal	Vertical	Non-Structural	-do-	Crack in the wall at the joint of Column and wall
C29	Internal	Vertical	Non-Structural	-do-	-do-
C30	Internal	Vertical	Non-Structural	-do-	-do-
C31	Internal	Vertical	Non-Structural	-do-	-do-
C32	Internal	Vertical	Non-Structural	-do-	-do-

C33	Internal	Vertical	Non-Structural	-do-	-do-
C34	Internal	Vertical	Non-Structural	-do-	-do-
C34	Internal	Vertical	Non-Structural	-do-	-do-
C34	Internal	Vertical	Non-Structural	-do-	-do-
C35	Internal	Vertical	Non-Structural	-do-	-do-

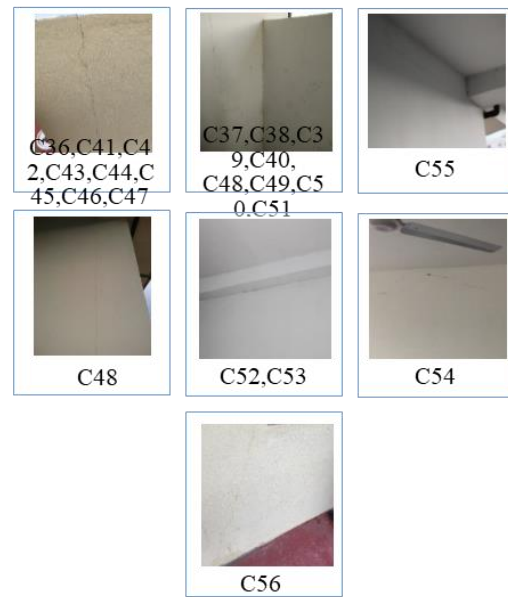
Fig. 5. Second floor cracks

Crack No.	External/ Internal	Crack Type	Structural/Non structural	Width	Location/Description
C36	External	Vertical	Non-Structural	Less than 1mm	Crack in the wall at the joint of Column and wall
C37	External	Vertical	Non-Structural	-do-	-do-
C38	External	Vertical	Non-Structural	-do-	-do-
C39	External	Vertical	Non-Structural	-do-	-do-
C40	External	Vertical	Non-Structural	-do-	-do-
C41	External	Vertical	Non-Structural	-do-	-do-
C42	External	Vertical	Non-Structural	-do-	-do-
C43	External	Vertical	Non-Structural	-do-	-do-
C44	External	Vertical	Non-Structural	-do-	-do-
C45	External	Vertical	Non-Structural	-do-	-do-
C46	External	Vertical	Non-Structural	-do-	-do-
C47	External	Vertical	Non-Structural	-do-	-do-
C48	Internal	Vertical	Non-Structural	-do-	-do-
C49	Internal	Vertical	Non-Structural	-do-	-do-
C50	Internal	Vertical	Non-Structural	-do-	-do-
C51	Internal	Vertical	Non-Structural	-do-	-do-
C52	Internal	Horizontal	Non-Structural	-do-	Crack in the wall at the joint of beam and wall

C53	Internal	Horizontal	Non-Structural	-do-	-do-
C54	Internal	Horizontal	Non-Structural	-do-	-do-
C55	Internal	Horizontal	Non-Structural	-do-	-do-
C56	Internal	Diagonal	Non-Structural	-do-	Crack in the wall starting from windowsill level to down

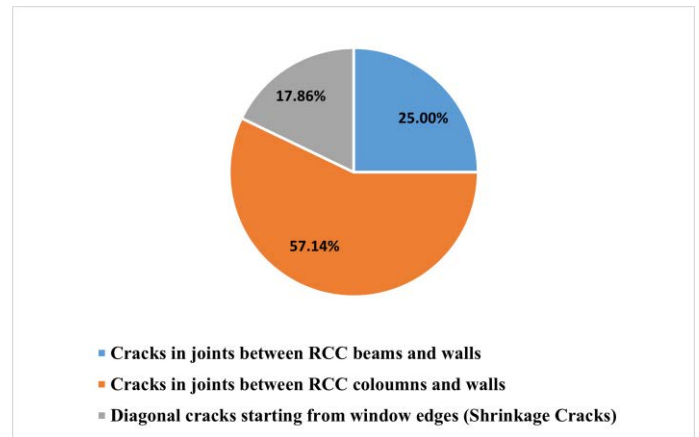
Fig. 6. Crack distribution within the building

The figure 6 illustrates the summary of crack types within the building and, accordingly, the majority is represented by the cracks between RCC columns and walls, it is 57.14% in percentage.
