CIM3410

Check 24V DC Power supply plug
The problem is relating to the X4 plug connection where the 24VDC is supplied to the HUB Controller.

445 - Hub computer com fault - V82

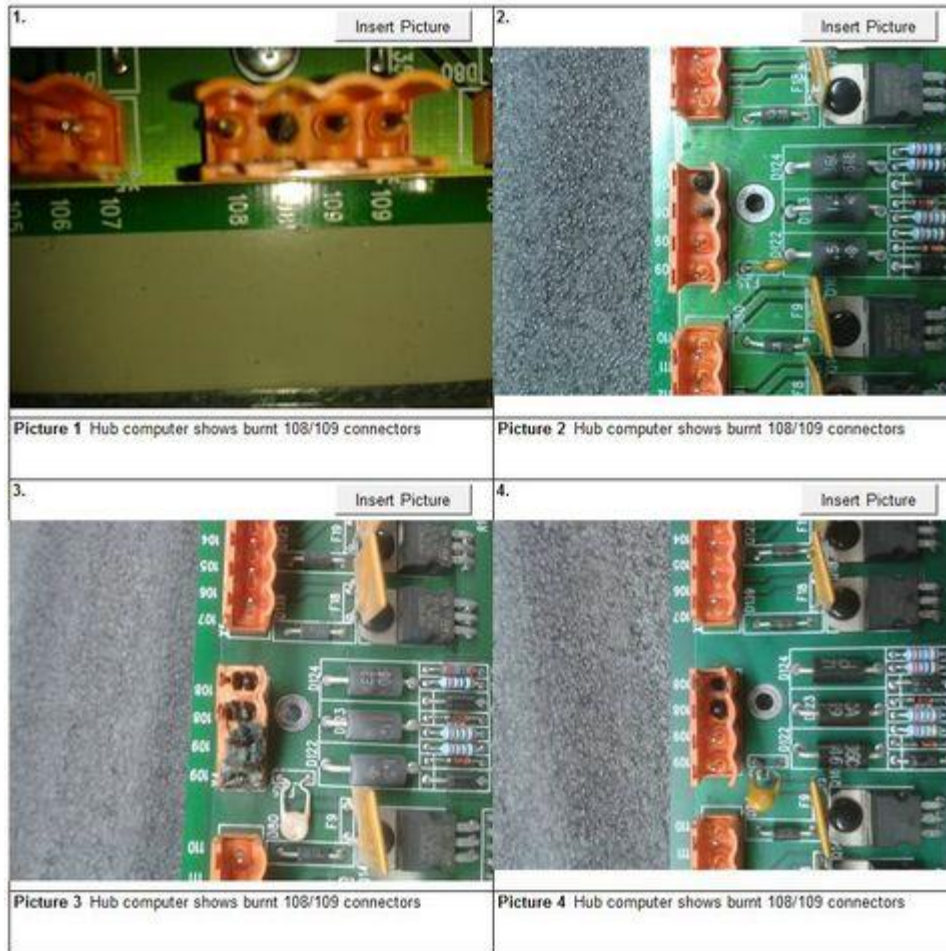
It has in many cases been seen that the plug connection have been overheated and burned as indicated on the below pictures.

The Minor Component Repair Team, has been requested to implement an improved interface on the PCB, so that the overheated connections could avoided.

Case creator have proposes a simple fix to mitigate the problem. Namelyto install a screw terminal versus the existing pin plug connector.

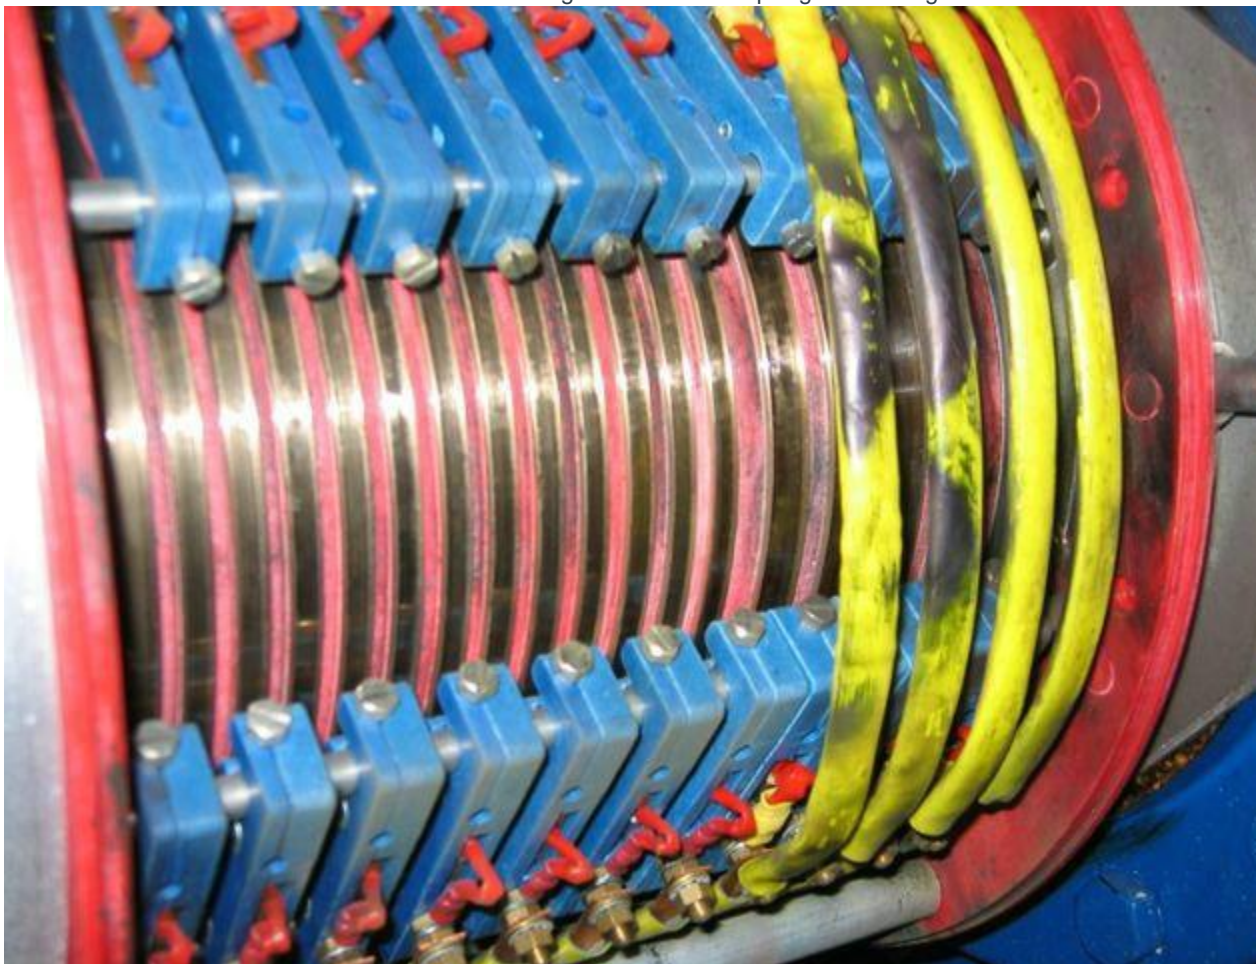
In most instances, a bad connection at the slip ring causes this alarm. Investigate the slip ring for damage, dust or oil contamination. Use document "0001-4933 - Cleaning Procedure for Slipring Unit" as a guideline.

Dust buildup and contamination on spring.

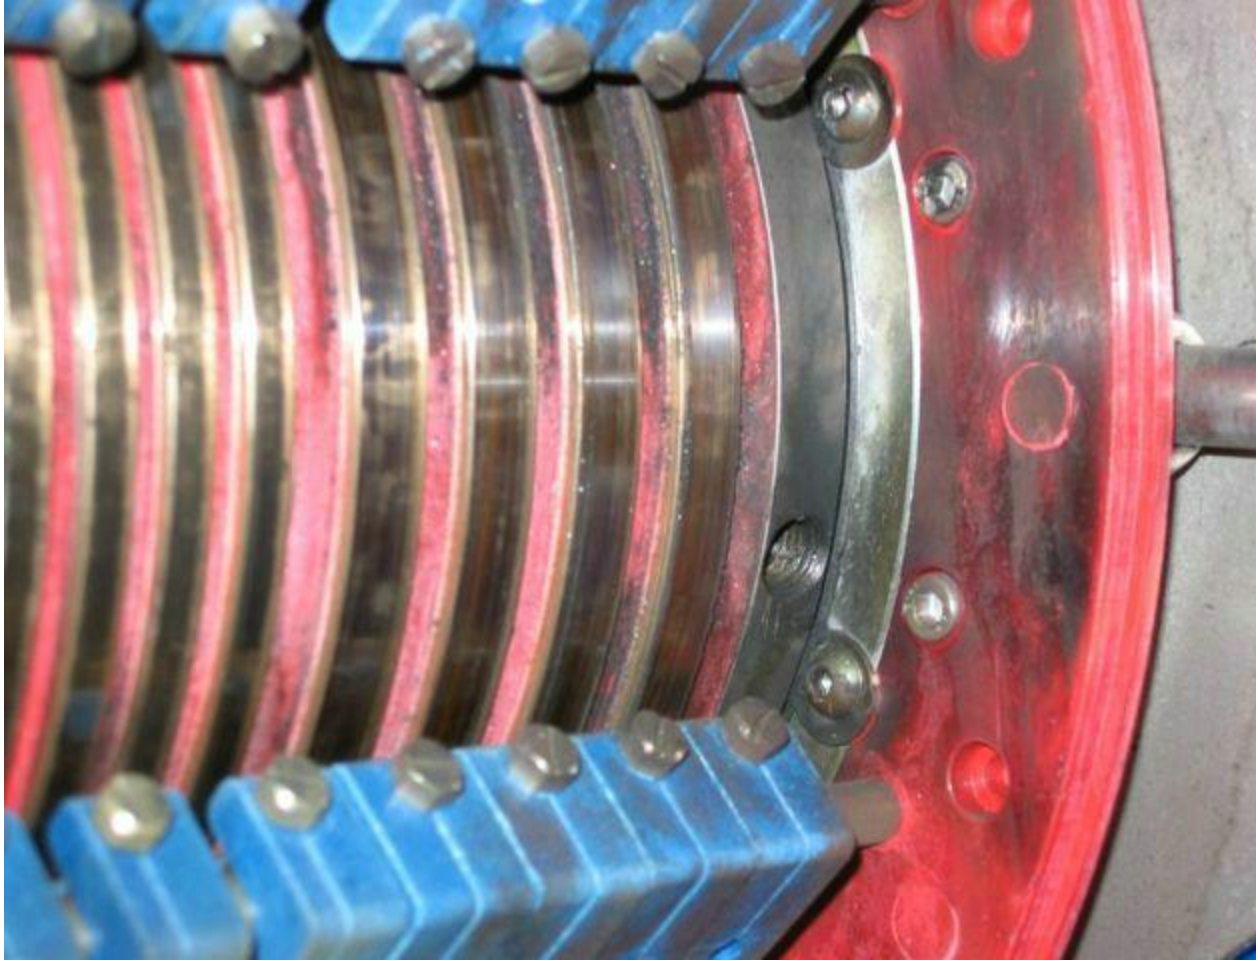
Pay particularly close attention to brushes on rings for 230VAC supply to hub and hub communications:

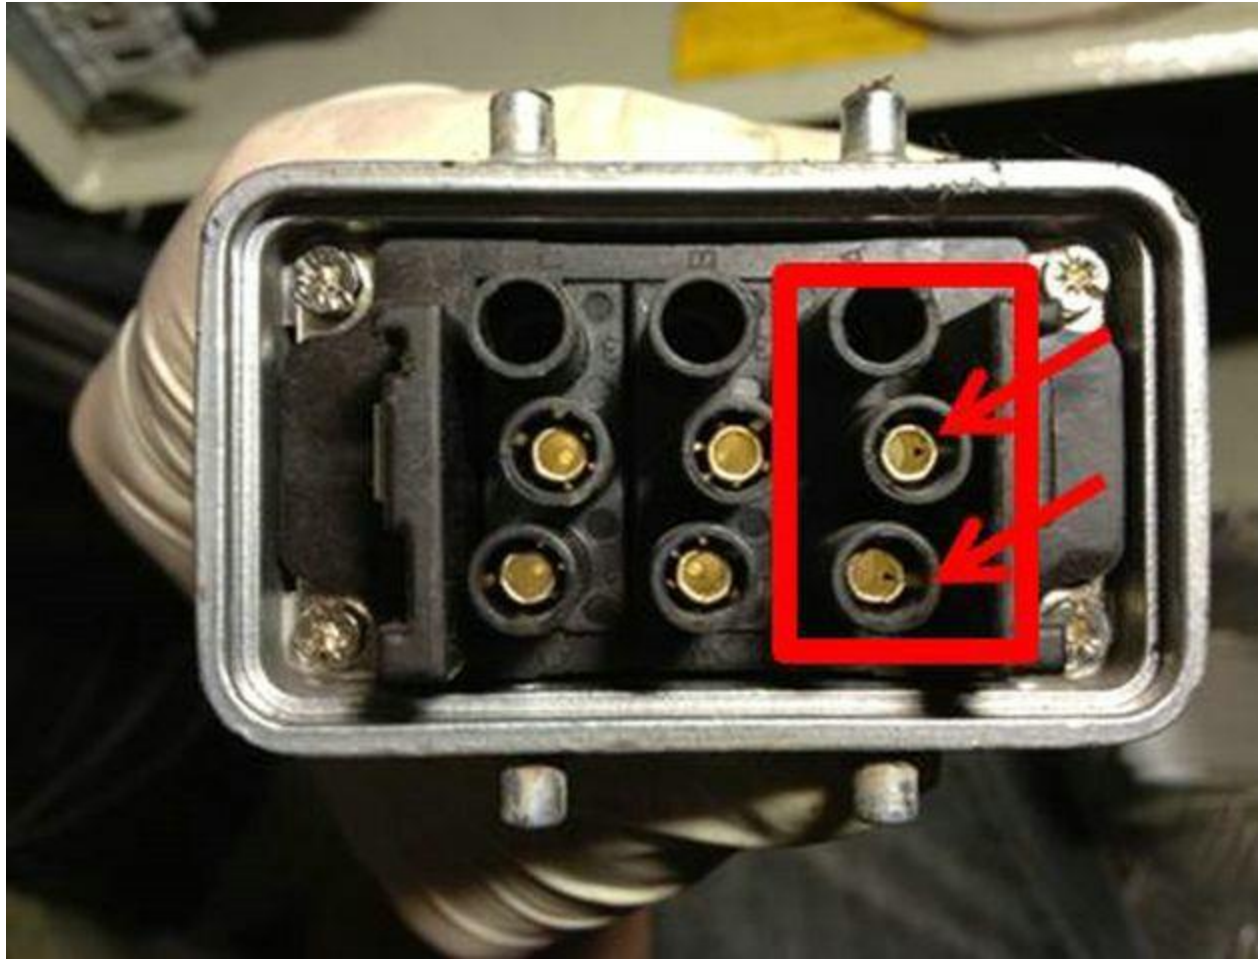
-X05 plug female pins:
Look for corrosion or broken pins on module A pins 1&2.

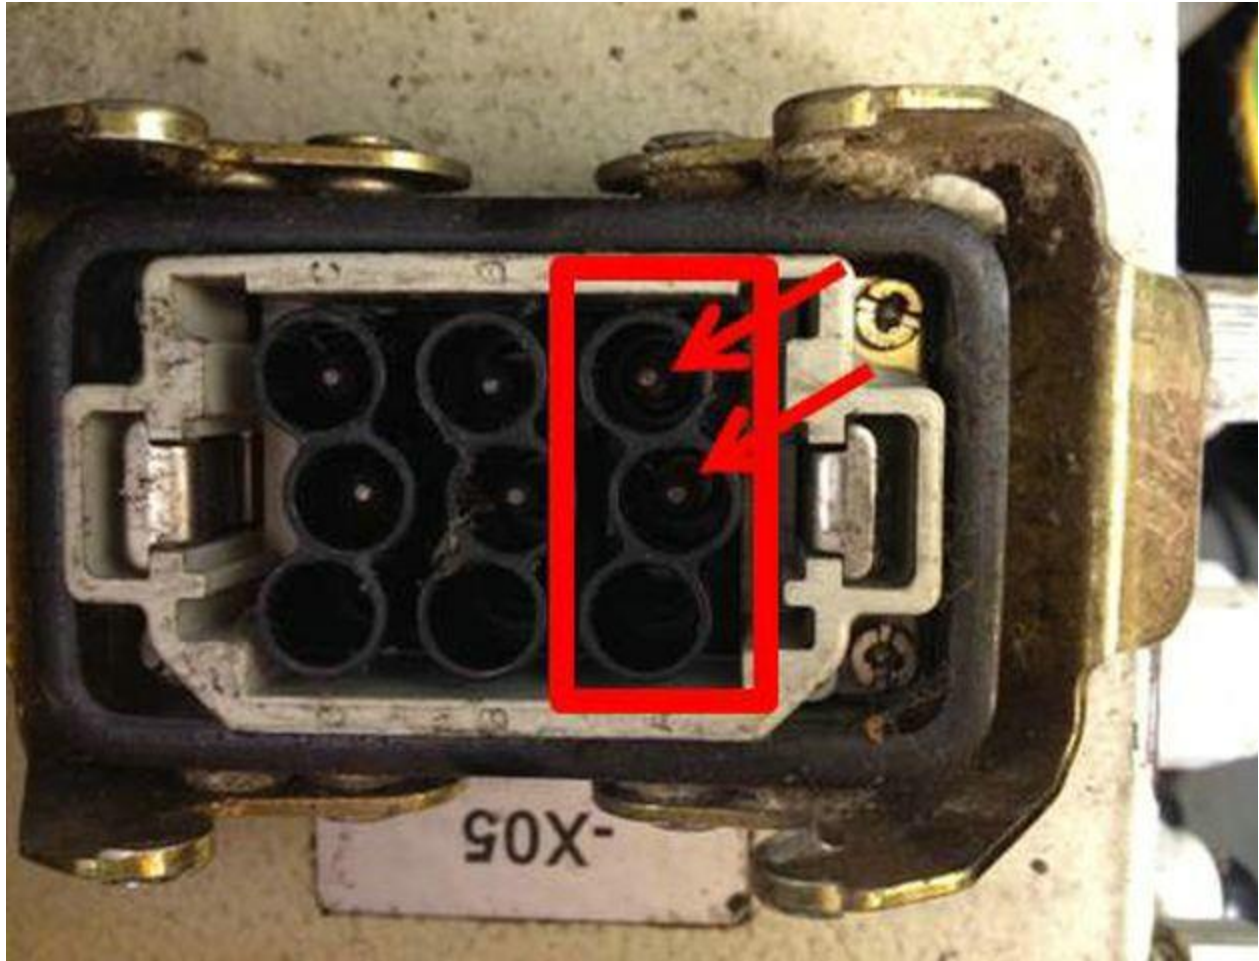
-X05 Male pins:
Look for corrosion or broken pins on module A pins 1&2.

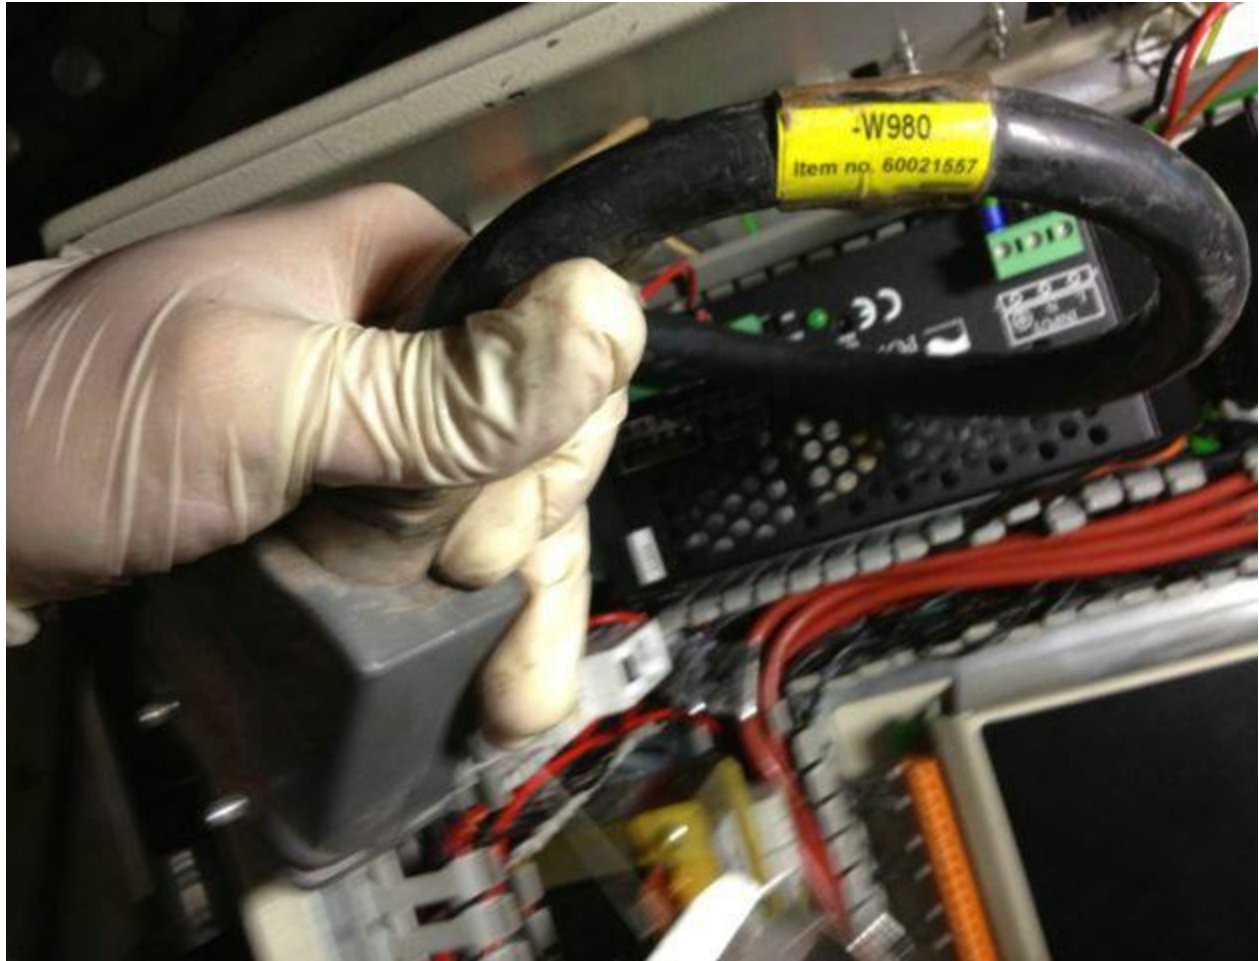
230VAC supply cable from slip ring –W980:
Check the condition of the –W980 cable in the hub. Look for cracks or wear on the cable.

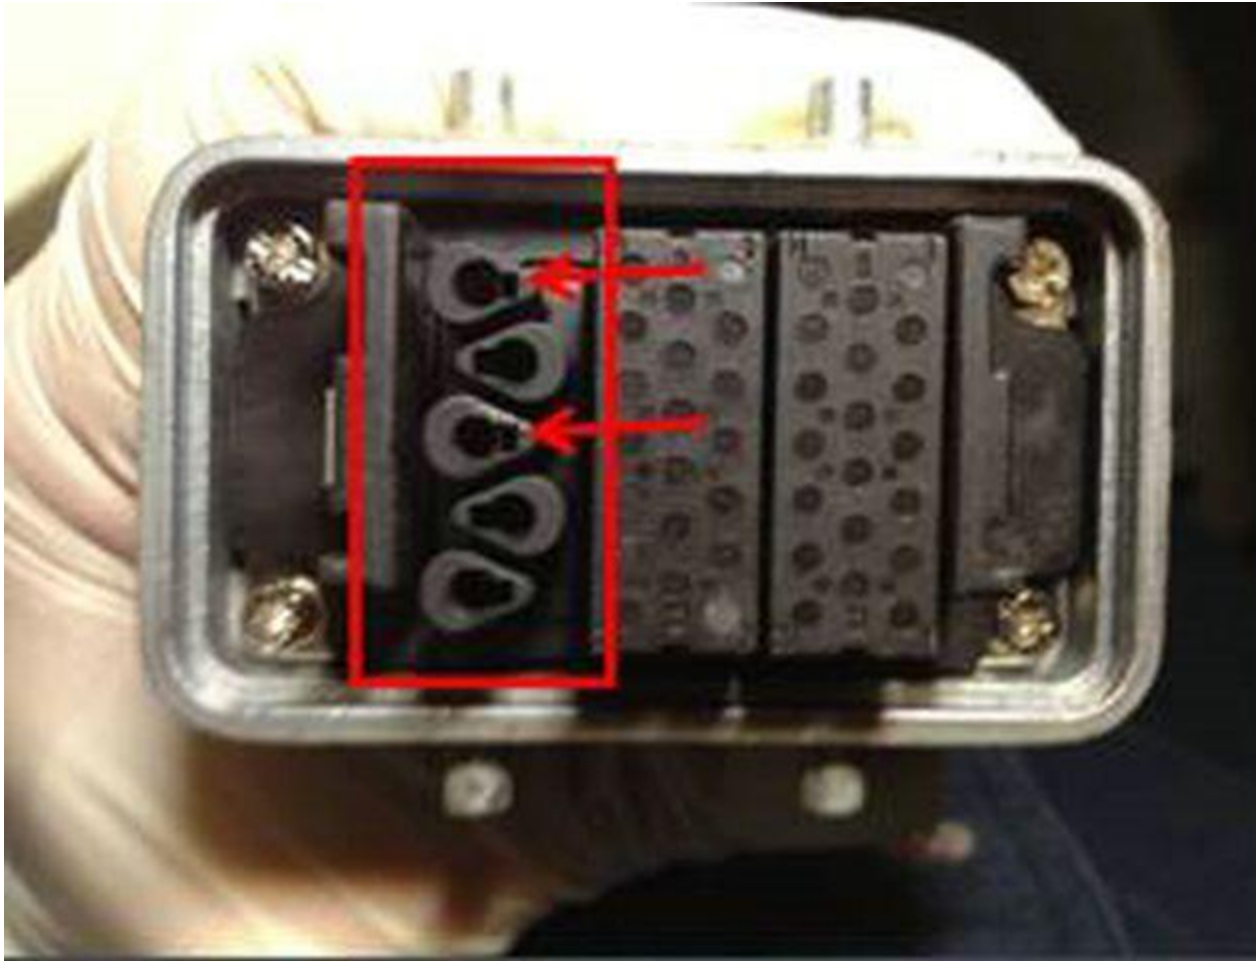
-X03 plug female pins:
Look for corrosion or broken pins on module A pins 1&3.

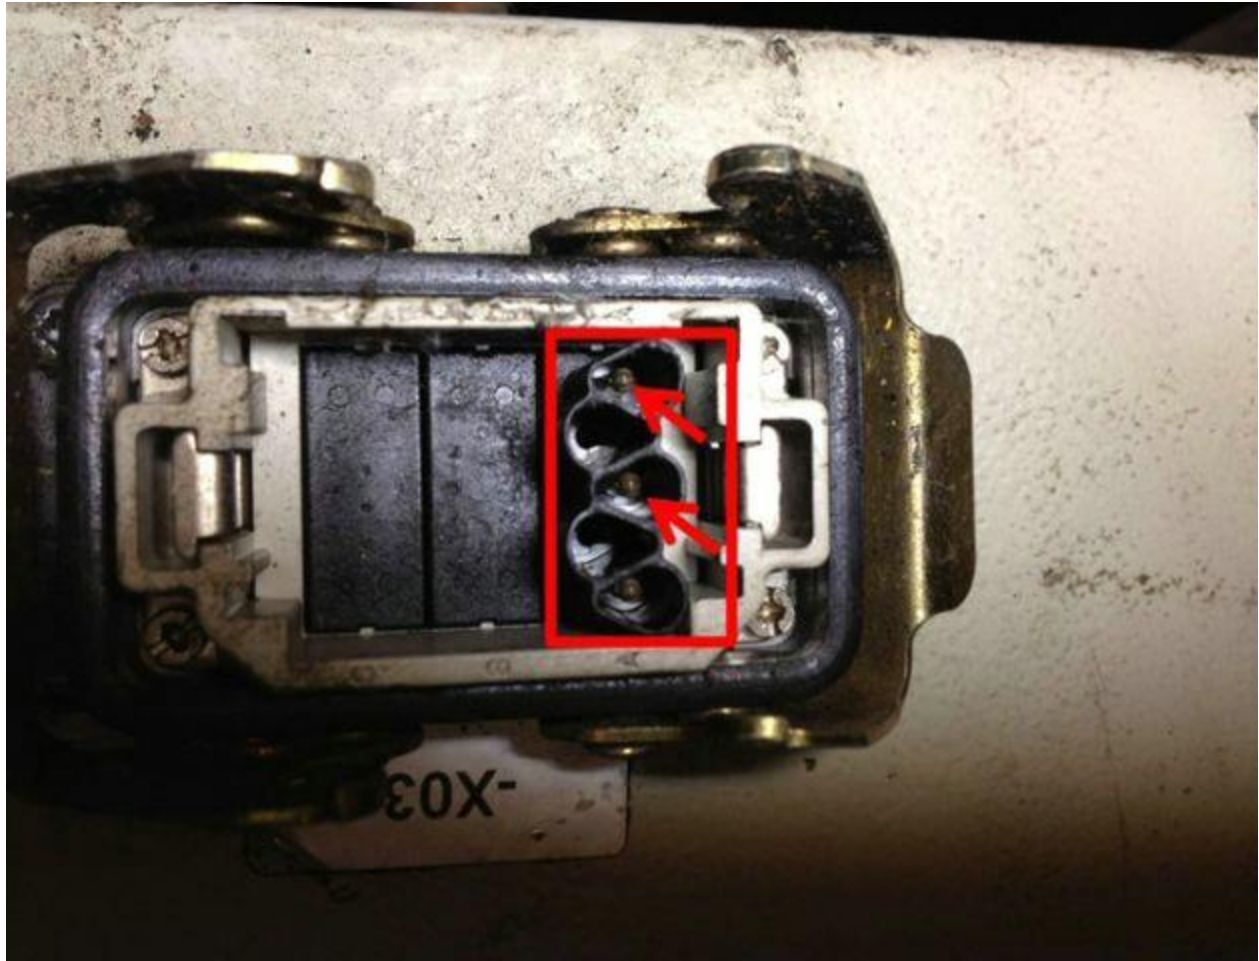
-X03 Male pins:
Look for corrosion or broken pins on module A pins 1&3.

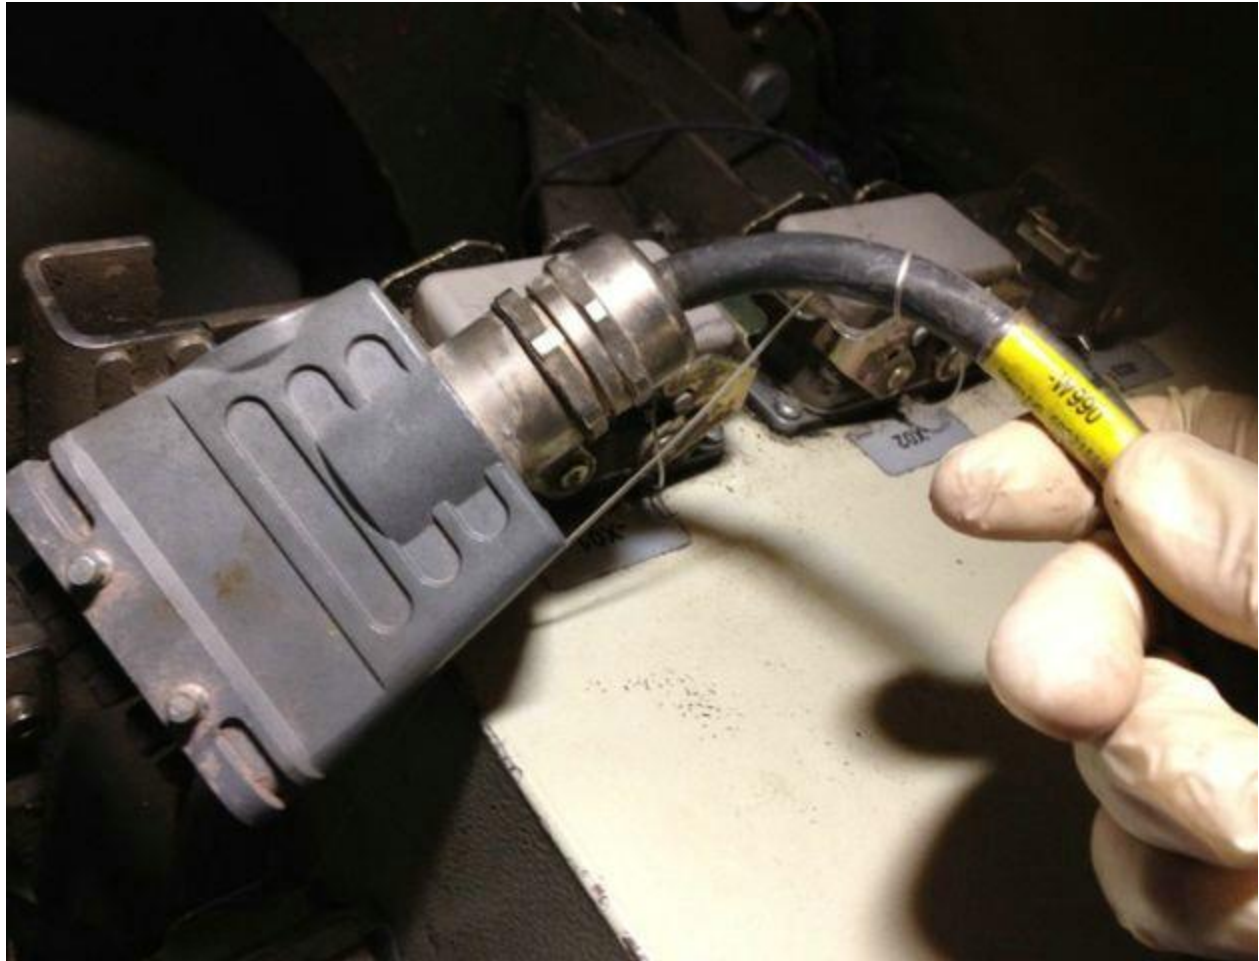
Communication cable from slip ring –W990:
Check the condition of the –W990 cable in the hub. Look for cracks or wear on the cable.

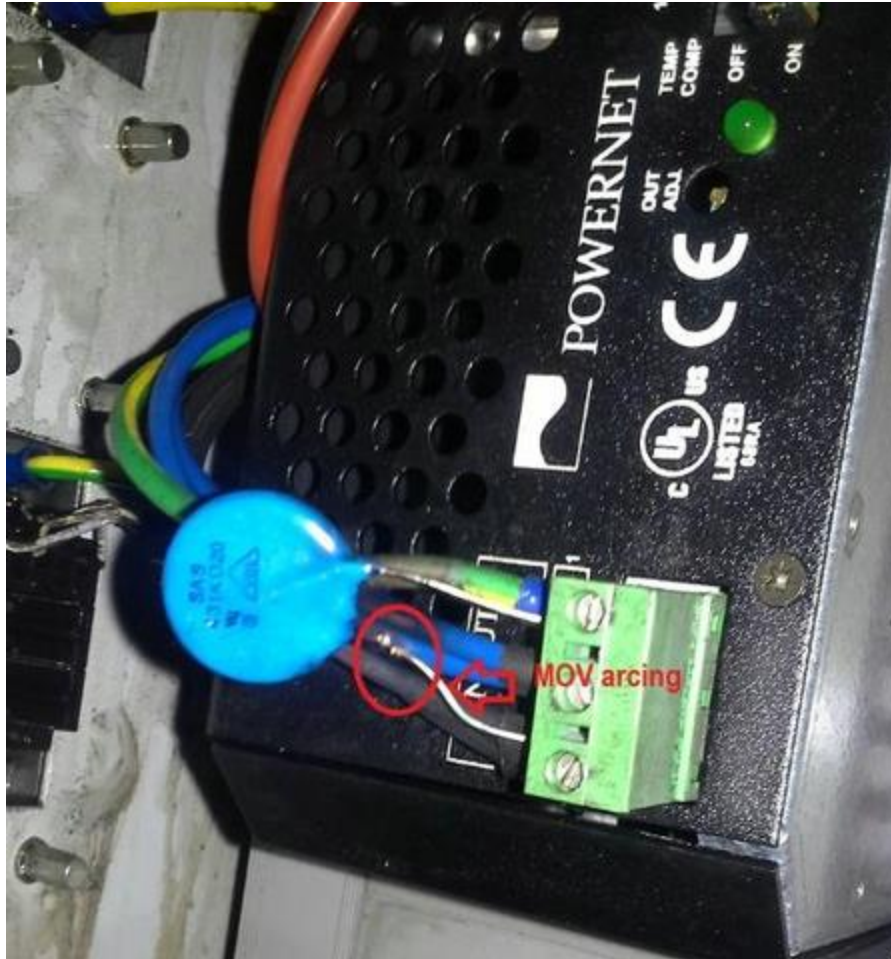
Check any loose connection and damage in the varistor fixed on G401 and replace if required
