473 - Hub output supply unstable - V82

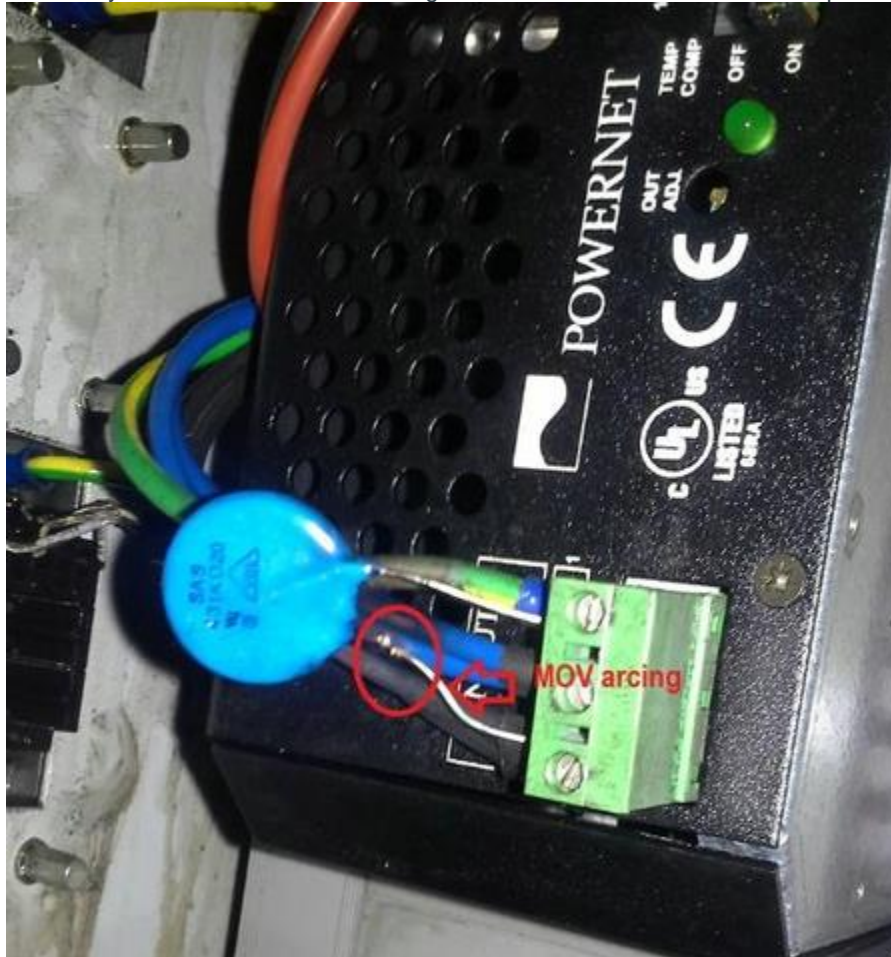
Check any loose connection and damage in the varistor fixed on G401 and replace if required

Check for the surge protector upgrade in Power Net as per Doc 0013-3681 or 0033-3872.

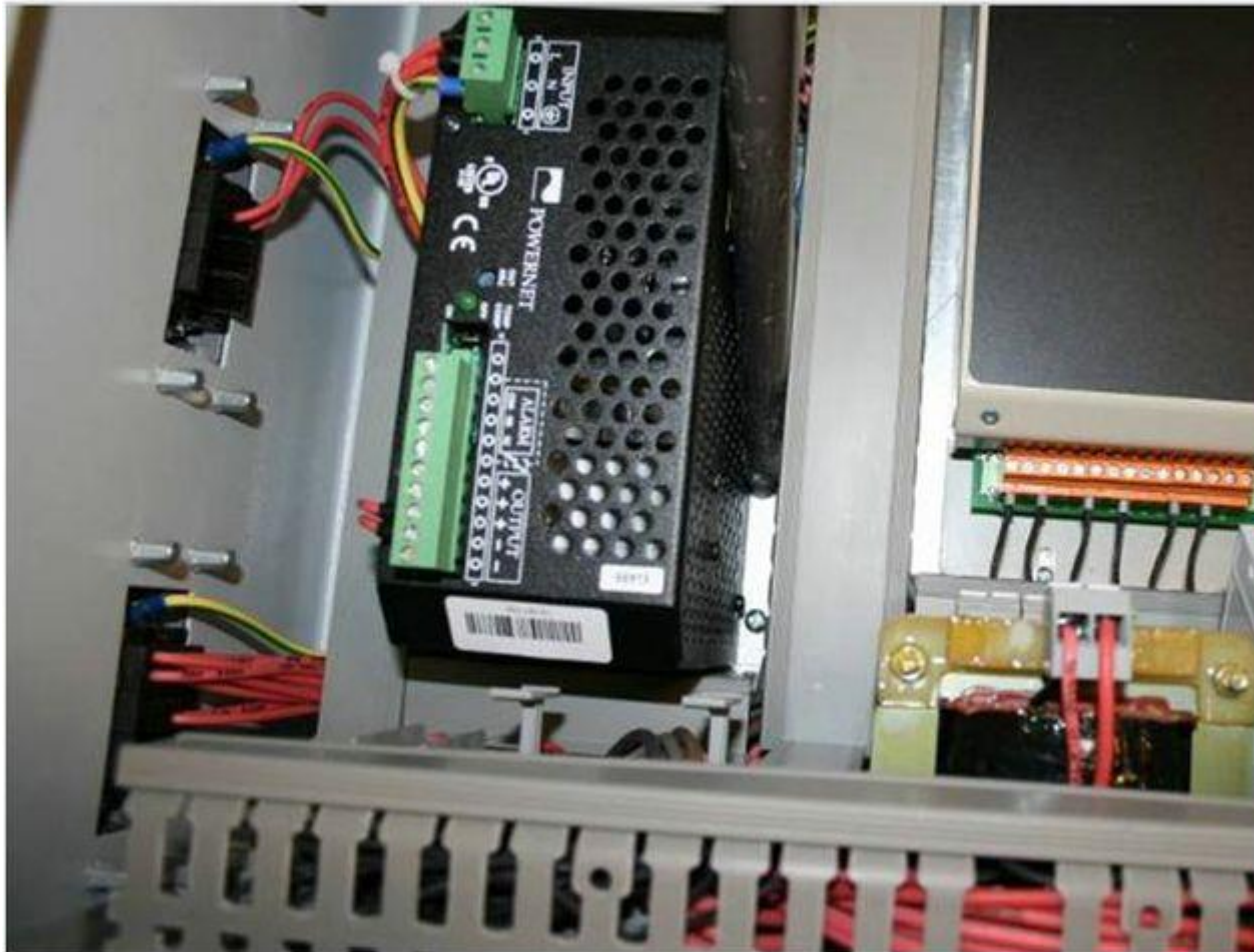
Check for any loose connections at the power net (Pos: G401)
Check the input and output voltage 230/115VAC => 24VDC
Replace the power net if it is defective.

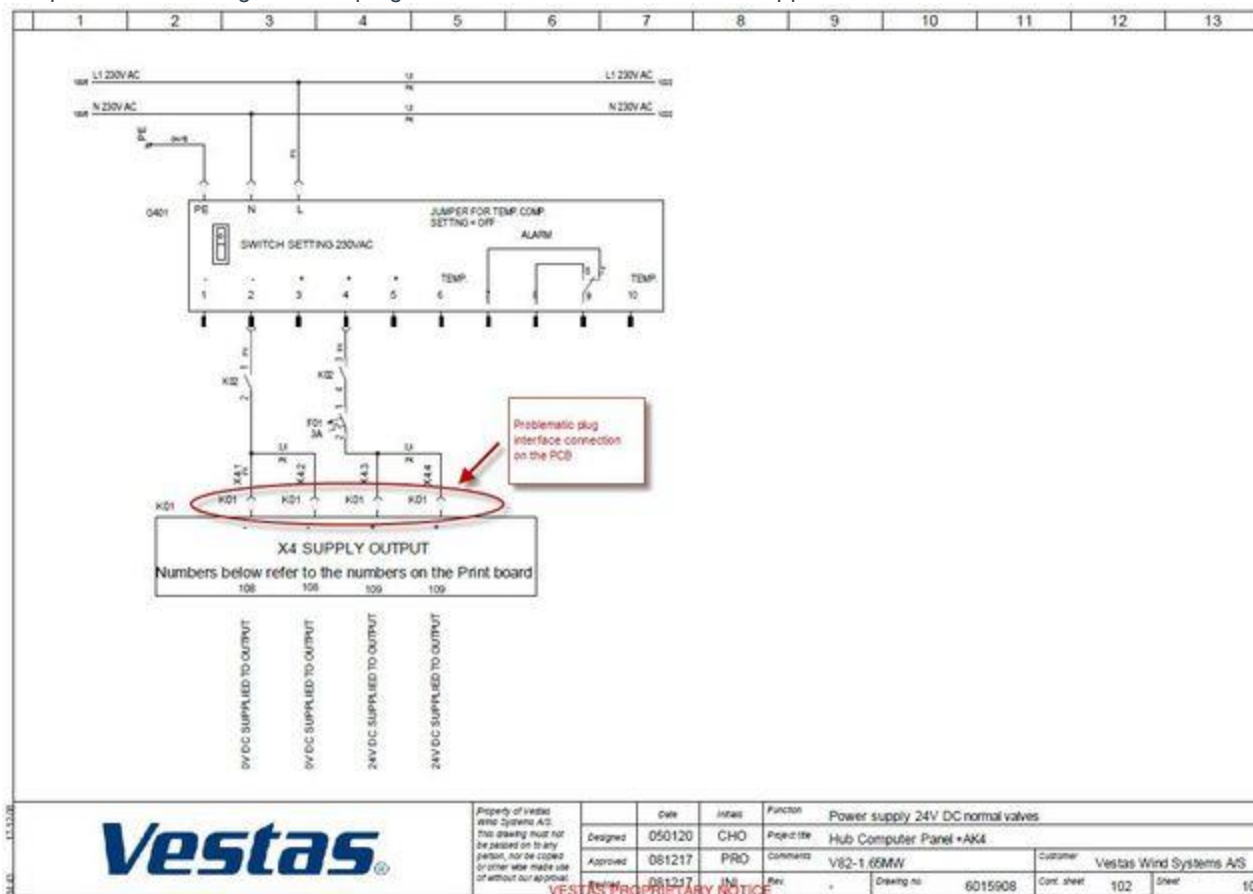
The problem is relating to the X4 plug connection where the 24VDC is supplied to the HUB Controller.

It has in many cases been seen that the plug connection have been overheated and burned as indicated on the below pictures.

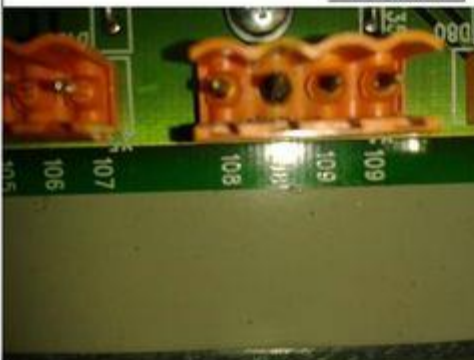
<p>Picture 1 Hub computer shows burnt 108/109 connectors</p>	<p>2. <input type="button" value="Insert Picture"/></p>

Case creator have proposes a simple fix to mitigate the problem. Namely to install a screw terminal versus the existing pin plug connector.

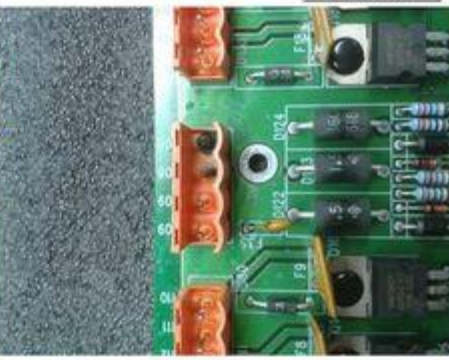
<p>Picture 2 Hub computer shows burnt 108/109 connectors</p>
<p>3. <input type="button" value="Insert Picture"/></p>

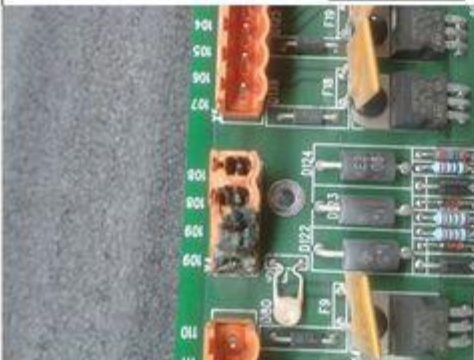
<p>Picture 3 Hub computer shows burnt 108/109 connectors</p>	<p>4. <input type="button" value="Insert Picture"/></p>

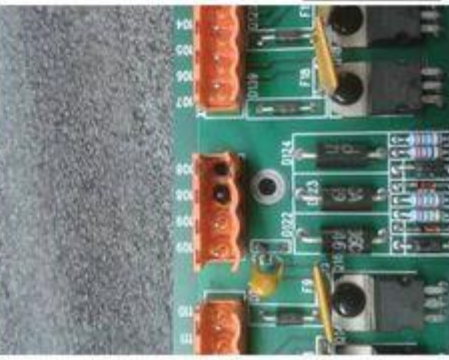
<p>Picture 4 Hub computer shows burnt 108/109 connectors</p>

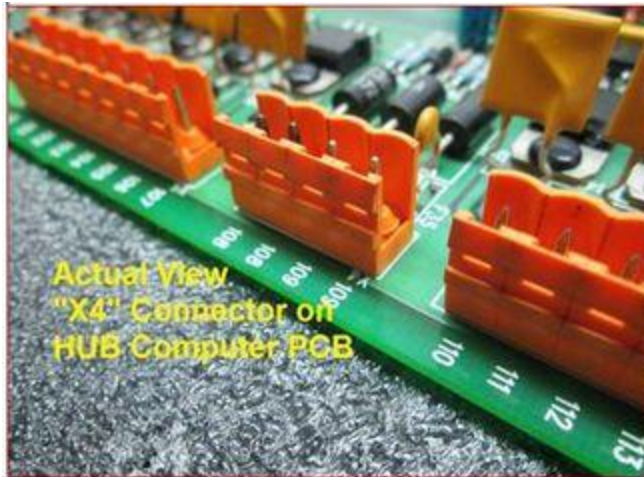
Picture 5 Existing Plugin type connector

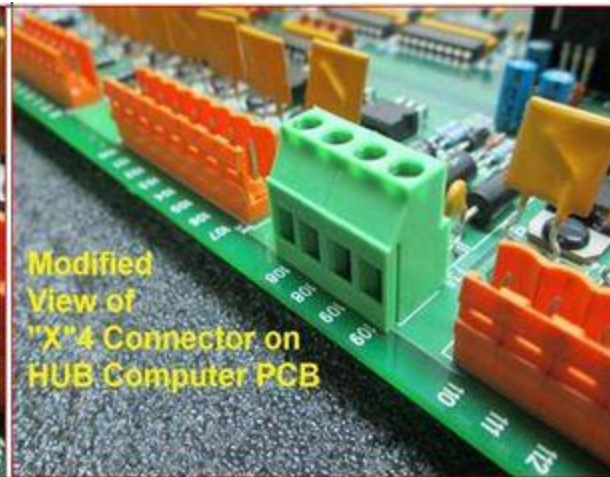
Picture 6 Proposed screw type connector

The proposed solution by case creator have been forwarded to the Minor Component repair Program, awaiting approval from technology responsible.

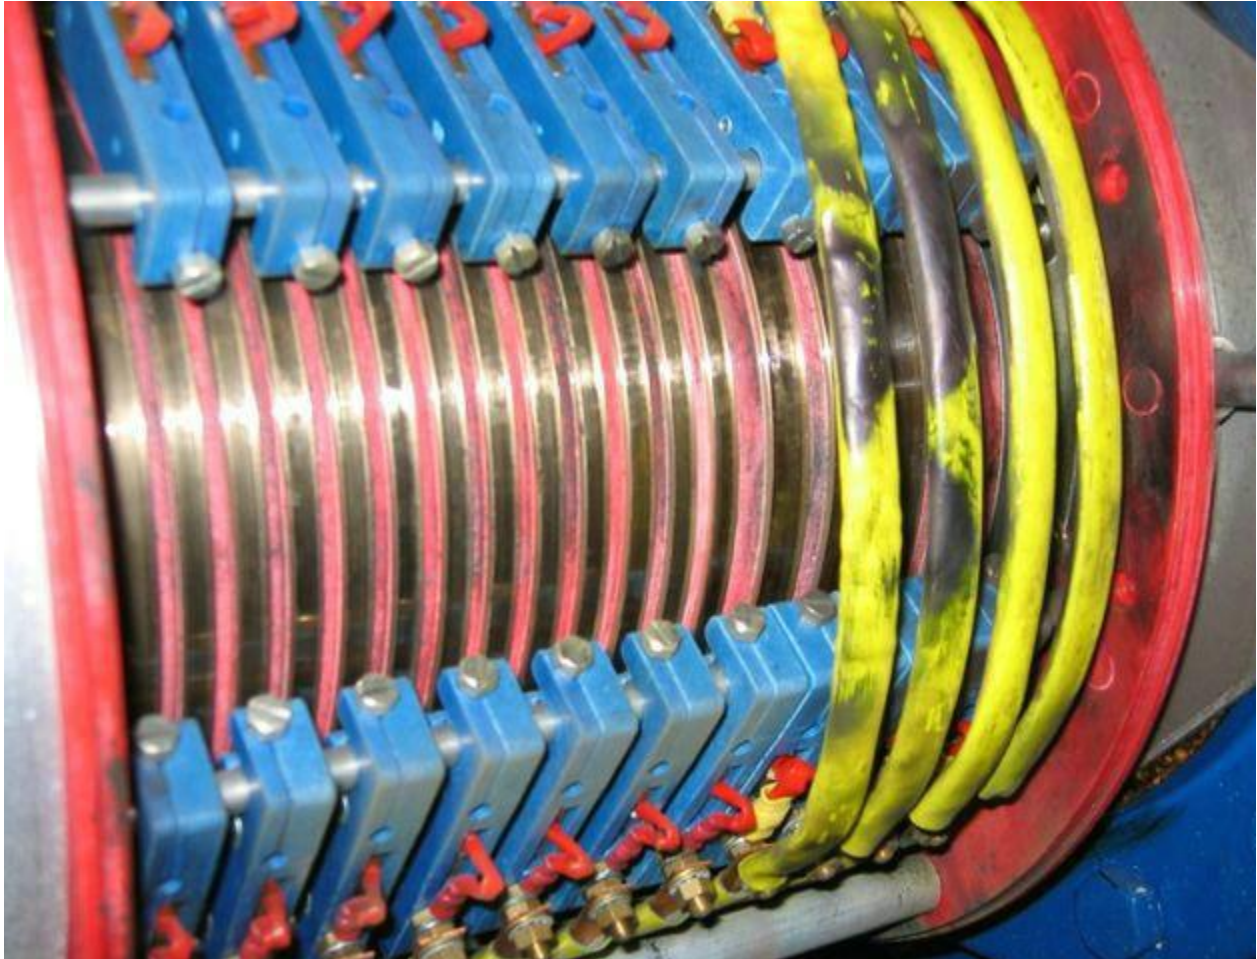
In most instances, a bad connection at the slip ring causes this alarm.
Investigate the slip ring for damage, dust or oil contamination.

Dust and oil accumulation on the slip ring short circuiting between the tracks which can cause this alarm.

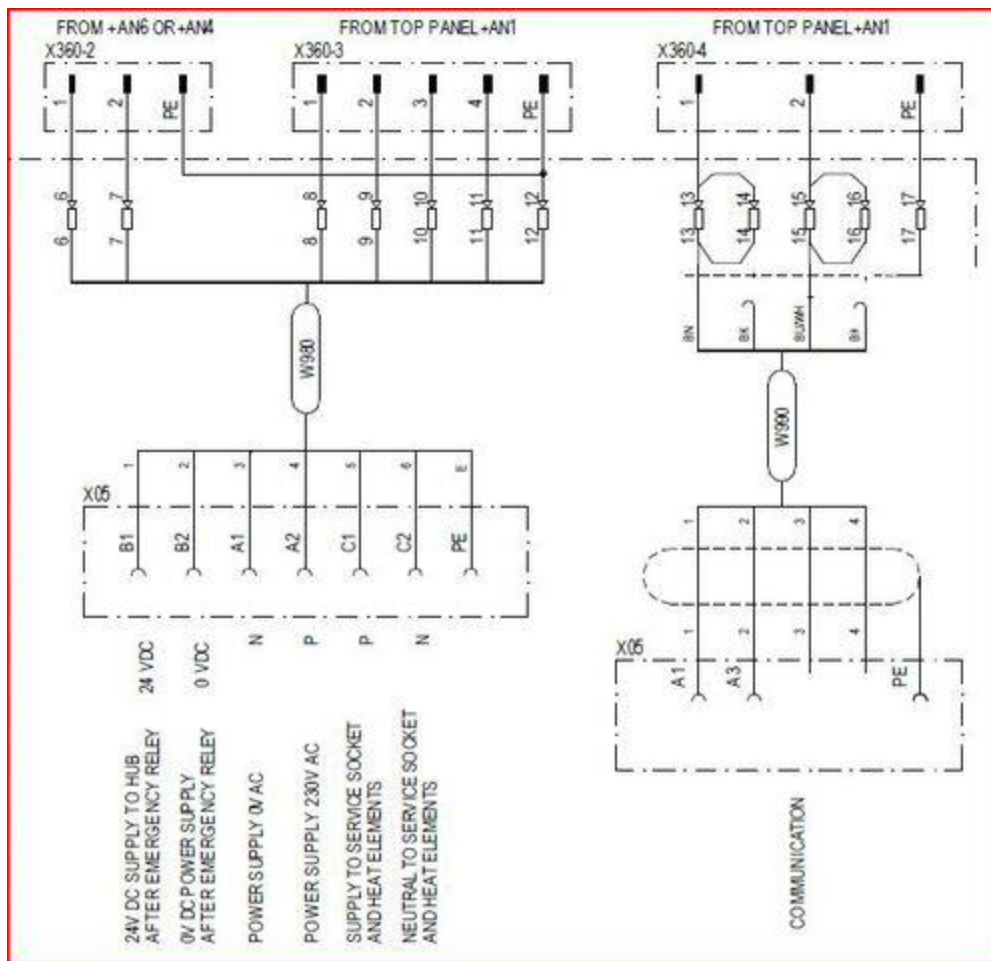
Check the condition of the brushes on the slip ring. Check for 230VAC supply to the hub and hub communications:

Replace the brushes if worn, damaged or contaminated beyond repair.
If any cable problems or sleeve damages are found, use the following re-termination KIT to rectify.

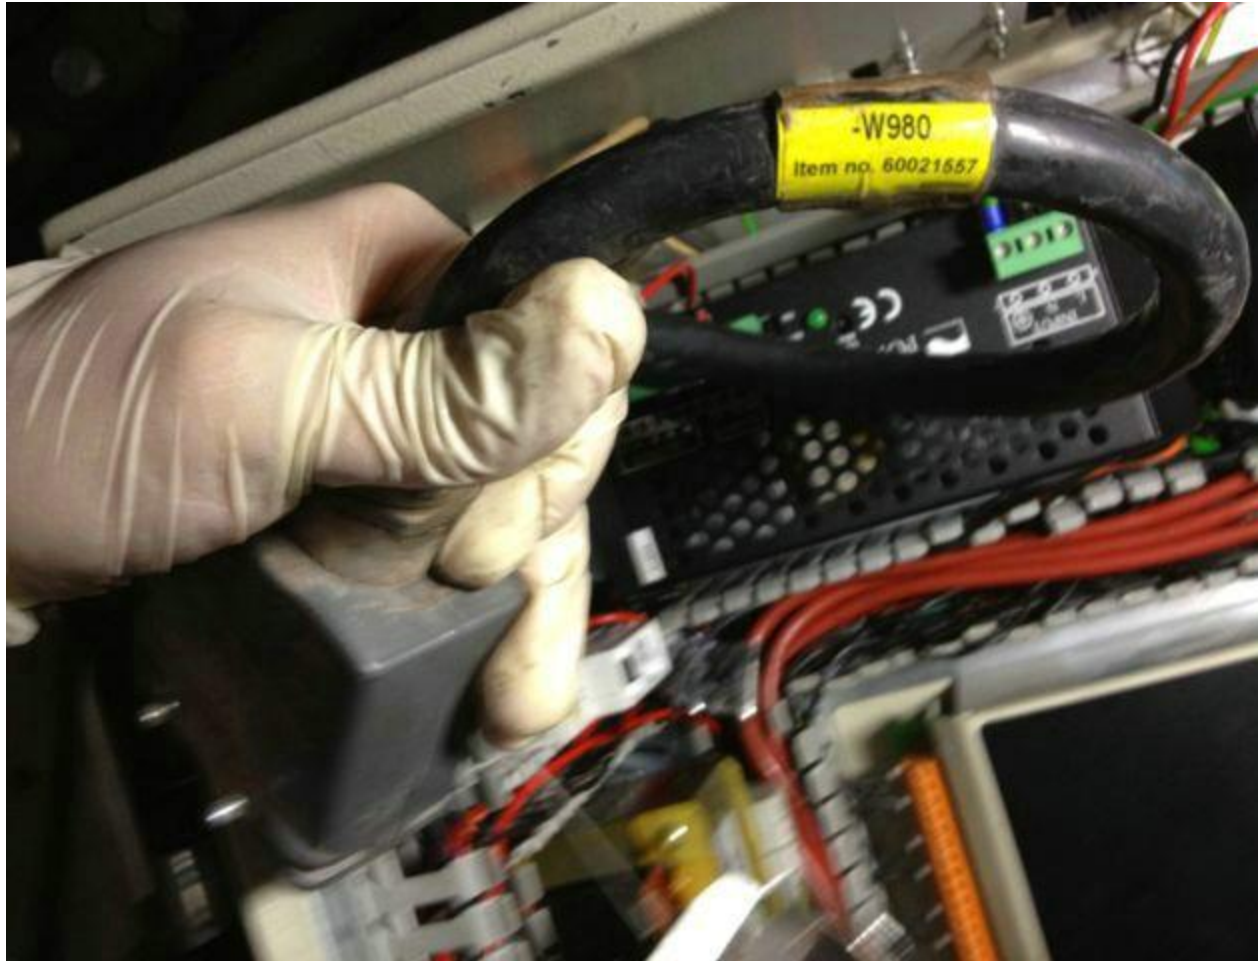
Check the condition of the –W980 cable in the hub.

Check for any cracks or wear on the cable.

Replace the cable if it is defective.
