SUBMARINE CABLE TO BORNHOLM HAS CLEAR DAMAGE AFTER ANCHOR OR SIMILAR

PUBLISHED ON 28.2.2022 14.45

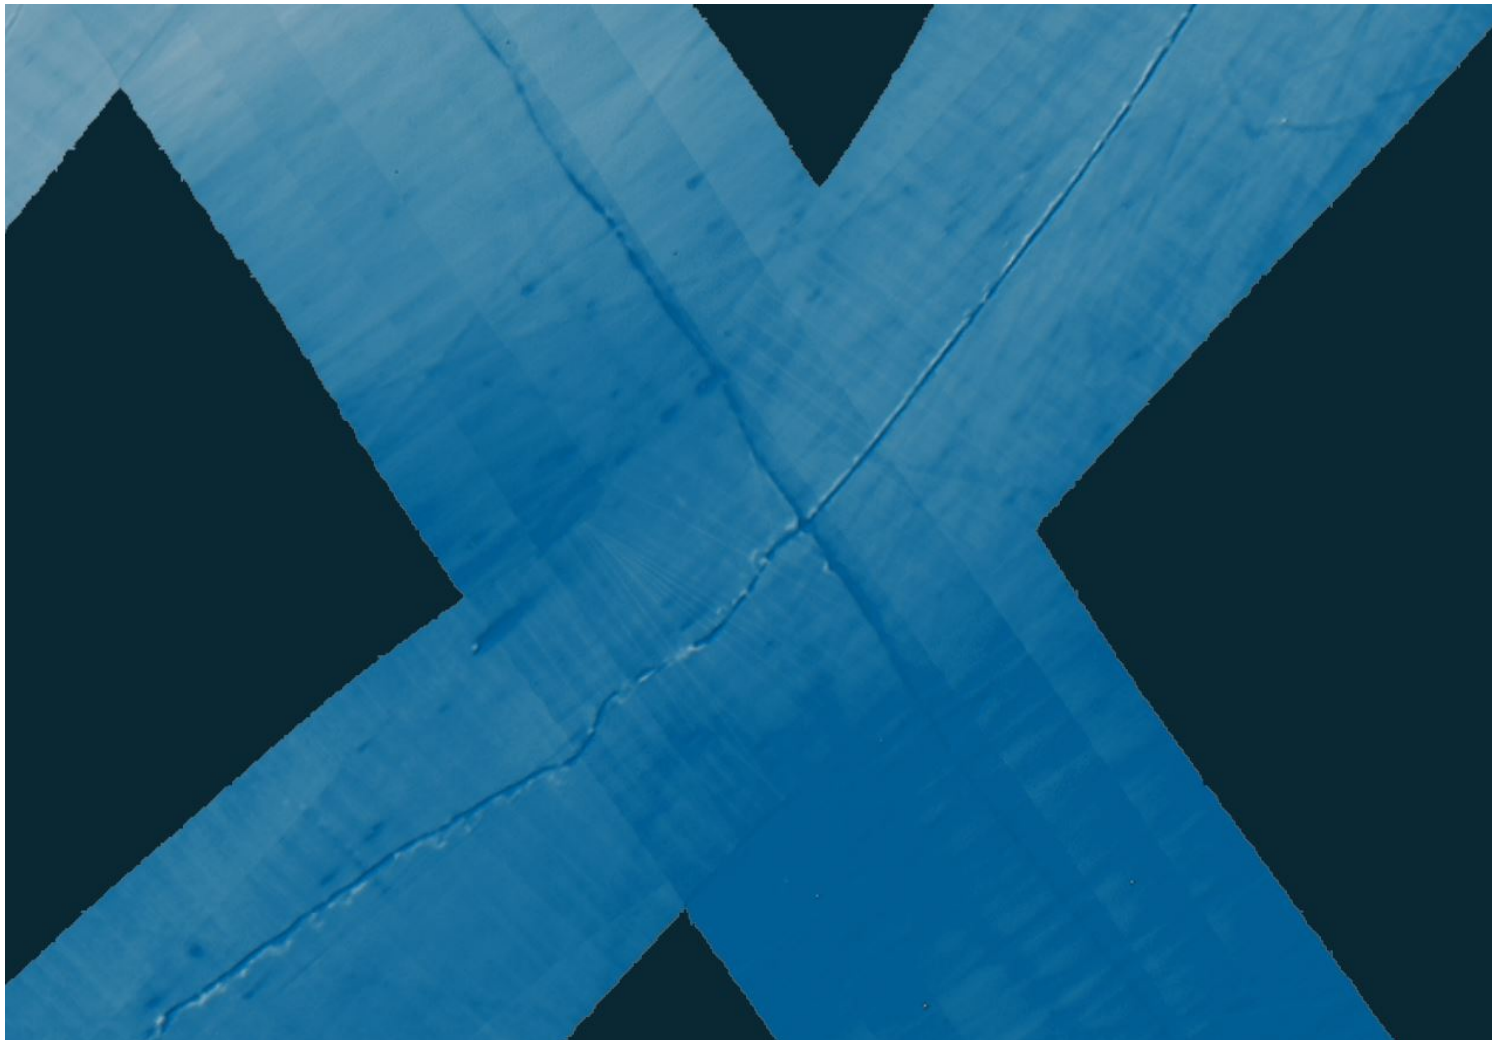
SCANNING IMAGE OF THE SEABED. THE PICTURE SHOWS THE CABLE ROUTE THAT GOES FROM THE UPPER LEFT CORNER TO THE LOWER RIGHT CORNER. A SHIP ANCHOR IS PULLED OVER THE SEABED FROM THE UPPER RIGHT CORNER TOWARDS THE LOWER LEFT CORNER. AFTER THE ANCHOR HITS AND GRABS THE CABLE, THE ANCHOR GETS A MORE UNEVEN ROUTE AND "JUMPS" ACROSS THE SEABED.

The surveys from the seabed made on Sunday show that the cable is damaged exactly at the place where the short circuit was measured. The pictures show clear damage to the cable's protective sheath. The damage, which is very similar to damage

erginet has previously seen when a ship anchor or fishing gear has hit submarine cables. Only one of the three cables that

together make up the electrical connection is assessed to be affected.

Everything at the moment indicates that this is an anchor damage.

"We have immediately started to have the cable repaired - we must have the damaged part cut off and a spare piece inserted. We have spare parts ready, but we can not yet say when the cable will be back in operation - it depends, among other things, of the weather conditions. It must be calm at sea so that we can pull the cable up to the surface and carry out the repair," says Steffan Ladegaard Morrison, area manager at Energinet.
