Why It Loosened — Even When Torque Was Right

*Field findings from 3 conveyor modules with vibration-induced loosening
How OEMs prevented downtime — without redesign
(Reference: DIN 65151, ISO 898-1)*

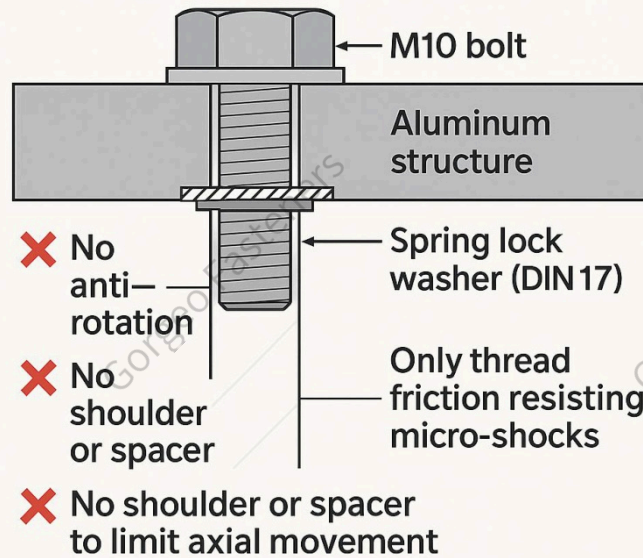
❌ Friction-Only Joint: Why It Loosens Despite Torque

- Bolt heads with micro-rotation wear marks
- Washers with circular polish tracks
- Thread bores ovalized after multiple cycles

No anti-rotation geometry under bolt head
-

No shoulder or spacer to limit axial movement
-

Only thread friction resisting ~4000 rpm micro-shocks

When thread friction is your only defense, even a perfect torque value can't hold against vibration-induced slip.

This was a classic case of self-loosening, not preload loss.

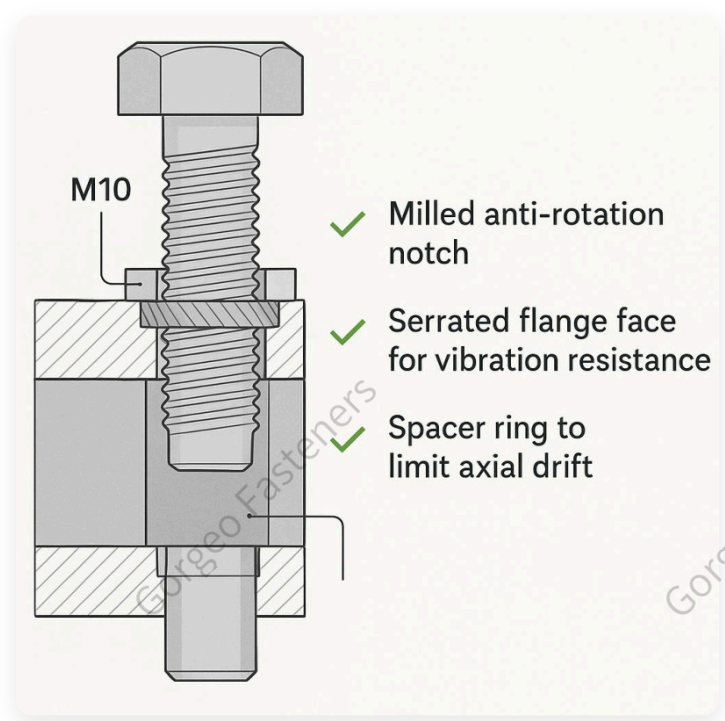
3-Month Field Comparison (Before vs After)

Metric	Before Fix	After Fix
Loosening Events	Every 1-2 weeks	No rework needed
Bolt Hole Wear	Ovalized	Intact
Assembly / Maintenance	Re-torque every 1-2 weeks	Held at 38 Nm
Operator Feedback	"Loosened again after 2 days"	"Stable after 3 months."

We tested 3 interface upgrades across all modules. No change to bolts, torque, or tools required.

- **Torque:** 38 Nm
- **Assembly time:** ~90 seconds per joint
- **Component type:** All from standard fastener catalogs (no custom machining)
