# EVALUATING CONSTRUCTION FAILURES

By Harvey A. Kagan,<sup>1</sup> M. ASCE

**ABSTRACT:** Four of the construction failures the writer has investigated are reviewed. Two failures involved light framed timber trusses, one failure involved precast tees, and one involved overloaded steel floor joists. Each collapse centered around a failure to recognize the weakness of a partly completed structure. Human failure was the heart of the problem. The writer suggests greater attention to details by those responsible for construction procedures.

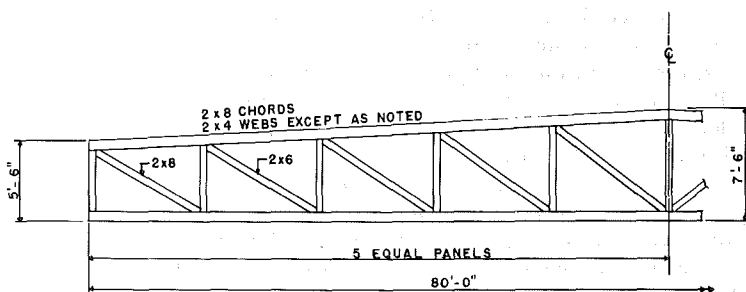
FIG. 1.—Church Roof Truss (1 in. = 25.4 mm)

The photographs showed the bundles were relatively undisturbed and appear to have dropped more or less vertically. Two stacks were placed transversely to the trusses approximately over the second panel point from the support. These were supported by 3 trusses. A third stack had been placed with its long axis parallel to the trusses over the third panel point from the support. This bundle was supported by 2 trusses. Therefore, excessively heavy bundles placed out on the span had been installed in violation of recommended procedures.

of the third bundle of plywood. The stress was limited by the lateral supports of the top chord. An analysis of stress in the roof truss caused by various positions of the plywood bundles *only* (no truss dead load), indicated a stress of 143 psi (985 kPa) for the laterally placed stacks, and a stress of 382 psi (263 kPa) for the bundle spanning only two trusses. The top chord of the truss was overstressed even under the most favorable conditions.

1. Stacks of plywood 50–55 sheets high placed on the top chords of trusses.
2. The top chords were insufficiently braced in the lateral direction and were overstressed. The trusses did not collapse immediately but remained standing in unstable equilibrium.
3. The vibration caused by the passing airplane was sufficient to provide the force needed to start the collapse chain. One or more truss chords buckled and pulled down the other trusses.

Had the contractor not been so careless in placing the bundles of plywood the collapse would not have occurred. He should have taken the time to break the bundles into piles of 8 sheets at the maximum and placed these on the trusses around the perimeter of the building. The carpenters would have had to break the bundles up later in any case.

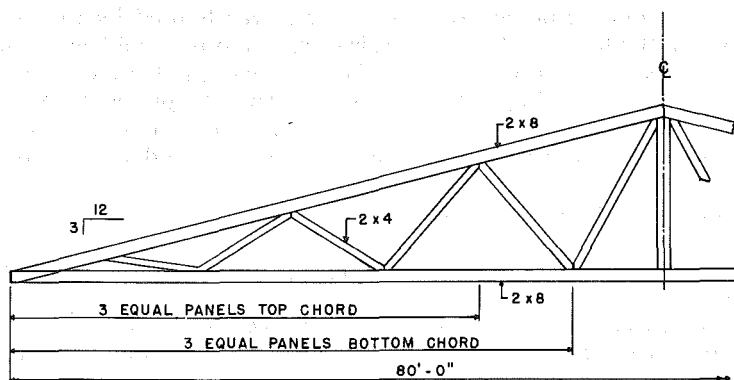
FIG. 2.—Warehouse Roof Truss (1 in. = 25.4 mm)

There were winds and thunderstorms again the night after truss erection was completed. Winds of over 40 mph (64.4 km/h) were recorded at a nearby recording station. The windstorm was in a direction perpendicular to the trusses. In the morning, the center section of trusses had warped out of plane. The contractor and his workmen proceeded

to straighten the trusses one at a time by loosening portions of the lateral bracing. During the operation, one truss fell over and collapsed the middle third of the trusses in a domino fashion. By good fortune, the workmen were all on the trusses which did not collapse. Damage was confined to the collapsed trusses.

During the windstorms, high dynamic forces were developed against the sides of the trusses. The temporary lateral bracing system was adequate enough to prevent collapse of the trusses but was inadequate to hold the trusses in place. The result was the shifting and distortion of the trusses. The accompanying rainstorm soaked the wood and possibly decreased the holding power of the nail plates. The net effect was the

During the straightening operation, one of two possibilities occurred: the contractor removed too many lateral supports and a truss collapsed, or a weakened truss connector or a lateral bracing connection failed and caused the collapse.

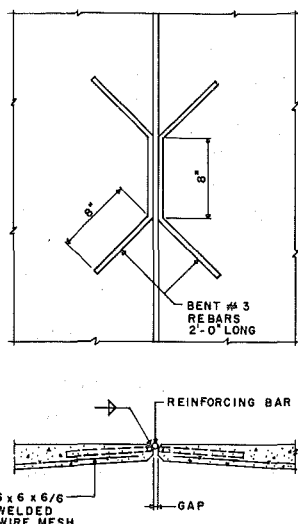
FIG. 4.—As-Built Tee Connection (1 in. = 25.4 mm)

The bent bars were not fastened in any manner to wire mesh, which constituted the flange reinforcement. The embedded bars were placed at 6 points along the flange tips, 10 ft (3.05 m) apart. As constructed, the "weld plates" were not connected to each other because of gaps between members in excess of 1/4 in. (6.4 mm). Instead, a large diameter reinforcing bar was welded between the two tips. These "weld plates" served as the only flange supports during construction.

the 6 "weld plates," the welded connection had held, but the embedded bars had either broken or pulled out of the tee flanges. Only one of the welded connections failed. There was no failure of the half tee itself.

From the photographs and descriptions of the collapse, it was evident that collapse was initiated by a loss of the flange support offered by the "weld plates." This was followed by an initial rotation of the half tee, a failure of the stem supports, a complete rotation, and then a drop of the half tee to the ground.

1. Collapse of the half tee resulted from a failure of flange support offered by the so-called "weld plates."
2. "Weld plates" as *designed* had insufficient embedment to develop the strength of the steel rod or weld.
3. No postulated construction load would have been of sufficient magnitude to cause failure of the "weld plates" had adequate embedment of the reinforcing bars been provided.

In the opinion of the writer this failure was the result of the negligence of the designer of "weld plates." The designer failed to observe minimum requirements for embedment length of reinforcing bars. The designer also failed to account for fabrication tolerances and allowed only a minimal amount of cover for the reinforcing steel. The result was a pull-out of the bars under construction loading and a tragic loss of life. More careful attention to detail could have prevented the failure.
