# INVESTIGATION OF EAST CHICAGO RAMP COLLAPSE

By Nicholas J. Carino,<sup>1</sup> A. M. ASCE, H. S. Lew,<sup>2</sup>  
and William C. Stone,<sup>3</sup> Members, ASCE

**ABSTRACT:** A summary is presented of the investigation performed by the National Bureau of Standards (NBS), at the request of the Occupational Safety and Health Administration, to determine the most likely cause of the collapse of a portion of a highway ramp in East Chicago, Indiana. The investigative effort included an extensive field study to ascertain the conditions prior to and after the accident. In addition, the NBS performed physical tests on key components of the temporary support system used to build the ramp. A structural analysis was performed to compute the magnitude of the forces acting in various components of the support system prior to the failure. The calculated forces were compared with the expected strengths of the structural components. It was concluded that the most likely triggering mechanism of the collapse was the cracking of concrete pads supporting a shoring tower. It was further concluded that there were four deficiencies that contributed directly to the collapse. Had any of these defici

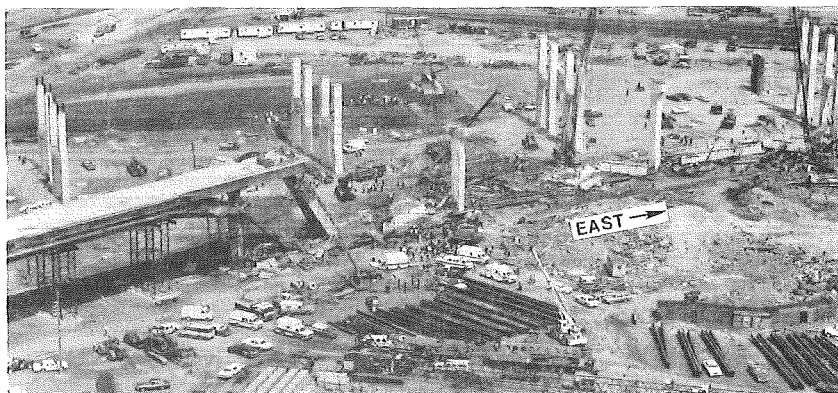
On April 15, 1982, portions of a highway ramp under construction in East Chicago, Indiana, collapsed, killing 13 and injuring 15 workers (Fig. 1). This was the worst construction accident in Indiana's history. Immediately after the collapse, the Occupational Safety and Health Administration, Department of Labor, requested the assistance of the National Bureau of Standards (NBS) to determine the technical reasons for the incident. A team of structural engineers arrived in East Chicago on April 16, 1982, and was briefed by personnel of the Indiana Occupational Safety and Health Administration (IOSHA), which had jurisdiction over the collapse site. Based on initial field observations the following day, the NBS team formulated a comprehensive investigative plan which included securing construction documents and material samples, interviewing workers on the project, performing detailed field investigations, performing physical tests on materials and components, and carrying out structural analyses of the partially completed structure.

**FIG. 1.—Overall View of Collapsed Portion of Ramp; View Is Approximately Toward North (Courtesy of Lake County Coroner's Office)**

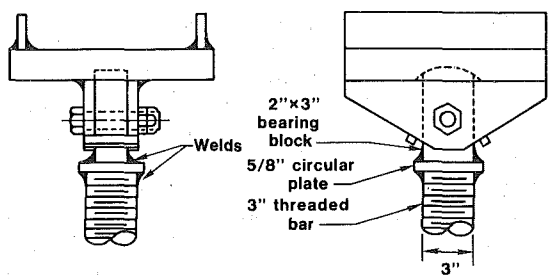
FIG. 7.—Front and Side Views of U-Heads Used to Support Crossbeams at Top of Shoring Towers

At the tops of the shoring towers, “U-heads” were used to support the crossbeams. Fig. 7 shows a front and side view of the upper portion of a U-head. Of special significance are the two welds used to connect the threaded bar to the rectangular bearing block. One weld joined the bearing block to a circular plate and the other weld joined the plate to the threaded bar. During the field investigation it was noted that many of the U-heads within the collapse debris had severed at either one of these welds. As can be seen in Fig. 7, a U-head can rotate about one axis as a result of the cylindrical fit between the bearing block and the top plate.

The broken U-heads belonging to the towers at 407.2 were also shipped to NBS for examination in order to determine the quality of the welded joints that had fractured during the collapse (see Fig. 7). The critical portions of the U-heads were removed, sectioned, and prepared for metallographic examination. It was concluded that the weld quality in the U-heads recovered from the collapse site was poor. There was evidence of lack of fusion between the base metal and the weld metal, and some of the welds were less than 1/4-in. (6-mm) thick.

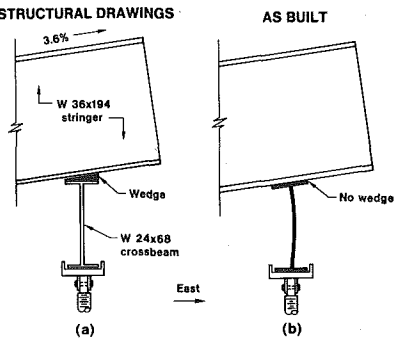
FIG. 8.—Comparison of Specified and As-Built Construction Detail Between Stringers and Crossbeams (Schematic, Not to Scale)

the standing portion of the ramp, no wedges were observed nor were any found within the collapse debris. The consequences of the missing wedges [Fig. 8(b)] were investigated by means of physical tests. The structural drawings also indicated that 1-in. (25-mm) bolts were to be used to connect the outer stringers to the cross-beams (see Fig. 5). There was no evidence that bolts had been used in ramp C; instead, friction clips (similar to those used to hold down railroad tracks) were substituted for the bolts.

As previously mentioned, wedges were omitted from between crossbeams and stringers (Fig. 8). Tests were carried out to determine the consequences of this omission. The arrangement for these tests is shown in Fig. 13. A piece of a W12  $\times$  92 beam was bolted to the head of a testing machine so that it had the approximate slope of the ramp. This beam was used to load the falsework assembly consisting of a crossbeam, a U-head, a welded frame, and two lower screw jacks. The threaded bar of the U-head was instrumented with strain gages from which the axial load and bending moment could be determined. The braces of the frame were also instrumented with strain gages so that these member loads could be determined. The results of these tests indicated that the absence of the wedges caused a horizontal force and a bending moment on the U-heads. It was determined that the horizontal force, acting toward the east, was about 2.4% of the vertical load. It must be realized that while the horizontal force seems to be small, when it is applied to the U-heads at the top of the 45-ft (14-m) towers, it creates a significant increase in the leg forces on the east side of the towers.

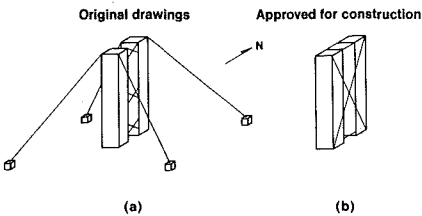
FIG. 9.—Comparison of Guying System in Original Drawings With System Approved and Used in Construction

The original structural drawings called for a tower guying system as indicated in Fig. 9(a). However, a substitute system was proposed by the contractor and approved by the Indiana State Highway Commission for construction [Fig. 9(b)]. The substitute X-bracing system—using 5/8-in. (16-mm) steel cables—did not provide the same degree of longitudinal stability to the top of the shoring towers as would have been provided by the external guying system.

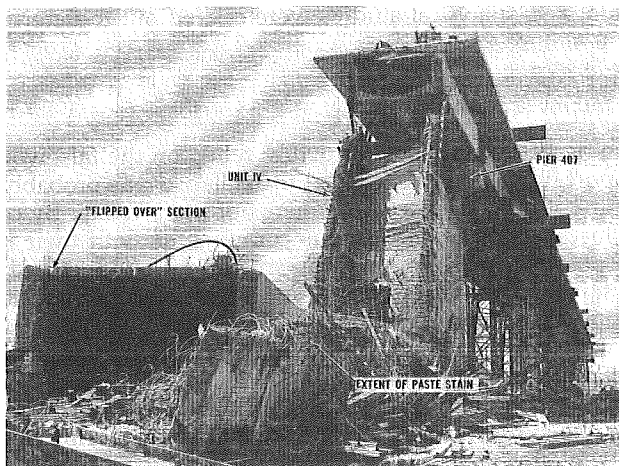
FIG. 11.—View of Unit IV Looking Toward Southwest

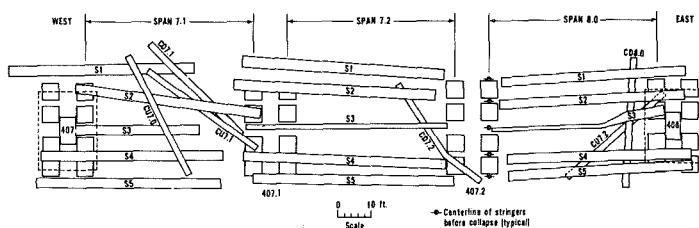
FIG. 12.—Location of Stringers and Crossbeams After Collapse

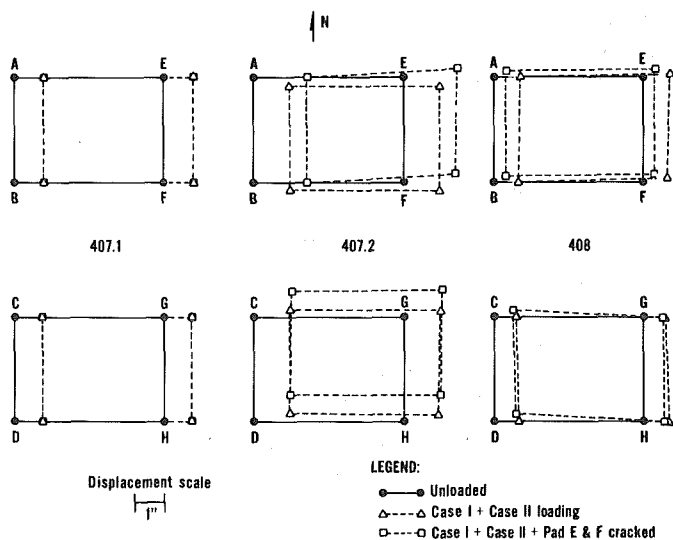
FIG. 15.—Longitudinal Displacements of Tops of Shoring Towers Under Various Loading Conditions

A significant effect due to cracking of Pads E and F is shown in Fig. 15, which shows the longitudinal displacements of the tops of the shoring towers at 407.1, 407.2 and pier 408 under different loading conditions. Cracking of pads E and F resulted in a sudden increase of about 0.8 in. (20 mm) in the longitudinal displacement at the top of the north tower at 407.2.

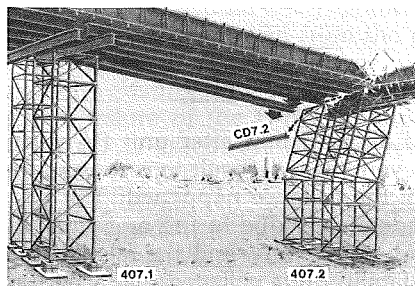
While it was difficult to pinpoint which of the U-heads at 407.2 failed first, examination of the physical evidence, such as the positions of the fallen crossbeams and of the fractured U-heads, suggested that U-heads at legs A and B failed first and were followed by failure of those at legs C and D. When crossbeam CD7.2 (supported by U-heads A through D) lost its support, all loads at 407.2 were transferred to the other crossbeam (DU7.2 in Fig. 12). With the east side of the towers being loaded heavily, the towers collapsed in a jackknife mode and crossbeam CU7.2 was propelled toward pier 408. This failure mode is shown in Fig. 16.

**FIG. 16.—Rendering of Likely Failure Mode of Shoring Towers at 407.2 After Crossbeam on West Side Lost Support**
