Lessons Learned from an Emergency Bridge Replacement Project

Yong Bai, P.E., M.ASCE¹; William R. Burkett, P.E.²; and Phillip T. Nash, P.E.³

DOI: 10.1061/(ASCE)0733-9364(2006)132:4(338)

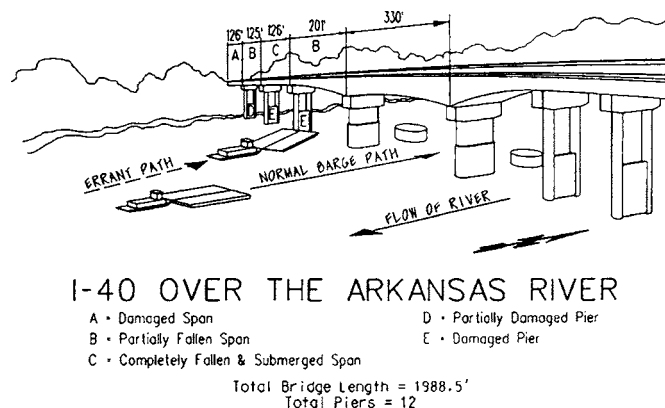
Fig. 1. I-40 bridge incident sketch

On the Memorial Day weekend of May 26, 2002, the towboat Robert Y. Love, pushing two empty barges owned by the Magnolia Marine Transport Company of Vicksburg, Mississippi, was moving upstream on the Arkansas River when it hit the I-40 Webbers Falls Bridge around 7:47 am. The incident caused a portion of the bridge, which is part of McClellan-Kerr Arkansas River Navigation System (waterway), to fall into the river. Drivers of 11 vehicles were unaware of the bridge collapse and plunged 19 m (62 ft) into the river. A total of 14 people died in the incident. The Oklahoma Department of Transportation (ODOT) closed I-40 near the bridge and the Navigation System. Interstate 40, one of the nation's three major east-west interstate highways, carries about 20,000 vehicles each day, transporting people, goods, and materials coast to coast (Stidger 2002).

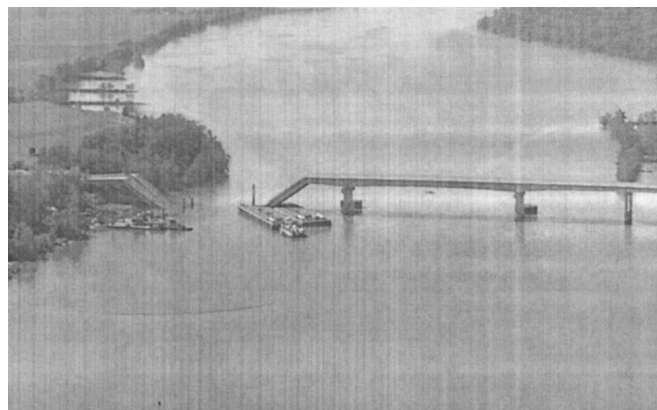
Fig. 2. Overview of damaged bridge

piers of the bridge, knocking down two piers (indicated as E piers) and partially damaging another (indicated as the D pier). Four spans totaling approximately 152 m (500 ft) were also damaged. Span 1 [38 m (126 ft), shown as damage type A] was damaged, but did not fall. Span 2 [38 m (125 ft), shown as damage type B] and Span 4 [61 m (201 ft), shown as damage type B] partially fell into the river. Span 3 [38 m (126 ft), shown as damage type C] completely collapsed into the river. Fig. 2 shows the damaged bridge.

still attached to the undamaged bridge, as shown in Fig. 2. The remainder of the bridge structure could have been further damaged if the crews had not been careful during the demolition. To prevent this from happening, the Magnolia Marine Transport Company stabilized the barges and the crews constantly monitored the movements of the bridge and barges. Combinations of demolition devices including a wrecking ball, explosives, concrete shears, and other cutting devices were used to meet the different needs at the site. The debris removed from the accident site was piled on a 2 ha (5 ac) site on the river's west bank and was trucked or floated away during the demolition.

The demolition crews knocked down the remaining piers first, and then began breaking up the concrete on the spans. Spans 1 and 2 were brought down using explosives, and the debris was removed from the site. Span 3, which had completely fallen into the river, had to be removed using underwater demolition. The working environment for the underwater demolition was hazardous due to poor visibility. Demolition of the damaged section of Span 4 was the most challenging task. This span was partially damaged. One end rested on the barges, while the other end was

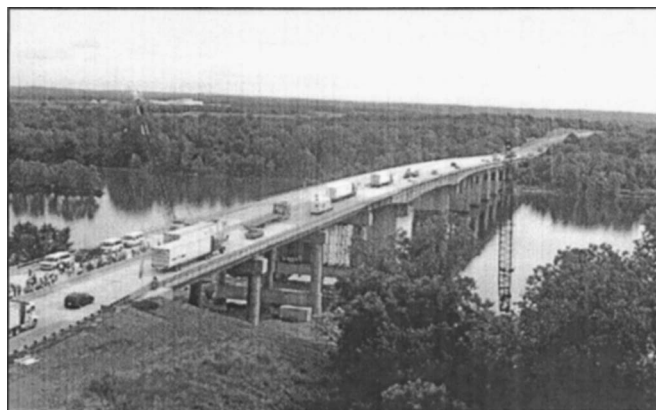
Fig. 5. I-40 bridge reopened to traveling public

streamline the bid review and approval procedures and get the reconstruction contract ready to put out for bid. ODOT also received technical help and cooperation from the U.S. Army Corps of Engineers, the U.S. Coast Guard, and other state DOTs. Fig. 5 shows the bridge as it was reopened to the traveling public on July 29, 2002.
