Tree Risk Assessment and Tree Protection

596 Ryan Road, Northampton, Massachusetts

II. Observations and Tree Risk – Site visit on 8/16/2022

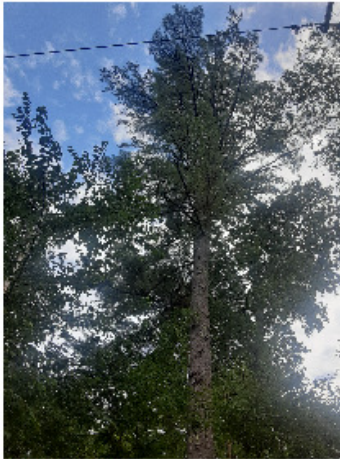
TREE 2721

Pinus	strobus	Date Inspected	08-18-2022
DBH	31"	Tree Height	80' TO 90'
TREE PROTECTION ZONE	34'		
TPZ RADIUS (measured from trunk)	17.0'		
PROTECT	No		
PROTECTION			
AIR EXCAVATION REQUIRED	N		
POTENTIAL FOR FAILURE	PROBABLE		
RECOMMENDATION	TAKEDOWN

there is a defect / cavity at ground level that originates below ground, the tree is exhibiting symptoms of pine needlecast

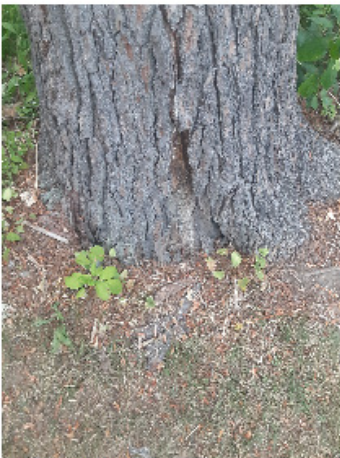
TREE 2722

Pinus	strobus	Date Inspected	08-18-2022
DBH	27"	Tree Height	80' TO 90'
TREE PROTECTION ZONE	34'		
TPZ RADIUS (measured from trunk)	17.0'		
PROTECT	No		
PROTECTION			
AIR EXCAVATION REQUIRED	N		
POTENTIAL FOR FAILURE	PROBABLE		
RECOMMENDATION	TAKEDOWN

there is a defect / cavity at ground level on both sides of the tree, it looks like past construction damage

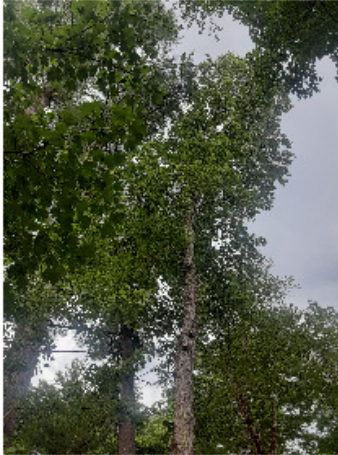
TREE 2723 Red Maple

Acer rubra Date Inspected 08-18-2022
DBH 28" Tree Height 60' TO 70'
TREE PROTECTION ZONE 35'
TPZ RADIUS (measured from trunk) 17.5'
PROTECT Yes
PROTECTION **FENCING AROUND TPZ**
AIR EXCAVATION REQUIRED N
POTENTIAL FOR FAILURE
RECOMMENDATION

the is a high branched red maple, it looks pretty good

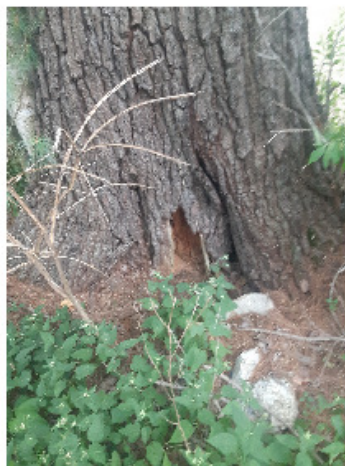
TREE 2724 White Pine

Pinus strobus Date Inspected 08-18-2022
DBH 32" Tree Height 80' TO 90'
TREE PROTECTION ZONE 35'
TPZ RADIUS (measured from trunk) 17.5'
PROTECT No
PROTECTION
AIR EXCAVATION REQUIRED N
POTENTIAL FOR FAILURE PROBABLE
RECOMMENDATION TAKEDOWN

the tree has a cavity on two sides of the tree with wood decay present at ground level, the tree has a pronounce lean towards the property

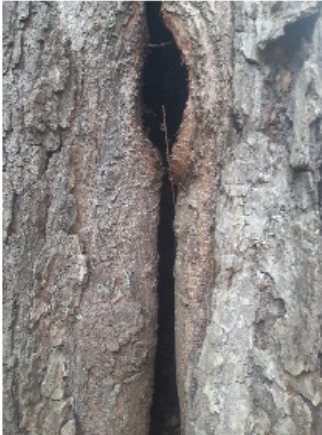
TREE 2725 Red Maple

the trunk is hollow, it is missing a top from past storm damage, it is leaning toward the neighbor's property

Acer rubrum Date Inspected 08-18-2022
DBH 22" Tree Height 30' TO 40'
TREE PROTECTION ZONE 35'
TPZ RADIUS (measured from trunk) 17.5'
PROTECT No
PROTECTION
AIR EXCAVATION REQUIRED N
POTENTIAL FOR FAILURE PROBABLE
RECOMMENDATION TAKEDOWN

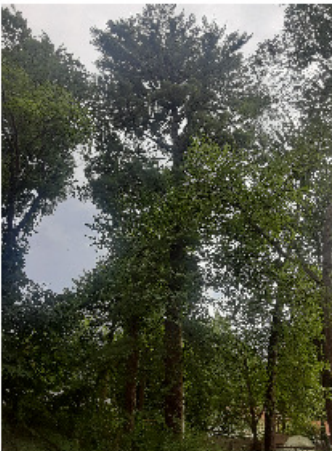
TREE 2726 White Pine

the tree looks good, some poison ivy growing up the trunk

Pinus strobus Date Inspected 08-18-2022
DBH 35" Tree Height 80' TO 90'
TREE PROTECTION ZONE 50'
TPZ RADIUS (measured from trunk) 25.0'
PROTECT Yes
PROTECTION **FENCING AROUND TPZ**
AIR EXCAVATION REQUIRED N
POTENTIAL FOR FAILURE
RECOMMENDATION

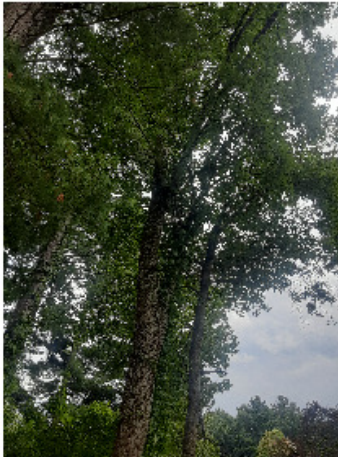
TREE 2727 Red Maple

Acer rubrum Date Inspected 08-18-2022
DBH 24" Tree Height 40' TO 50'
TREE PROTECTION ZONE 50'
TPZ RADIUS (measured from trunk) 25.0'
PROTECT Yes
PROTECTION **FENCING AROUND TPZ**
AIR EXCAVATION REQUIRED N
POTENTIAL FOR FAILURE
RECOMMENDATION

the tree looks good, there is bittersweet growing up the trunk, some poison ivy growing up the trunk

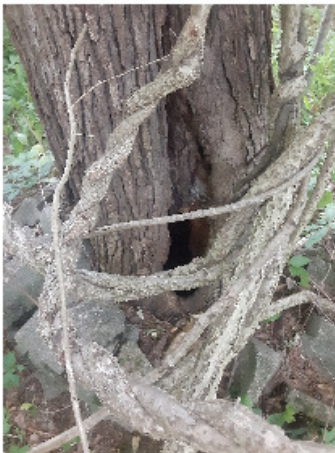
TREE 2728 Red Maple

Acer rubrum Date Inspected 08-18-2022
DBH 20" Tree Height 50' TO 60'
TREE PROTECTION ZONE 30'
TPZ RADIUS (measured from trunk) 15.0'
PROTECT No
PROTECTION
AIR EXCAVATION REQUIRED N
POTENTIAL FOR FAILURE PROBABLE
RECOMMENDATION TAKEDOWN

has a hollow trunk

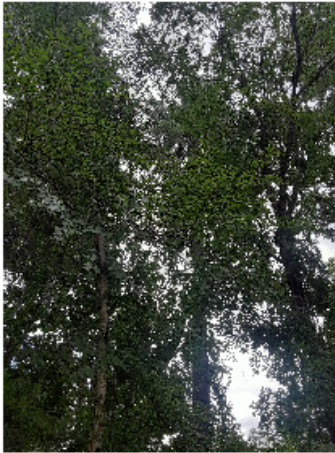
TREE 2729 White Pine

the trunk looks solid

Pinus strobus **Date Inspected** 08-18-2022
DBH 32" **Tree Height** 70' TO 80'
TREE PROTECTION ZONE 30'
TPZ RADIUS (measured from trunk) 15.0'
PROTECT Yes
PROTECTION **FENCING AROUND TPZ**
AIR EXCAVATION REQUIRED N
POTENTIAL FOR FAILURE
RECOMMENDATION

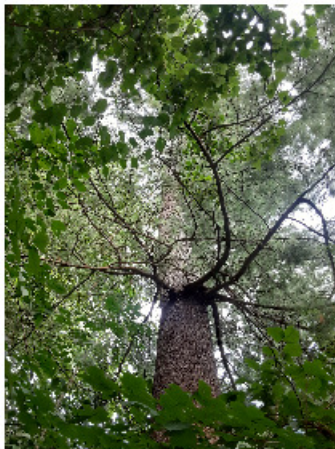
TREE 2730 White Pine

the tree looks good

Pinus strobus **Date Inspected** 08-18-2022
DBH 28" **Tree Height** 80' TO 90'
TREE PROTECTION ZONE 45'
TPZ RADIUS (measured from trunk) 22.5'
PROTECT Yes
PROTECTION **FENCING AROUND TPZ**
AIR EXCAVATION REQUIRED N
POTENTIAL FOR FAILURE
RECOMMENDATION

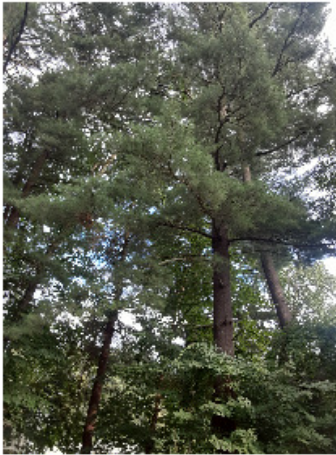
TREE 2731 White Pine

the tree looks good

Pinus strobus **Date Inspected** 08-18-2022
DBH 31" **Tree Height** 80' TO 90'
TREE PROTECTION ZONE 45'
TPZ RADIUS (measured from trunk) 22.5'
PROTECT Yes
PROTECTION **FENCING AROUND TPZ**
AIR EXCAVATION REQUIRED N
POTENTIAL FOR FAILURE
RECOMMENDATION

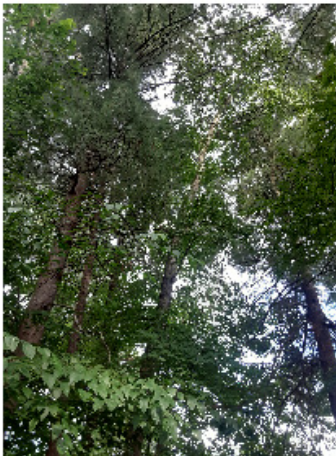
TREE 2732 Red Maple

the tree looks good, the tree is on-sided towards the back neighbor

Acer rubrum **Date Inspected** 08-18-2022
DBH 20" **Tree Height** 50' TO 60'
TREE PROTECTION ZONE 25'
TPZ RADIUS (measured from trunk) 12.5'
PROTECT Yes
PROTECTION **FENCING AROUND TPZ**
AIR EXCAVATION REQUIRED N
POTENTIAL FOR FAILURE
RECOMMENDATION

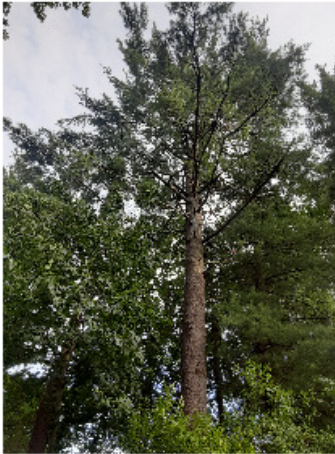
TREE 2733 White Pine

the tree looks good, there are some lower dead branches

Pinus	strobus	Date Inspected	08-18-2022
DBH	39"	Tree Height	50' TO 60'
TREE PROTECTION ZONE	40'		
TPZ RADIUS (measured from trunk)	20.0'		
PROTECT	Yes		
PROTECTION	FENCING AROUND TPZ		
AIR EXCAVATION REQUIRED	N		
POTENTIAL FOR FAILURE			
RECOMMENDATION

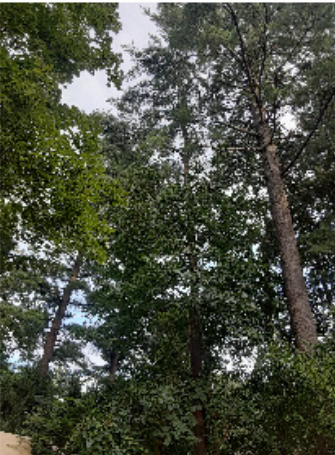
TREE 2734 White Pine

there is an oak tree embedded in the trunk creating a cavity, it is onside towrds the neighbor

Pinus	strobus	Date Inspected	08-18-2022
DBH	24"	Tree Height	70' TO 80'
TREE PROTECTION ZONE	40'		
TPZ RADIUS (measured from trunk)	20.0'		
PROTECT	No		
PROTECTION			
AIR EXCAVATION REQUIRED	N		
POTENTIAL FOR FAILURE	PROBABLE		
RECOMMENDATION	TAKEDOWN

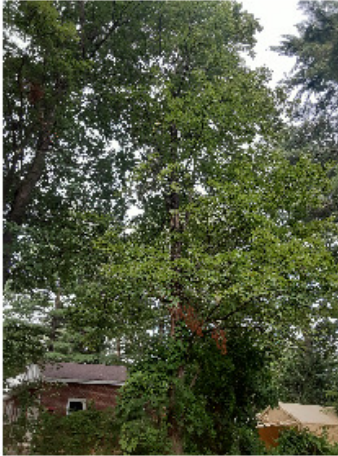
TREE 2735 Acer Rubrum

the tree looks good, has bittersweet growing up the trunk that should be removed

PROTECTION **FENCING AROUND TPZ**

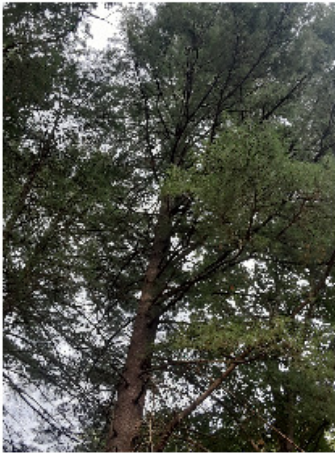
TREE 2736 White Pine

the tree looks good, the tree has some deadwood

PROTECTION **FENCING AROUND TPZ**

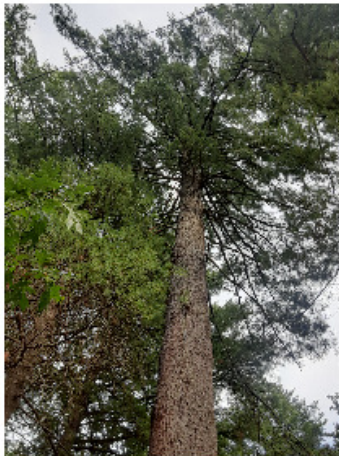
TREE 2738 White Pine

Pinus strobus **Date Inspected** 08-18-2022
DBH 33" **Tree Height** 80' TO 90'
TREE PROTECTION ZONE 50'
TPZ RADIUS (measured from trunk) 25.0'
PROTECT Yes
PROTECTION **FENCING AROUND TPZ**
AIR EXCAVATION REQUIRED N
POTENTIAL FOR FAILURE
RECOMMENDATION

the tree looks good, the tree has some deadwood

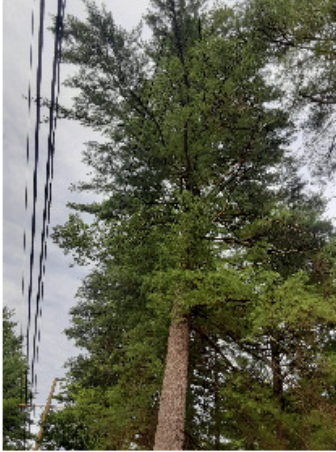
TREE 2739 White Pine

Pinus strobus **Date Inspected** 08-18-2022
DBH 32" **Tree Height** 80' TO 90'
TREE PROTECTION ZONE 40'
TPZ RADIUS (measured from trunk) 20.0'
PROTECT Yes
PROTECTION **FENCING AROUND TPZ**
AIR EXCAVATION REQUIRED N
POTENTIAL FOR FAILURE
RECOMMENDATION

the tree has some surface girdling roost, there is some needlecast symptoms in the canopy,

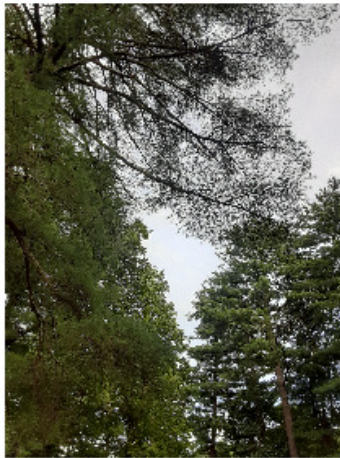
TREE 2740 White Pine

Pinus strobus **Date Inspected** 08-18-2022
DBH 39" **Tree Height** 80' TO 90'
TREE PROTECTION ZONE 40'
TPZ RADIUS (measured from trunk) 20.0'
PROTECT No
PROTECTION
AIR EXCAVATION REQUIRED N
POTENTIAL FOR FAILURE PROBABLE
RECOMMENDATION TAKEDOWN

the tree has significant needlecast symptom, consider removal
