Project Name
EXISTING CONDITION PHOTOGRAPHS

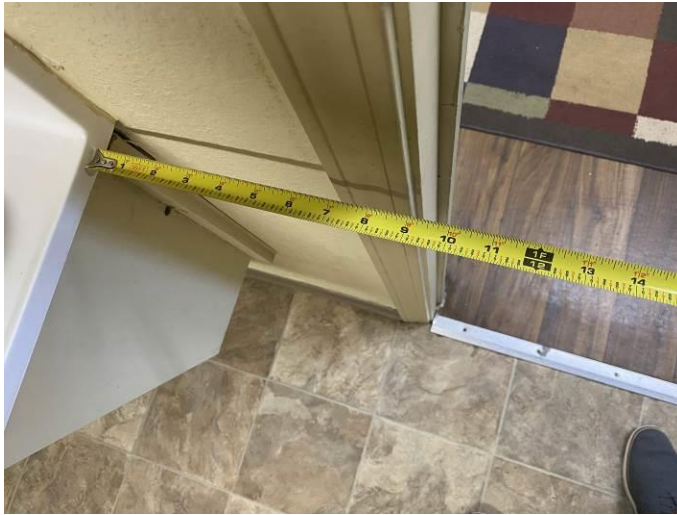
ORIGINAL Move sink over 8 inches

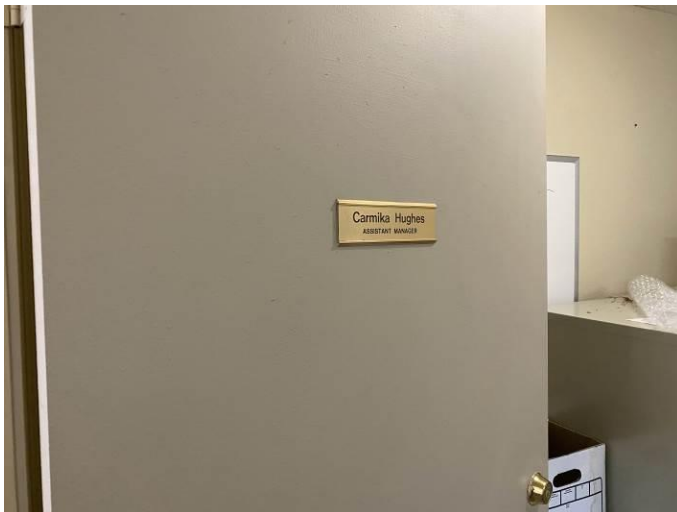
Improper office signage

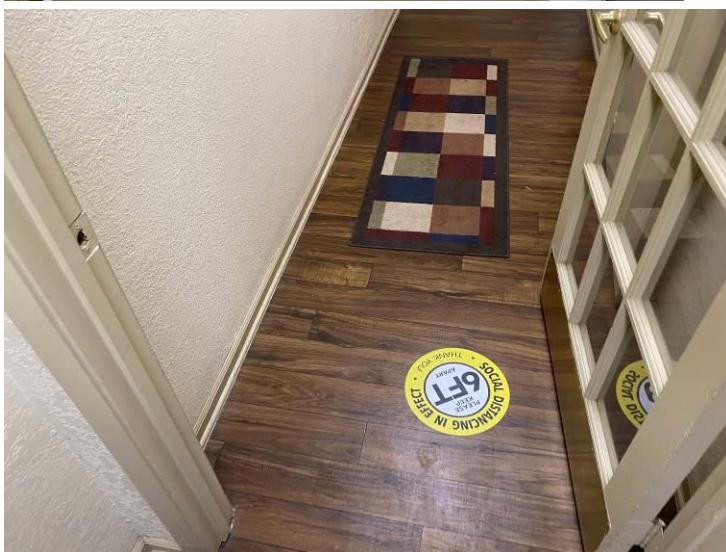
Corridor door should be removed
(18 inches minimum pull front
approach)

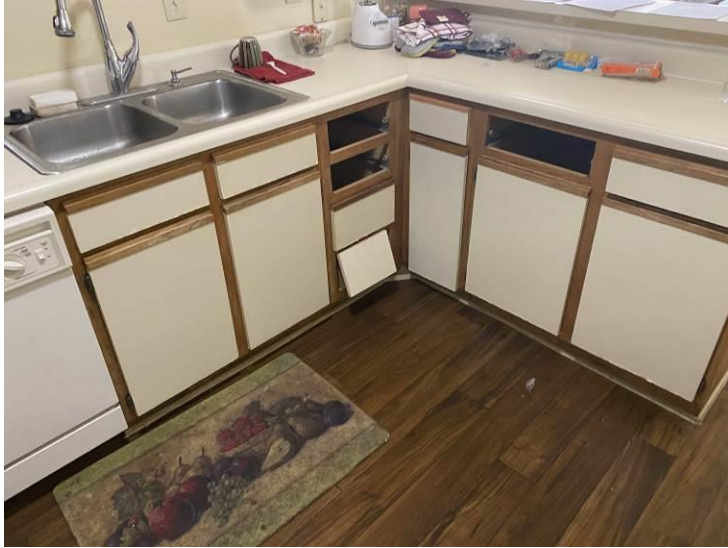
Broken cabinets, no legroom under sink, load center too high

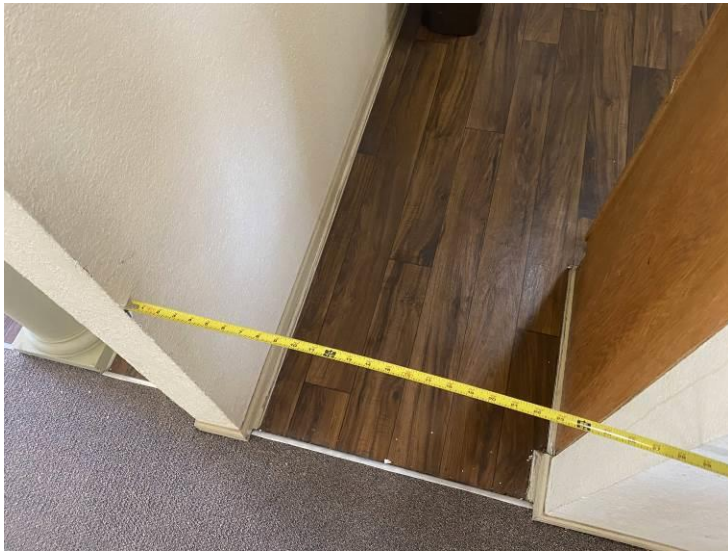
Aisle into kitchen is 28.5 inches

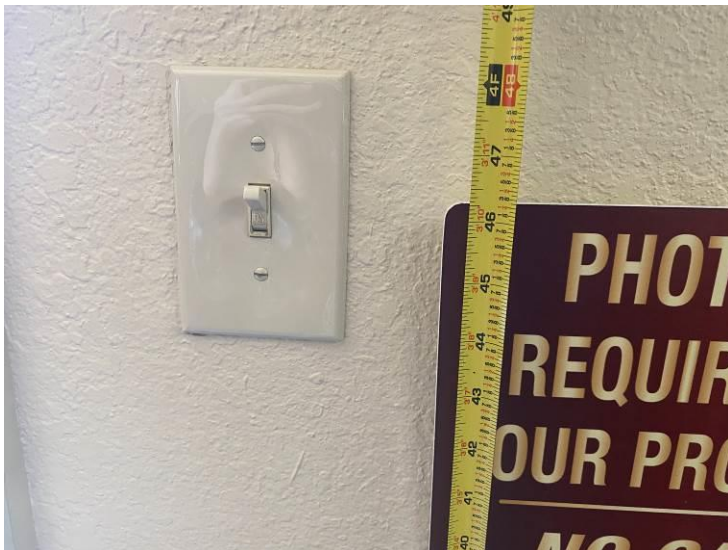
Light switch at 46

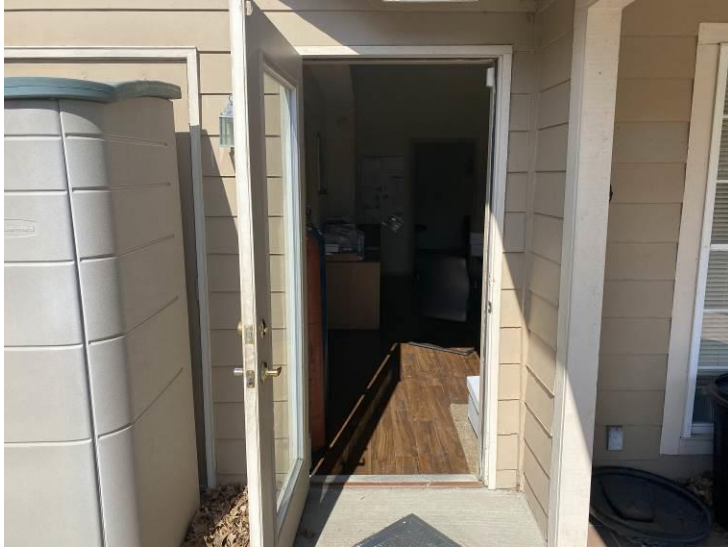
18 inches required front pull approach

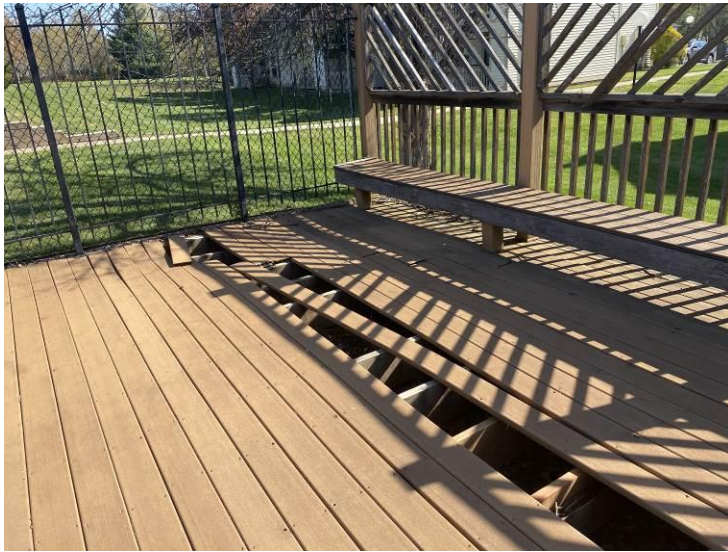
Damaged pool deck

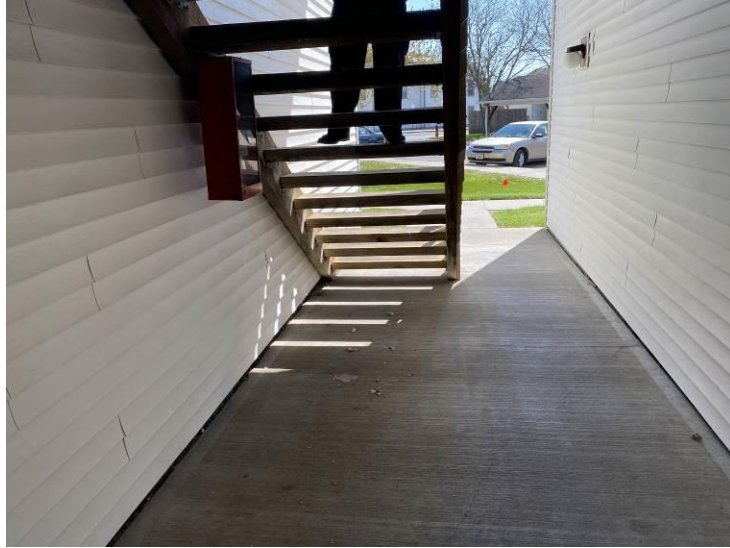
Protruding stairwell
