May 3, 2023

Project Safety Inspection

FAIRFAX CORNER

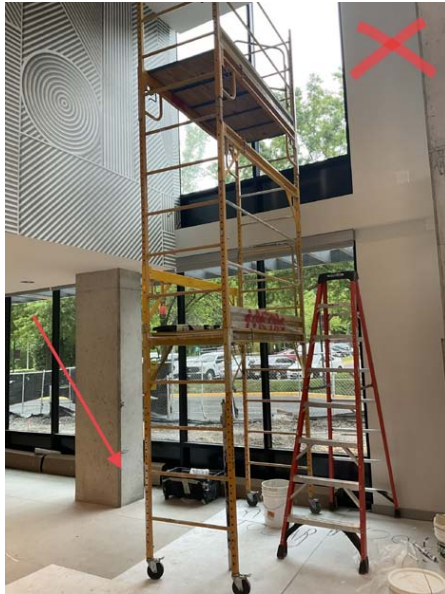
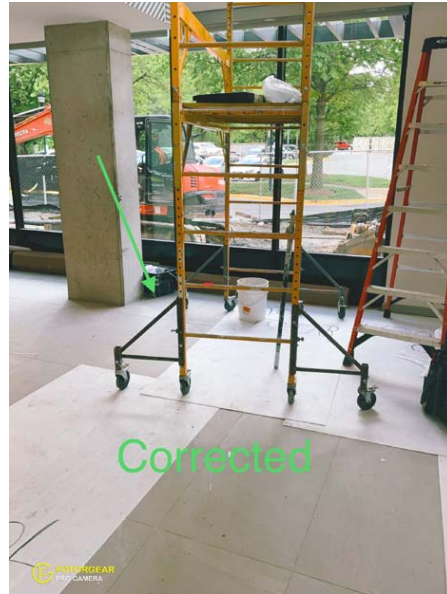
Observation 1

Missing parts

Level 1 we found this scaffold that was missing outrigger which is not safe to work like that . We talk to painters they did the correction.

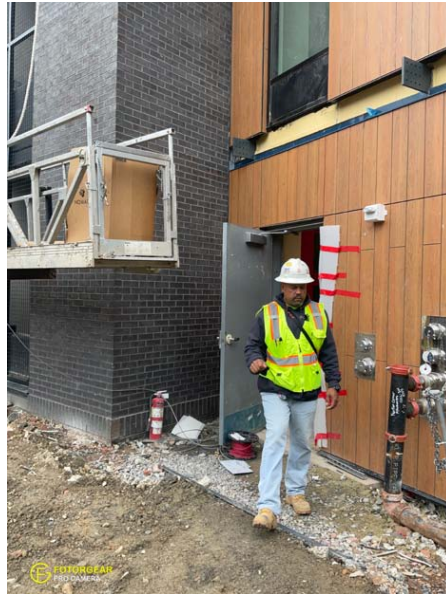
Observation 2

Precautions

Ground level this door needs to be closed because there is a swing stage above or we can place a over head protection

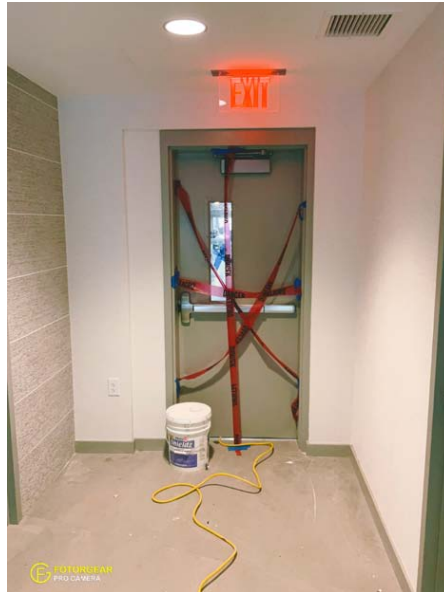
Observation 3

Preventions

Parking garage they are doing coat in the floor they have closed doors to prevent people slip or trip

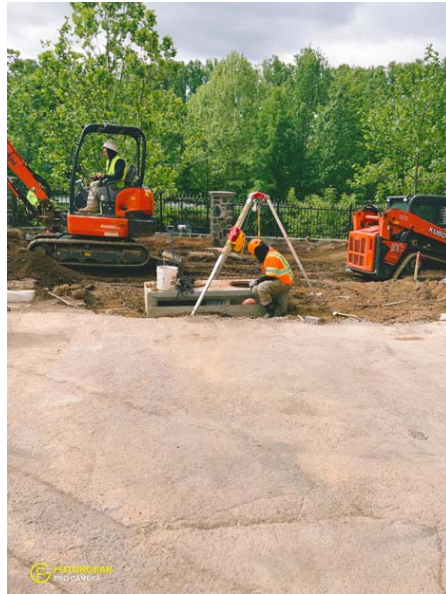
Observation 4

Precautions

Ground level they are working in a main Hole for good prevention they have confined space tripod installed which is a safe operation

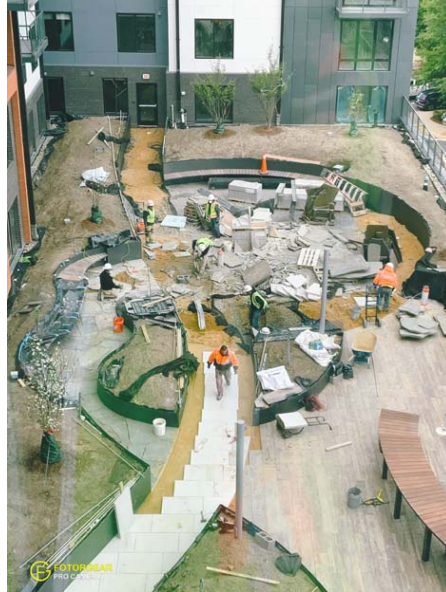
Observation 5

Personal protective equipment

Level 4 we found some guys working in court yard with not hard hat on . We talked to them they did the correction

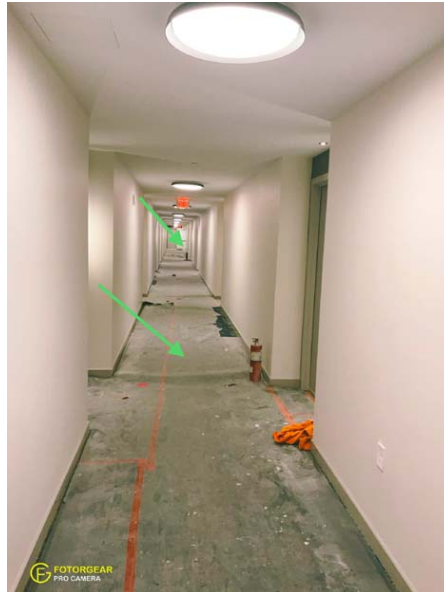
Observation 6

Fire protection

Level 7 fire extinguishers are there in the middle of walkway ready to be use in case of fire
