# Adrift – Problem solving FS2 drift issues. – Squirrel Engineering

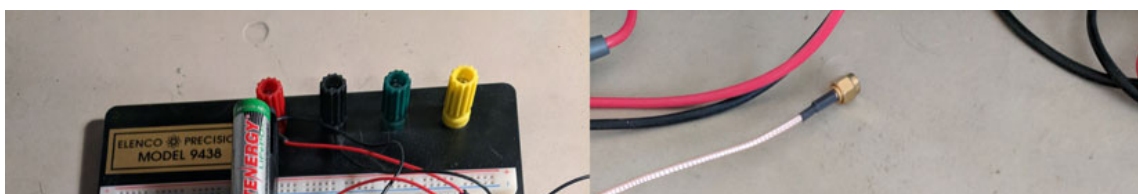
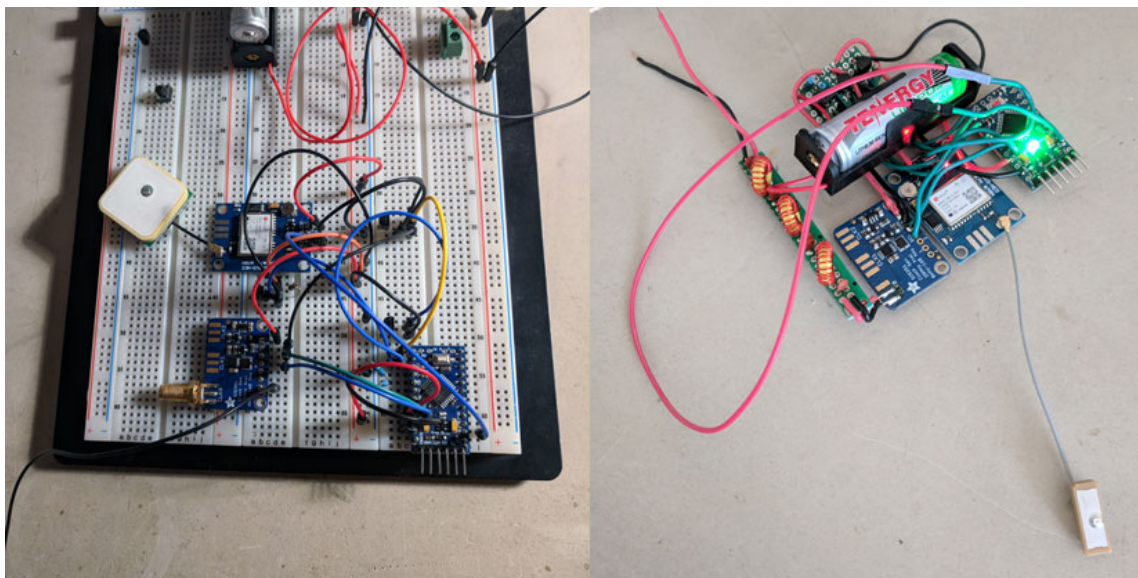
On the breadboard prototype the signals were being decoded almost every time FS2 transmitted a WSPR message. However, on the flight hardware, many of the WSPR transmit sequences were not decoding. Stranger yet, of the two types of WSPR messages FS2 sends (Type 2 & Type 3) one or the other would decode, but not both. Sometimes I would get the Type2 messages every time and an occasional Type3 message decode. Other times it was the reverse. Very strange!

A view of the FS2 breadboard prototype and the flight hardware circuit.

After constructing the first flight hardware, I ripped it apart and built a new version, making some improvements along the way. I suspected that maybe the proximity of the Si5351A board (Radio) and the Arduino Pro (Microprocessor) might be causing some interference.

This change produced no improvement.

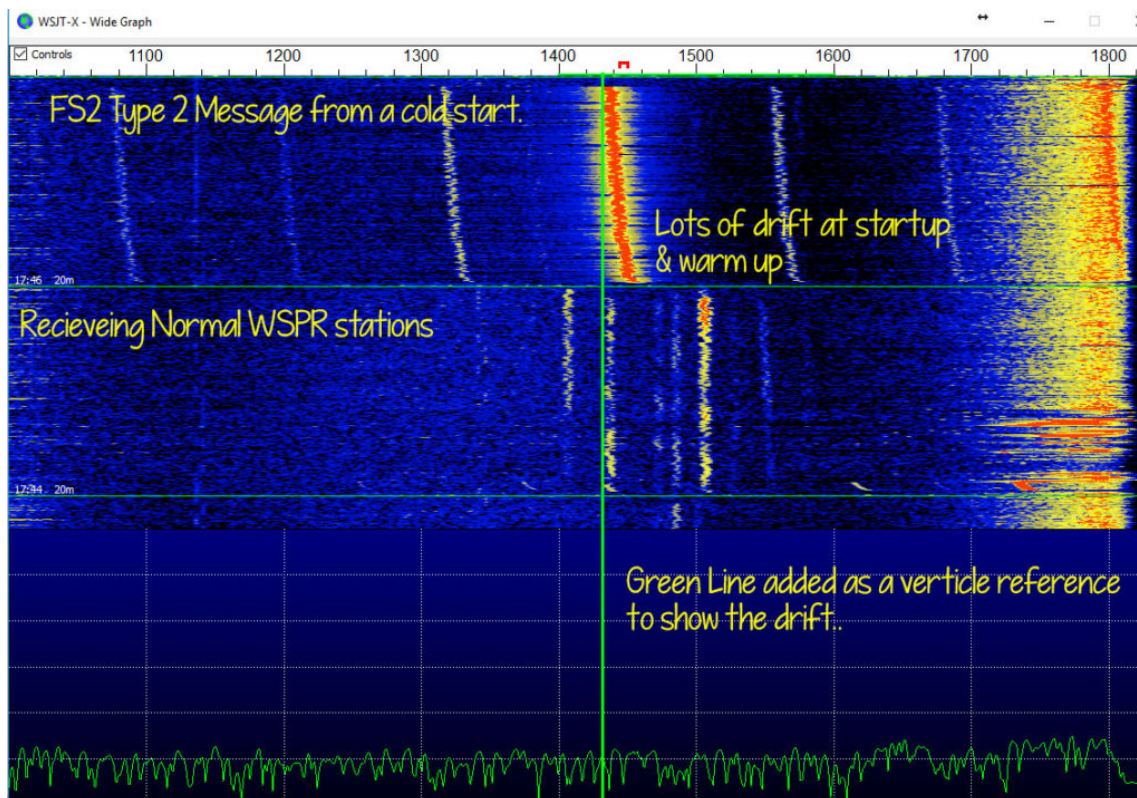
As I tested, I observed that the Si5351A drifted in frequency quite a bit as it warmed up from a cold start. A drift of about 25hz was clearly observable in the WSPR waterfall display. A WSPR signal has a total bandwidth of 6 Hz, so a 25Hz drift is significant. The main culprit of this drift is temperature change.

Waterfall showing FS2 sending a WSPR type 2 Message from a cold start. Compare the angles line vs the straight signal traces transmitted in the preceding time slot (Below). Also seen are FS2 images frequencies every 120Hz above and below the main signal due to mixing products with the local power mains. ( $2 \times 60 \text{ Hz} = 120$ ) This is normal for very strong WSPR signals.

To conserve battery power, FS2 shuts off the radio board and the GPS when not needed. When FS2 is ready to send telemetry, it powers up the radio shortly before transmission begins. This causes some noticeable drift to occur as the chip begins to heat up a small amount. The FS1 balloon, got around this by transmitting a 5 second tuning signal that allowed the radio to warm up and stabilize from a cold start before data was sent. The WSPR protocol will not allow this extra warm up signal without causing interference to others, so that was not an

option. With a little clever arrangement of the FS2 Telemetry schedule this problem was solved a large degree. A minute prior to sending the Type 2 WSPR message, FS2 will send a tuning signal followed by a FSQ telemetry message, on a separate frequency, at 3 baud which takes approximately 50 seconds to send. The radio board is left powered on, but not transmitting, so that the radio stays warm for the start of the 2 minute WSPR message type 2 transmission and then remains on until the 2 minute WSPR type 3 message is complete.

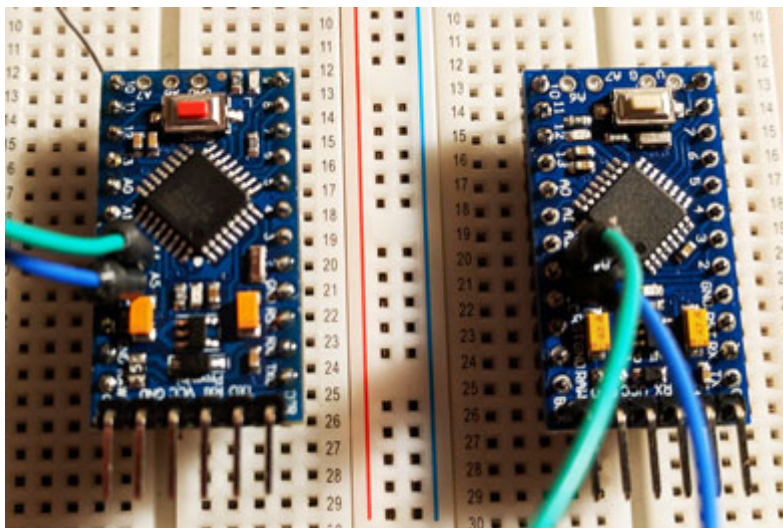
Two weeks into this problem, I could clearly demonstrate that swapping a white button Arduino with a red button Arduino caused failure. I ordered a few more white button models and tested with them and had mixed results, none of which were great. They were better or worse but not perfect. What was the difference between these boards?

The two versions of Arduinos used in FS2 development. Notice the different button colors and very slight changes to parts placement.

hardware problem which lead to two weeks (not full time) of hair ripping diagnostic delay getting working flight hardware. I suspect that there is just a slight difference in timing between the boards and the timing error was just at a threshold of good enough for a decode on the white button board. The red button version might just a bit slower pushing past the threshold and failing. This would probably be a very small amount of difference, but maybe enough to push past a threshold of acceptable signal quality.

```
1 for (int i = 0; i < symbol_count; i++)
2 {
3   unsigned long starttime = micros();
4   si5351.set_freq((freq * 100) +
5 (tx_buffer[i] * tone_spacing),
6 SI5351_CLK0);
7 while ((micros() - starttime) <
8 tone_delay) {};
9 }
```

This new code makes timing much more accurate. First it uses a Micro-second timer `micros()` which has the resolution to give a much more proper 0.682667 delay. (Plus or minus a few microseconds error, that averages out). There is no accumulating roundoff of the delay time now. The code also considers the time needed for the frequency change function by starting the time just before the function call `set_freq()`. The latter error was the most significant source of the decoding problems.
