Annual Monitoring Report 2008
Central Appalachia Mining, LLC
USACE Authorization No. 200400215
Remining No. 2 Surface Mine

Remining No. 2 Surface Mine

Lick Fork/Grapevine Creek Stream Restoration

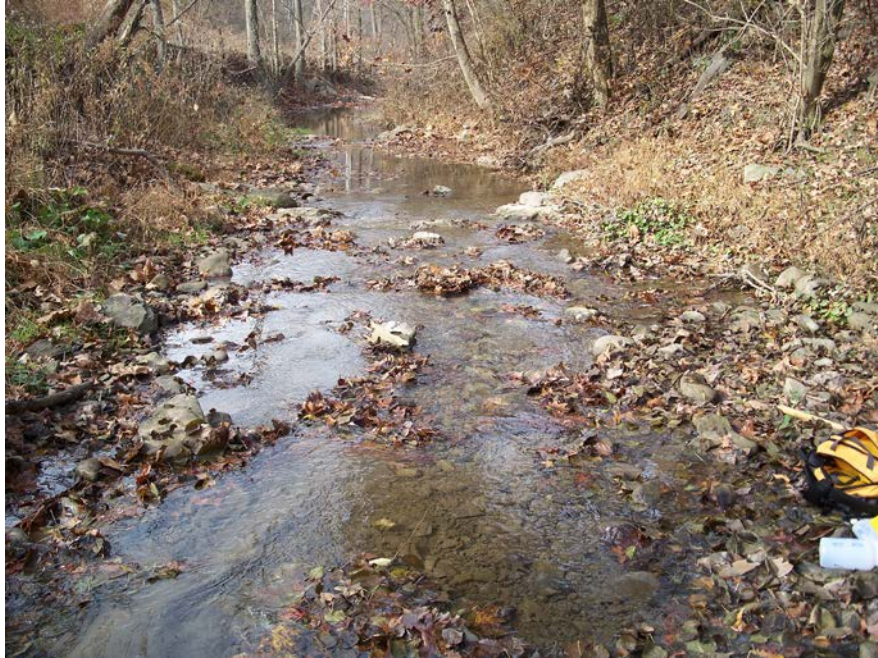
Downstream view of Benthic Site 028 within Lower Grapevine Fork.

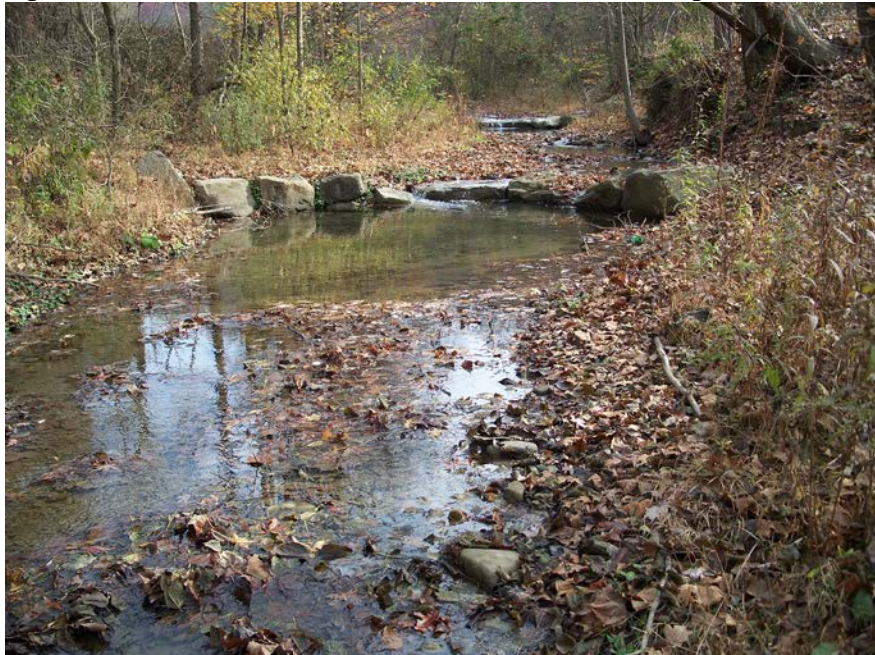
Upstream view of Benthic Site 028 within Lower Grapevine Creek.

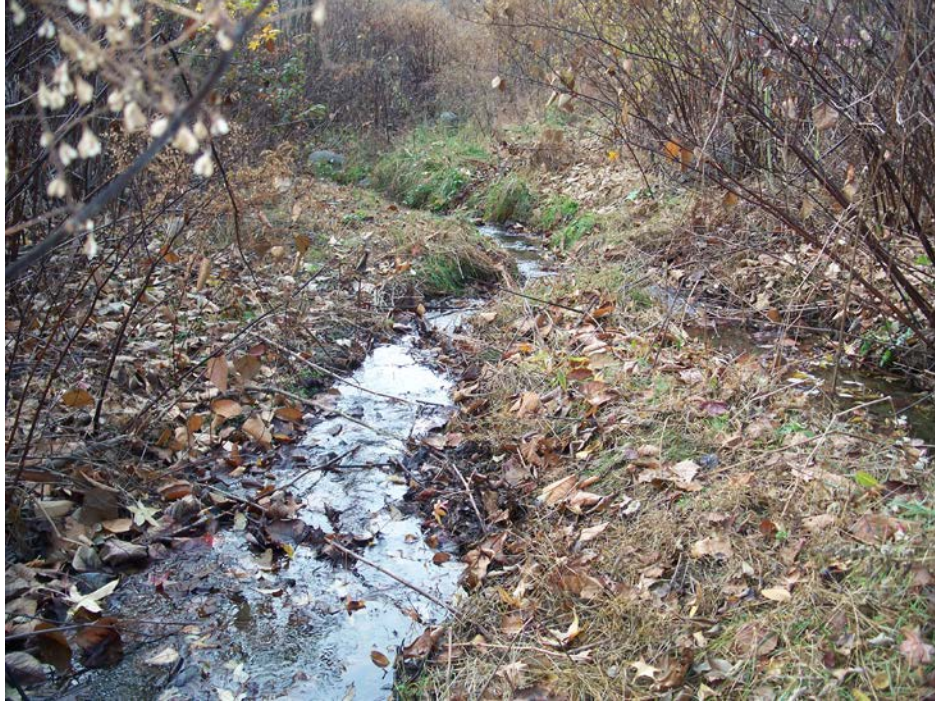
Downstream view of Benthic Site 029 located within Lick Fork

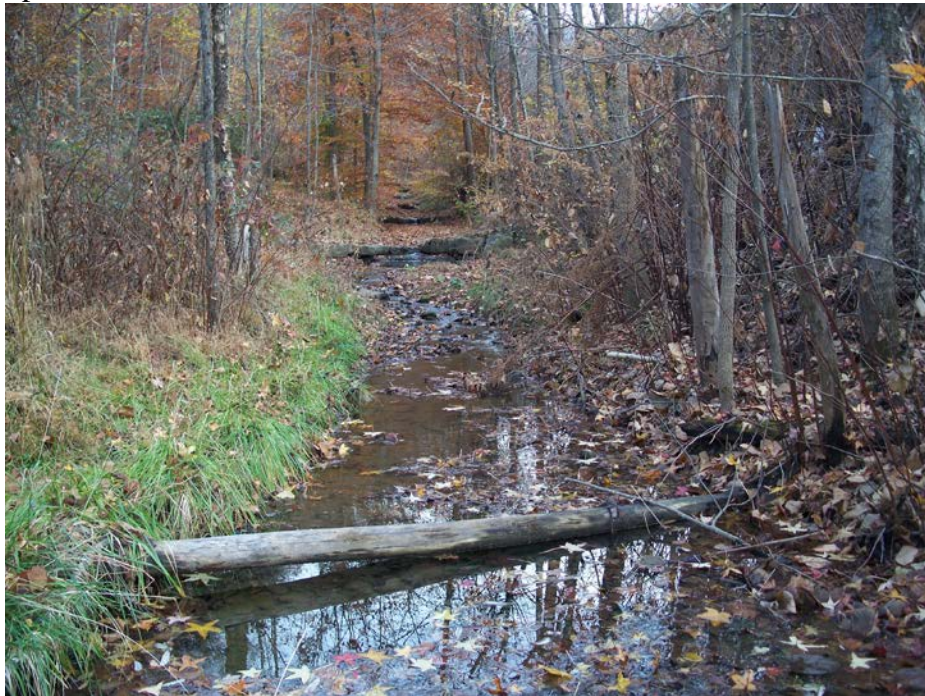
Upstream view of Benthic Site 029 located within Lick Fork
