**Nally & Hamilton Enterprises, Inc.
USACE LRL-2008-00751
KDNR #866-0311
2013 Annual Mitigation Report**

May 17, 2013

USACE, LRN-2008-00751

Project Overview	
United States Army Corps of Engineers District	Lakes Region Louisville (LRL-2008-00751)
Party Responsible for Monitoring	Biological Systems Consultants, Inc.
Date of Annual Report	May 17, 2013
Mitigation Location	Leslie County, KY
Type of Impact	Stream
Type of Mitigation	On-site Stream Mitigation Following Pond Removal
Location Coordinates	Lat.: N 36.934543 / Long.: W -83.477452

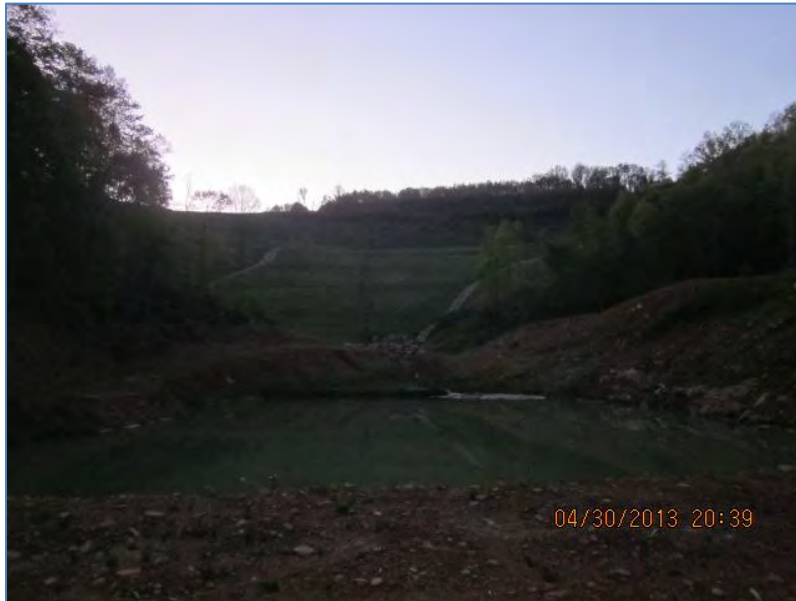
Mitigation Area: Pond 2
Latitude/Longitude: N 36.929315 / W-83.774796
Direction Facing: North
Date: April 30, 2013
Notes: Pond in place
