YEAR ONE MONITORING REPORT
UNITED STATES CORPS OF ENGINEERS
Little Sue Branch Reach 11
KDNR PERMIT NO. 813-0361

Prepared:
December 19, 2011

Laurel Mountain Resources, LLC Little Sue Branch Reach 11 Mitigation Year One Monitoring Report

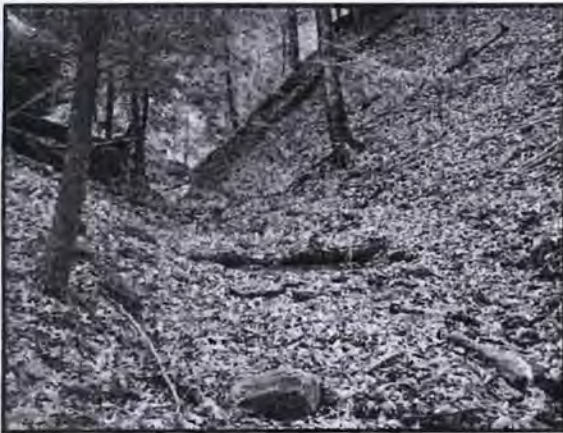
Figure 1. Little Sue Branch Reach 11 11/10/11
Pic. 763 Facing Upstream, 37.58225, -83.15538

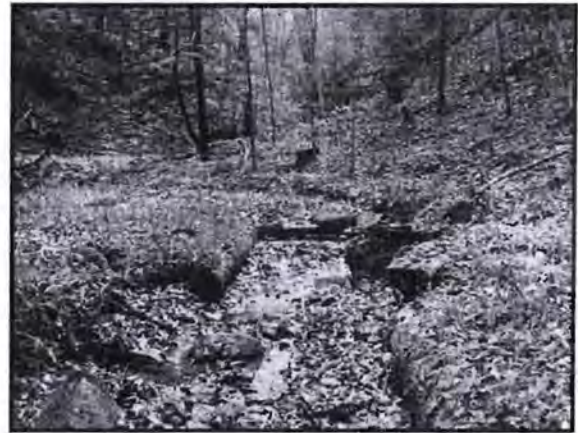
Figure 2. Little Sue Branch Reach 11 11/10/11
Pic. 765 Facing Upstream, 37.58263, -83.15628

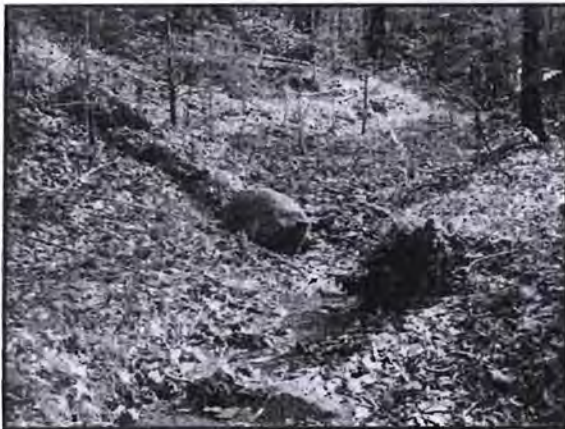
Figure 3. Little Sue Branch Reach 11 11/10/11
Pic. 766 Facing Upstream, 37.58287, -83.15638

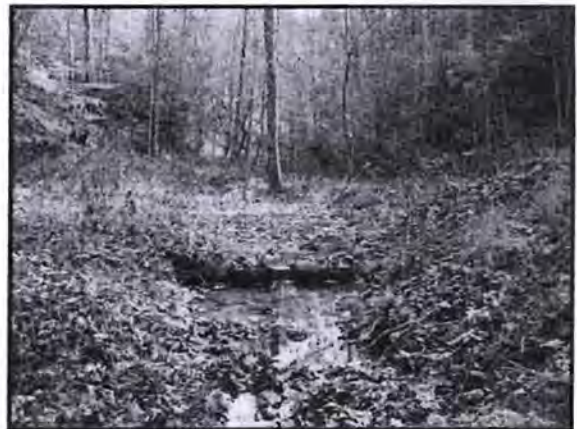
Figure 4. Little Sue Branch Reach 11 11/10/11
Pic. 769 Facing Upstream, 37.58381, -83.15745

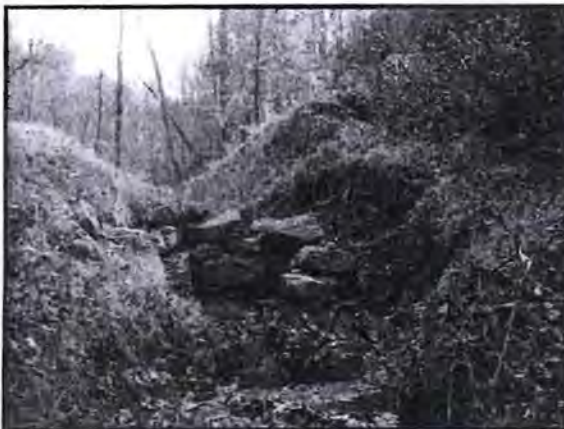
Figure 5. Little Sue Branch Reach 11 11/10/11
Pic. 770 Facing Upstream, 37.58387, -83.15769

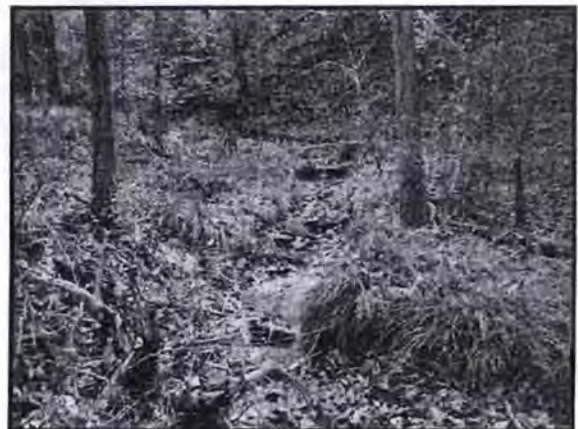
Figure 6. Little Sue Branch Reach 11 11/10/11
Pic. 772 Facing Upstream, 37.58447, -83.15853
