YEAR TWO MONITORING REPORT
UNITED STATES CORPS OF ENGINEERS
Salyers Branch Mitigation
KDNR PERMIT NO. 836-0407

Laurel Mountain Resources, LLC.

Prepared:
December 28, 2011

Laurel Mountain Resources, LLC. Salyers Branch Mitigation Year Two Monitoring Report

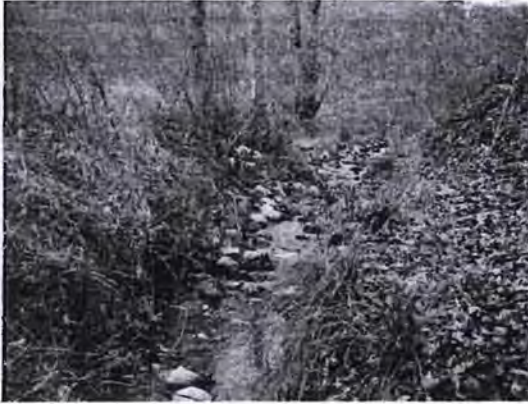
Figure 1 Looking Upstream Upper Reach 11/30/11 Pic. 897

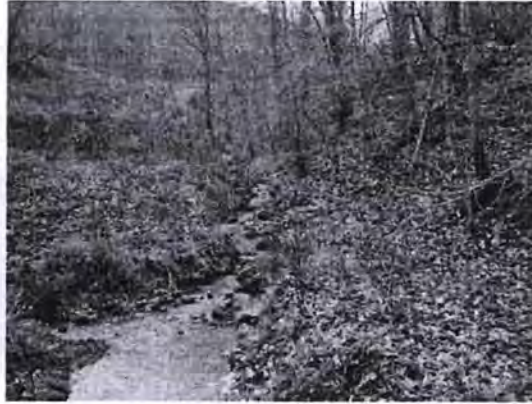
Figure 2 Looking Upstream Upper Reach 11/30/11 Pic. 896

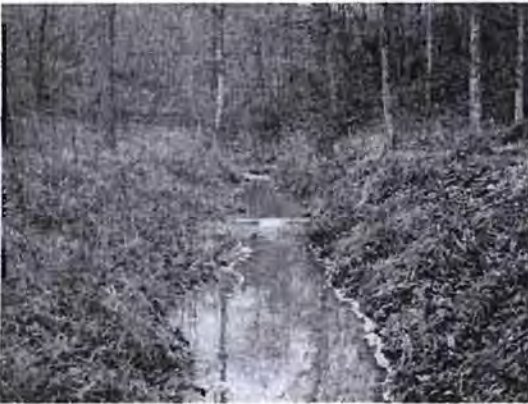
Figure 3 Looking Upstream Middle Reach 11/30/11 Pic. 894

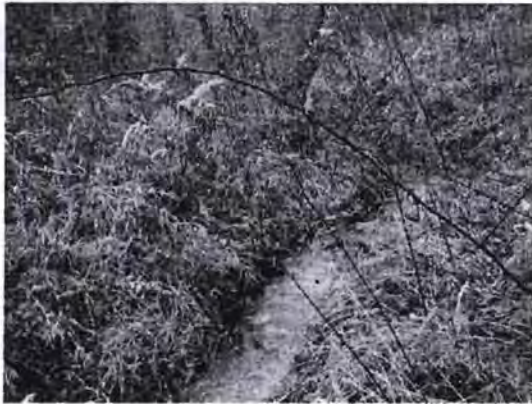
Figure 4 Looking Upstream Middle Reach 11/30/11 Pic. 895

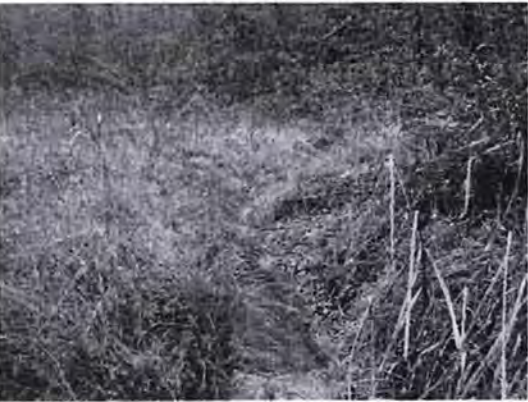
Figure 5 Looking Upstream Lower Reach 11/30/11 Pic. 888

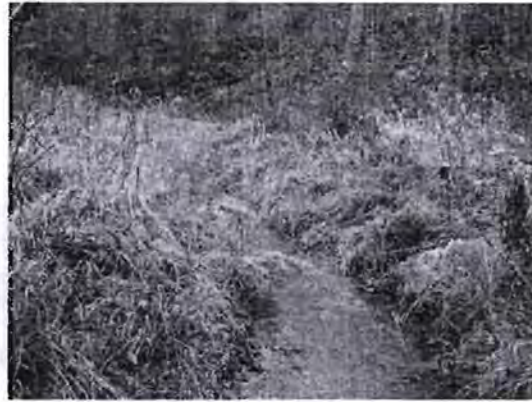
Figure 6 Looking Upstream Lower Reach 11/30/11 Pic. 887
