Annual Monitoring Report
Joe Branch Surface Mine No. 1
Beech Branch Stream Restoration
JMAC Leasing, Inc
08228

Annual Monitoring Report

Joe Branch Surface Mine No. 1

Beech Branch Stream Restoration

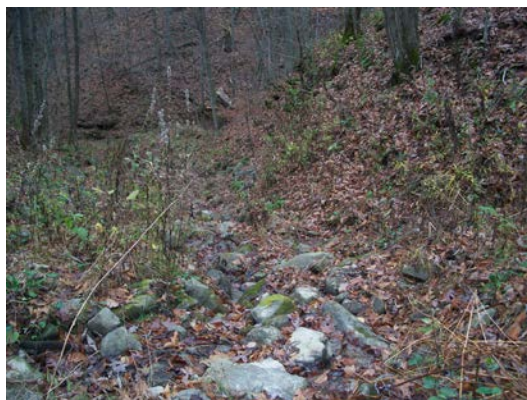
Downstream view of Benthic Site 015 in the UT of Beech Branch

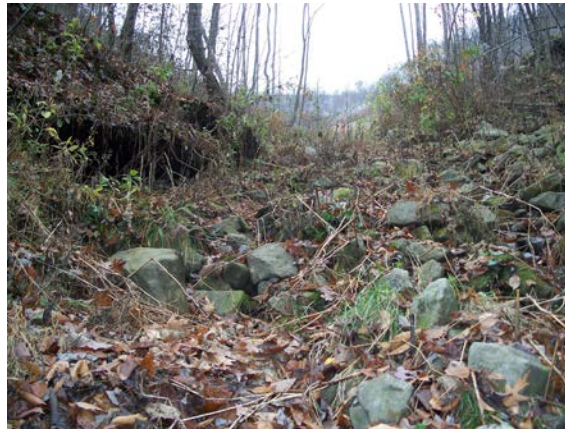
Upstream view of Benthic Site 015 in the UT of Beech Branch

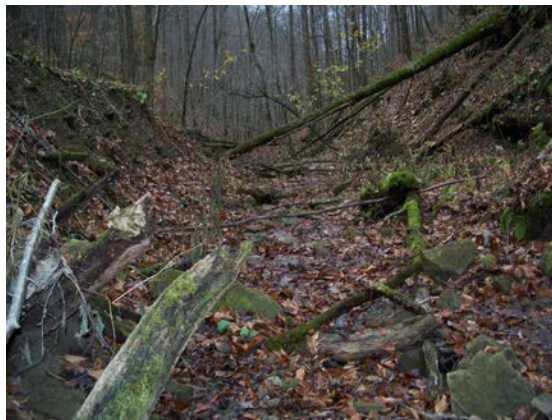
Downstream view of Benthic Site 016 in Beech Branch

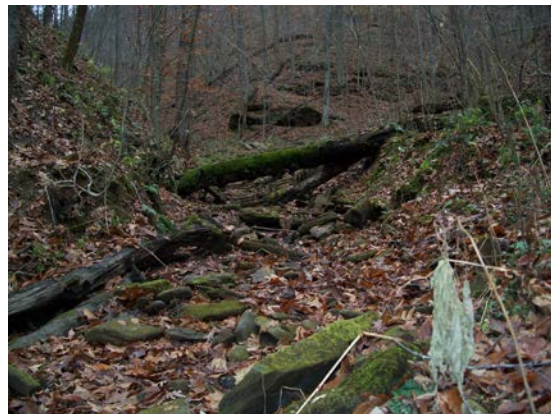
Upstream view of Benthic Site 016 in Beech Branch
