RE: Nally & Hamilton Enterprises, Inc. / LRL-2006-00340 / KDNR # 860-0404/
Carr Fork / 2011 Mitigation Monitoring Report / BSC# 211046

Nally & Hamilton Enterprises, Inc.
2011 Mitigation Monitoring Report
LRL-2006-00327, KDNR 860-0404
USACE Louisville District
BSC # 211046

**US Army Corp of Engineers
CWA Section 404
2011 Mitigation Monitoring Report**

**USACE # LRL-2006-00327
Kentucky Department for
Natural Resources SMCRA Permit # 860-0404**

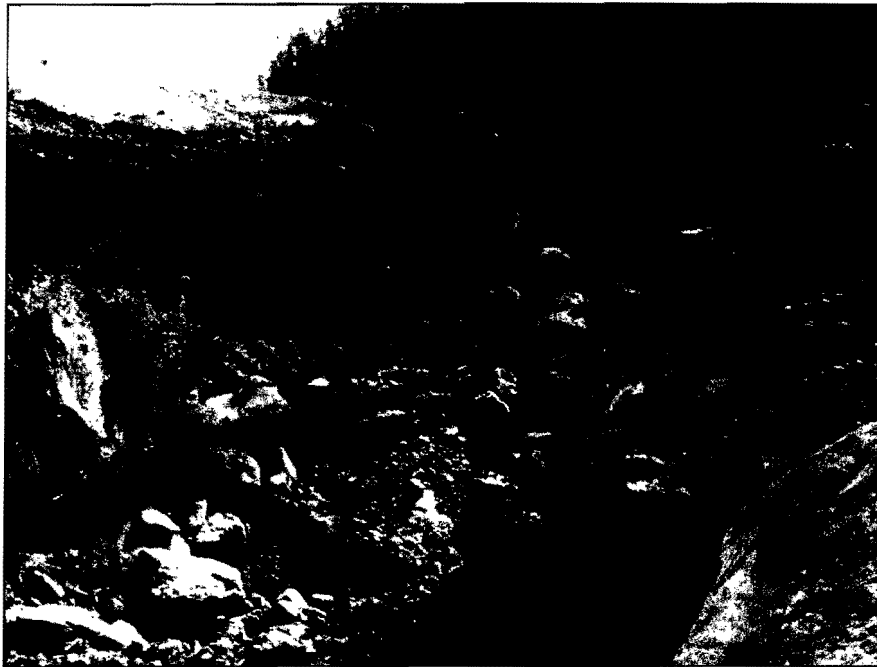
Assessment Site HF#2: facing south

Maintenance activities are currently being completed for the HF#2 mitigation area. Following the use of equipment, revegetation of the riparian corridor will control sedimentation in the mitigation area. To adaptively manage the mitigation site for the purpose of meeting the mitigation plan success criteria, the following recommendations are provided:

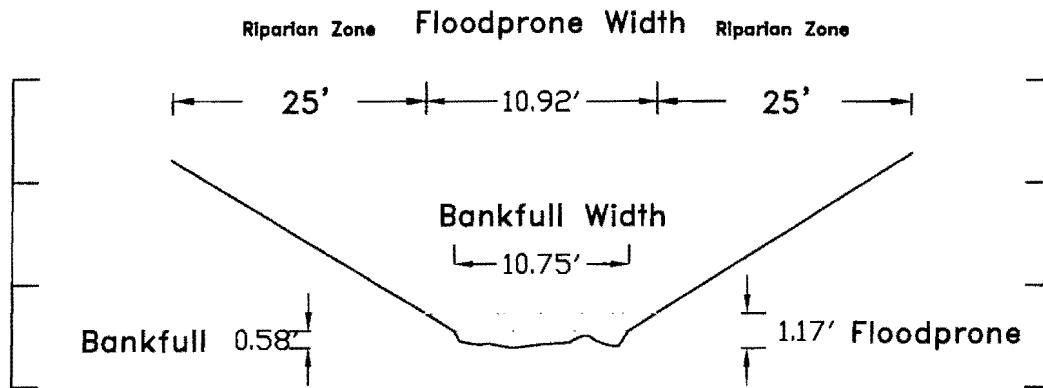
Cross Section #1 (HF2)
Existing stream cross-section

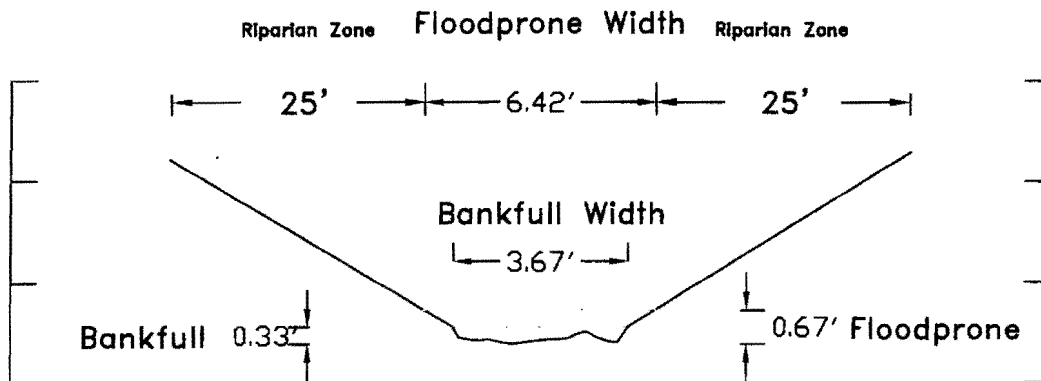
Cross Section #2 (HF1)
Existing stream cross-section
