December 29, 2011

Re: DNR# 866-0281 Am. 8, LRL-2007-334-odm

YEAR TWO MONITORING REPORT
UNITED STATES CORPS OF ENGINEERS
Beech Grove Mitigation
KDNR PERMIT NO. 866-0281 AM 8

ICG Hazard, LLC. Beech Grove Mitigation Year Two Monitoring Report

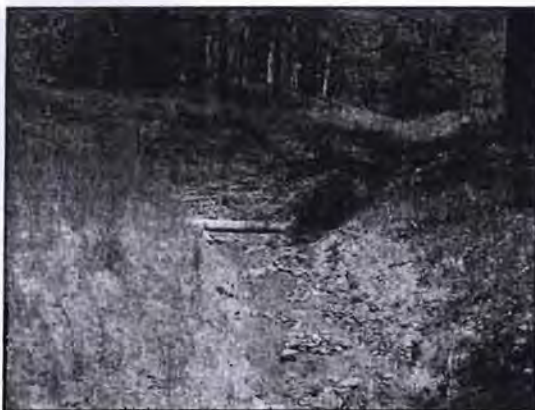
Figure 1. Looking Upstream Upper Reach 5/11/10 Pic. 117

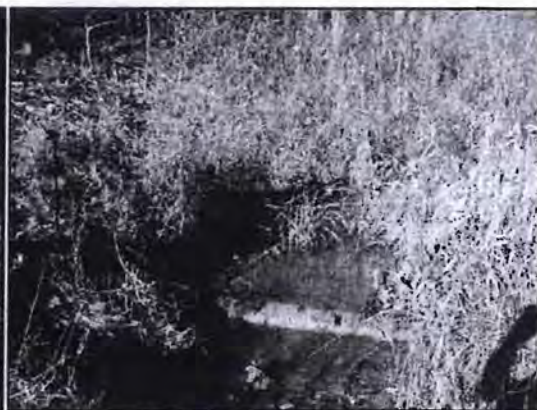
Figure 2. Looking Upstream Upper Reach 12/08/11 Pic. 003

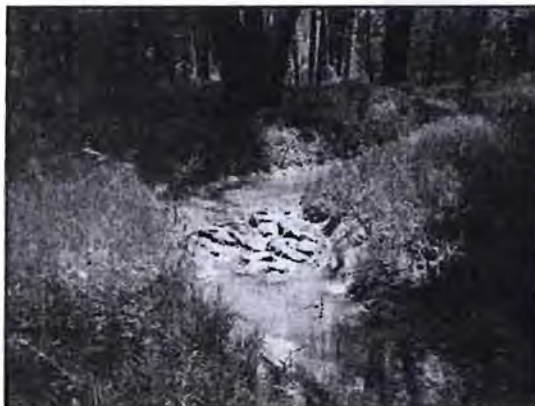
Figure 3. Looking Upstream Upper Reach 5/11/10 Pic. 110

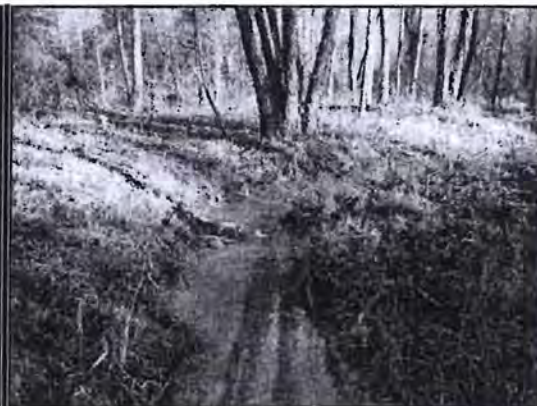
Figure 4. Looking Upstream Upper Reach 12/08/11 Pic. 998

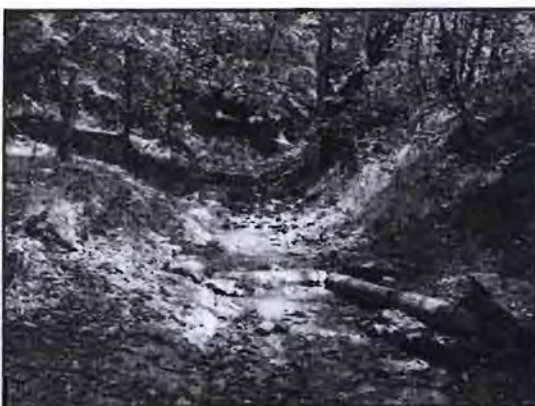
Figure 5. Looking Upstream Middle Reach 5/11/10 Pic. 099

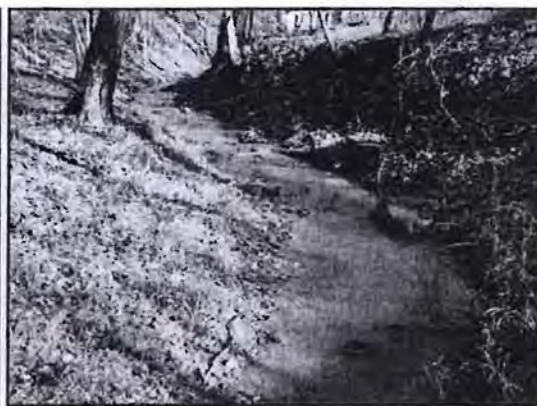
Figure 6. Looking Upstream Middle Reach 12/08/11 Pic. 990

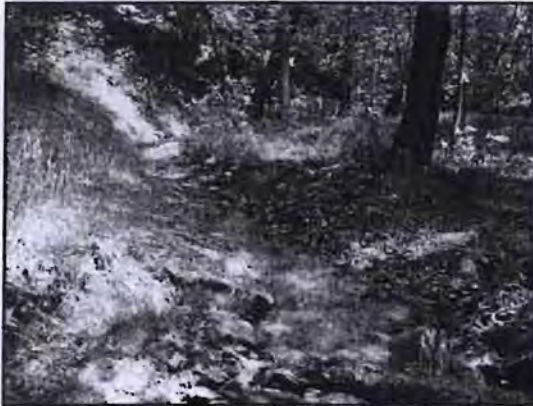
Figure 7. Looking Upstream Middle Reach 5/11/10 Pic. 096

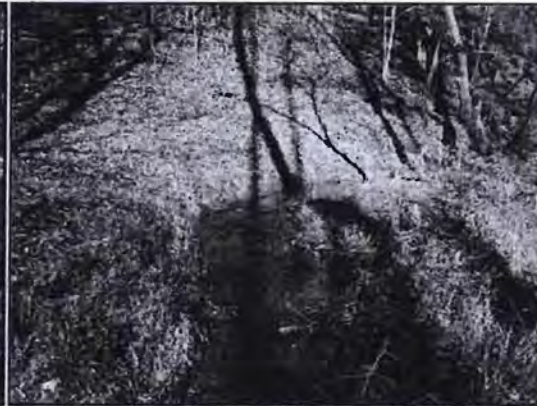
Figure 8. Looking Upstream Middle Reach 12/08/11 Pic. 989

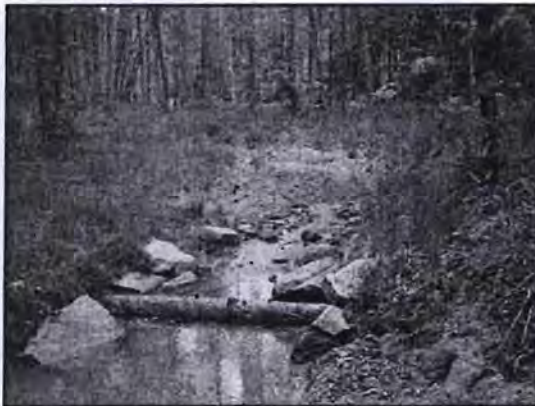
Figure 9. Looking Upstream Lower Reach 5/11/10 Pic. 064

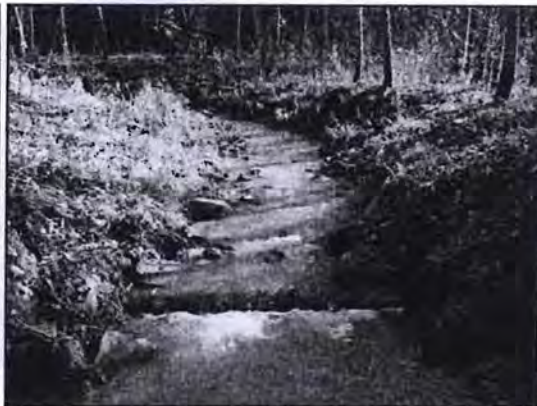
Figure 10. Looking Upstream Lower Reach 12/08/11 Pic. 964

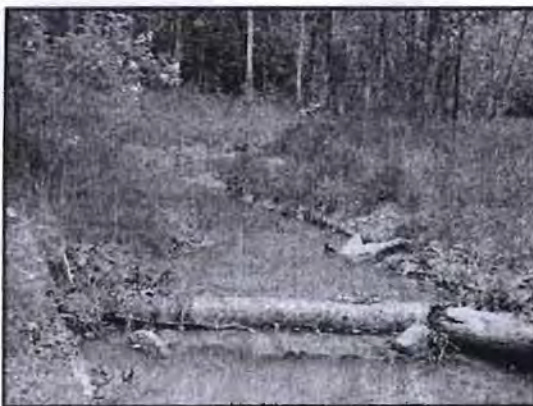
Figure 11. Looking Upstream Lower Reach 5/11/10 Pic. 057

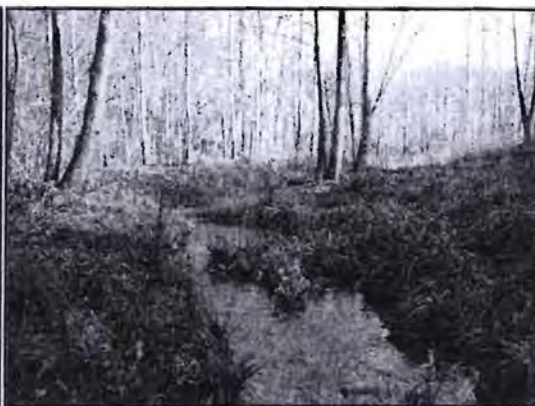
Figure 12. Looking Upstream Lower Reach 12/08/11 Pic. 958
