Mitigation Monitoring Report

White Flame Energy, Inc.

Evans Ferrell Branch

Surface Mine No. 10
(Permit No. S-5015-01)

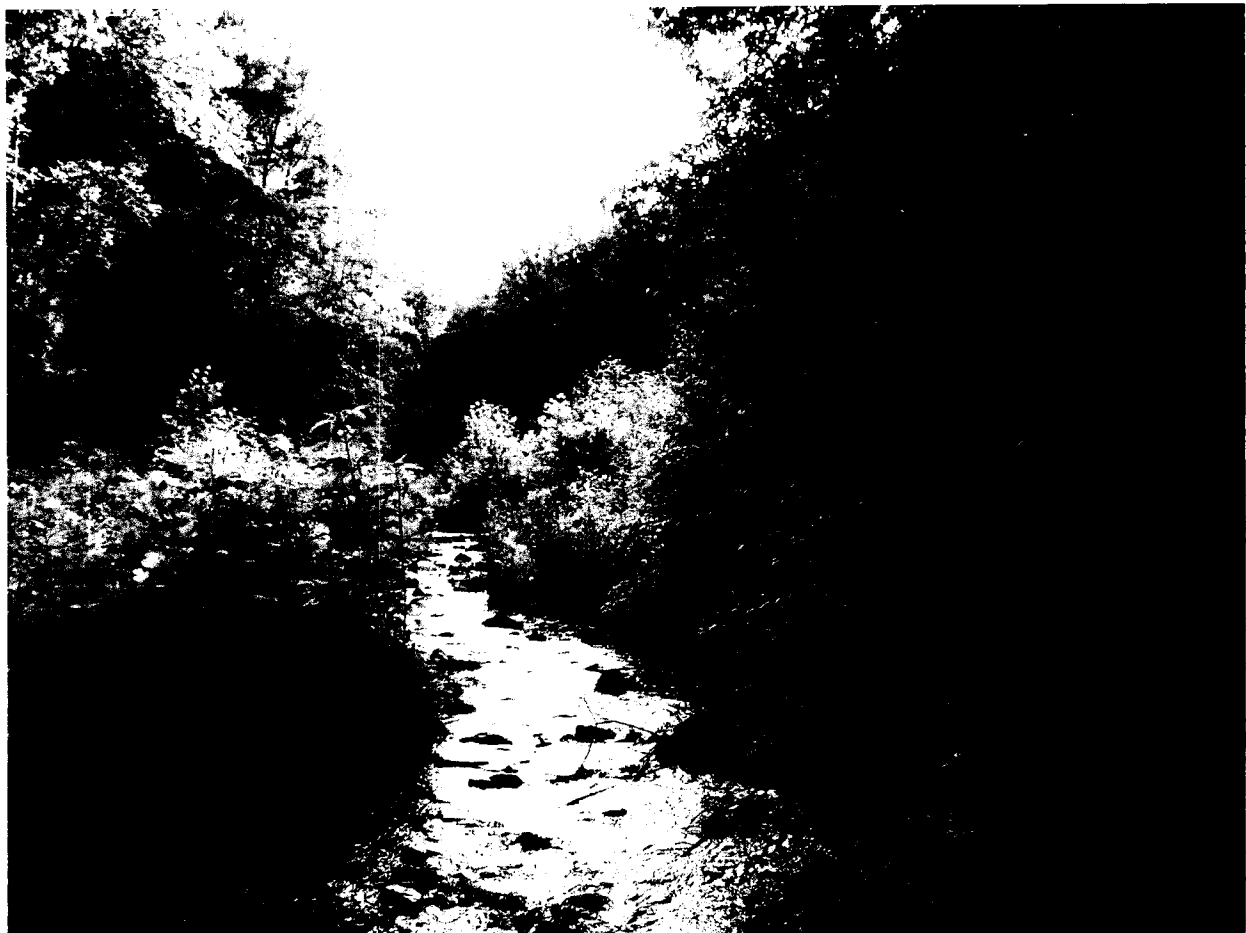
Figure 1. Benthic site 2010.

The mitigation and enhancement activities for Evans Ferrell Branch CMP have been completed (Table 1). A single habitat approach was used to sample benthic macroinvertebrates using the United States Environmental Protection Agency (EPA), Rapid Bioassessment Protocols for use in Streams and Wadeable Rivers. Habitat, benthic, and species richness values collected downstream of mitigation activities of Evans Ferrell Branch (Fig. 1), reflected a suboptimal habitat (142) with a fair WVSCI score (55.38) and a species richness values of eight (Tables 2 and 3).
